Property Health Check

Your Building Survey Report

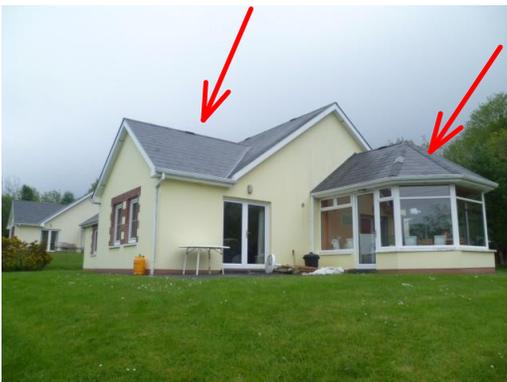
Side conservatory / sunroom added, 10 meters squared.

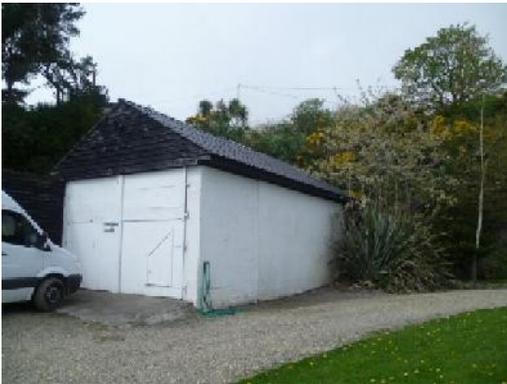
Size of out building, c.45 meters squared for masonry building.
+ 20 meters squared for adjacent timber framed shed.
Total, c.65 meters squared.

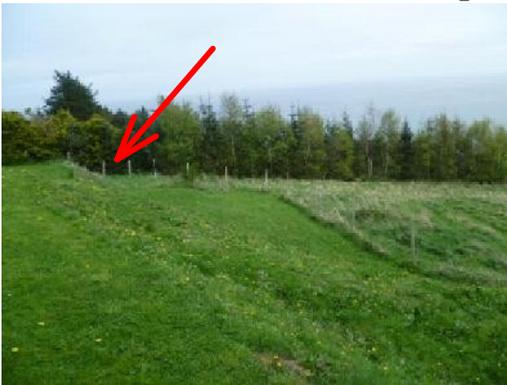
Percolation area would appear to be located outside the wire fence boundary.

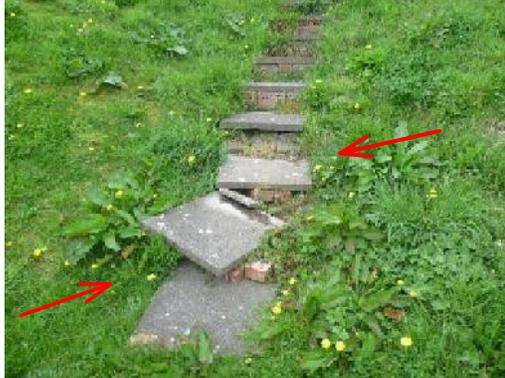
Maintenance Required **Steps and Rails:**
Brick and stone paved paths
Concerns about Steps and Rails
Steps uneven / loose.

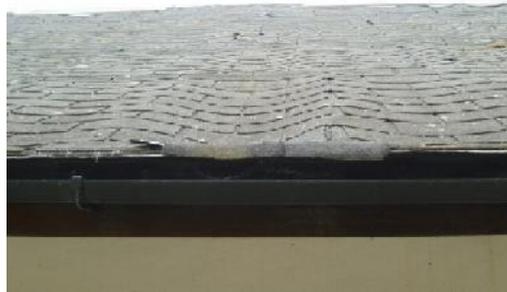
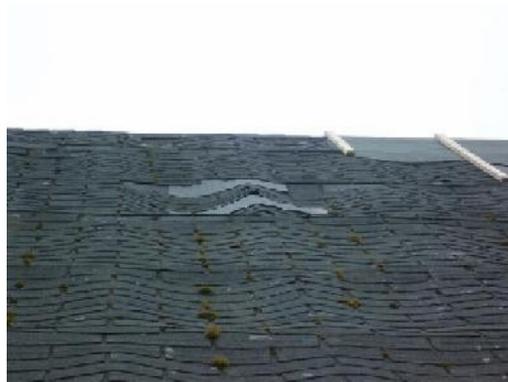
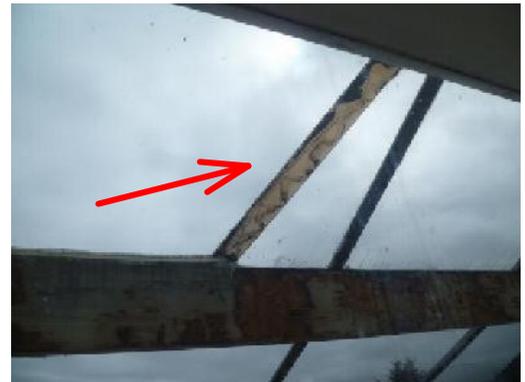
Note, the felt singles and felt underlay will all need to be replaced.

The timber sub-structure that the singles are nailed on to is also rotten in places. Budget to replace entire roof sub-structure.

I did not notice any structural defects to roof purlins. The roof rafters may have some defects, however these areas should in be repairable.

Budget to replace the entire roof coverings and sub-structure.

For a replacement of roof coverings only using fibre cement roof slates, expect to pay c.15,000-20,000 euro. Updating the glass roof with toughened double glazings would cost c.6,000 euro

A high end finish to roof using metals, budget up to 50,000. A copper roof finish will cost more.

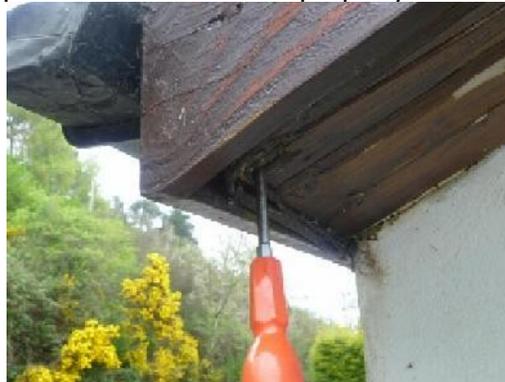
Wood rot at corners of roof eaves.

Eaves need to be replaced / repaired.

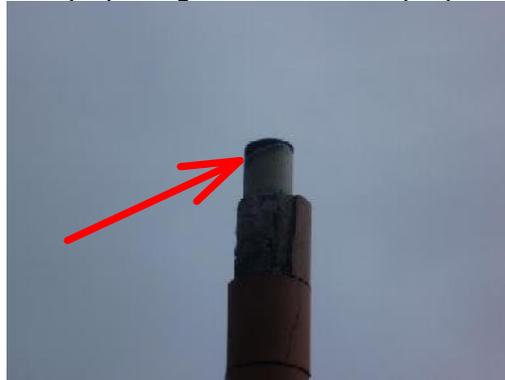
Asbestos flue to living room fireplace.

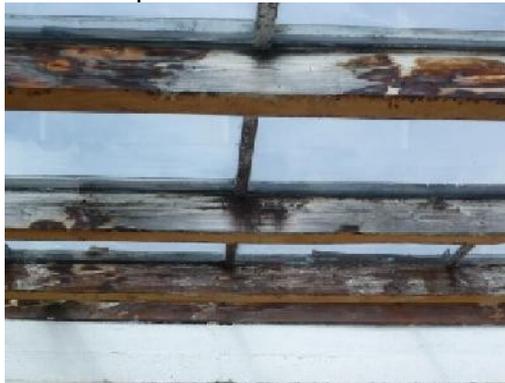
Numerous old moisture stains visible in ceiling timber panells and walls.

Current active water leaks through roof.

Staining to roof purlins, see sunroom.

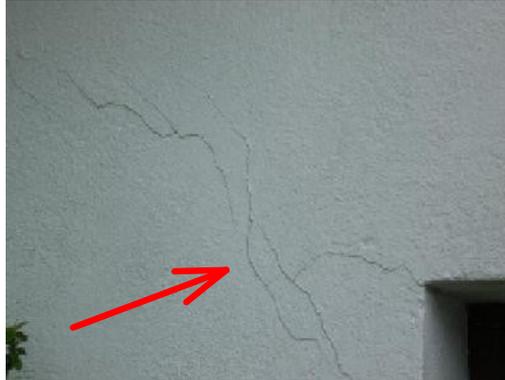
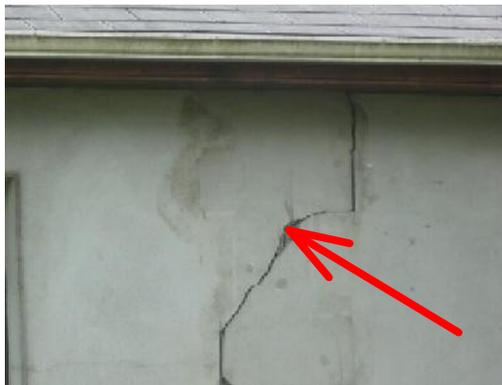
Concerns about walls,

Budget to repair cracks to all exteriors walls, front, back and side walls.

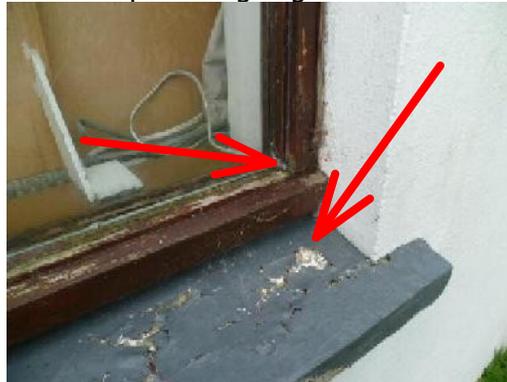
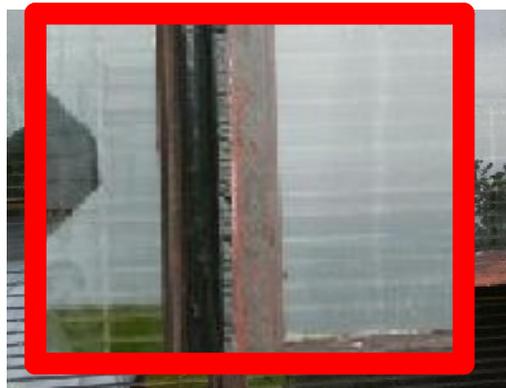
Delayed maintenance to door, budget to repair / replace.

Delayed maintenance to timber window frames.

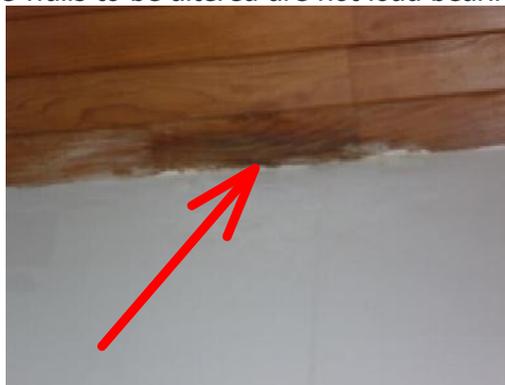
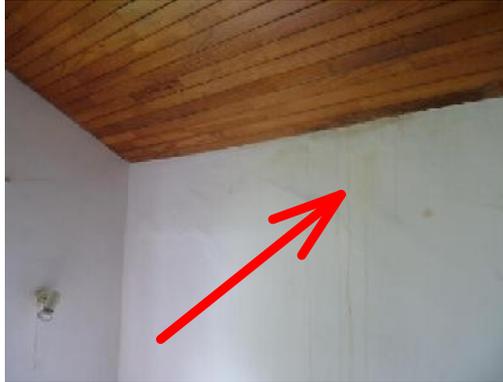
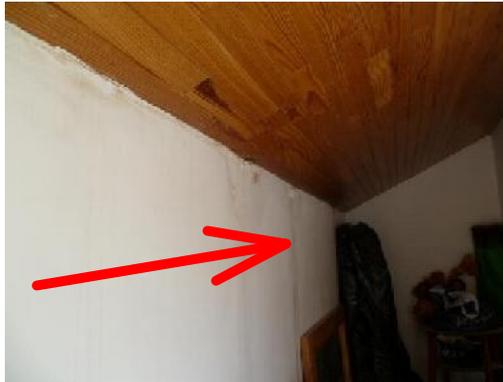
Mold present-potential health concern-needs removal/correction.

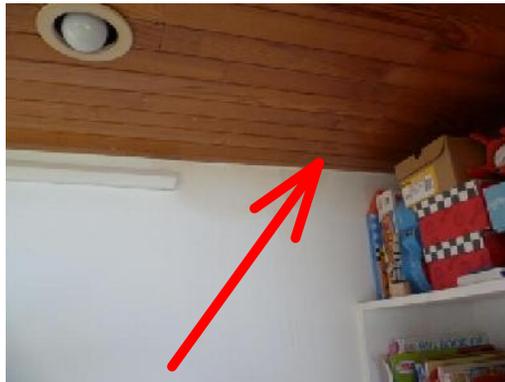
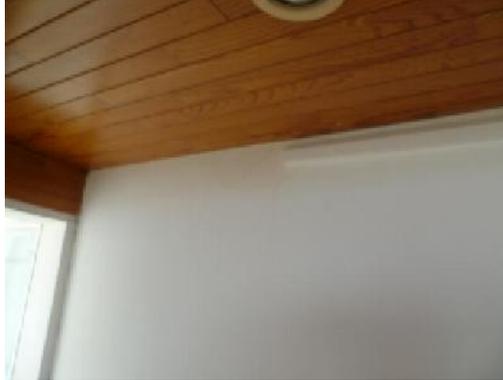
Numerous old leaks from roof.

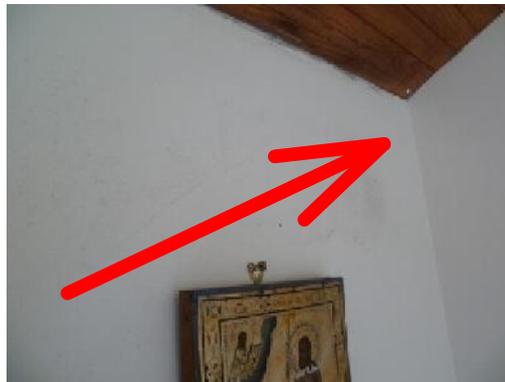
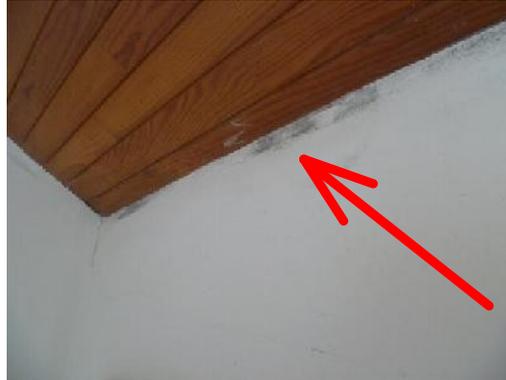
No vents opening fitted, ventilation through old windows not closing to frames, gaps.

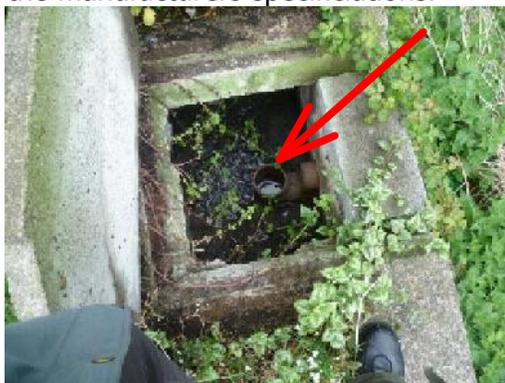
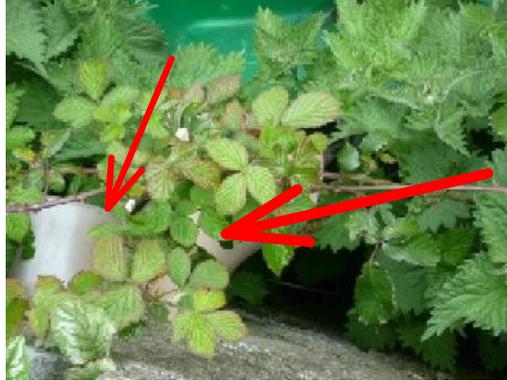
Waste water over flowing from pipes to back of septic tank.

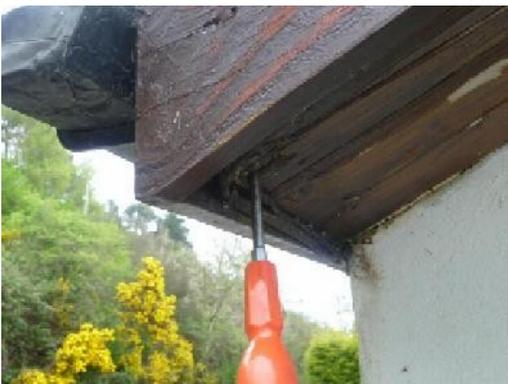
5. **Roof Coverings: Skylights / Rooflight/s:** Metal framed., Timber Framed.
6. **Roof Coverings: Ventilation Openings:** Recommend additional ventilation be installed.
7. **Roof Coverings: Roof Eaves, fascia & soffits:** Timber., PVC eaves Eaves need to be replaced / repaired.
Wood rot at corners of roof eaves.

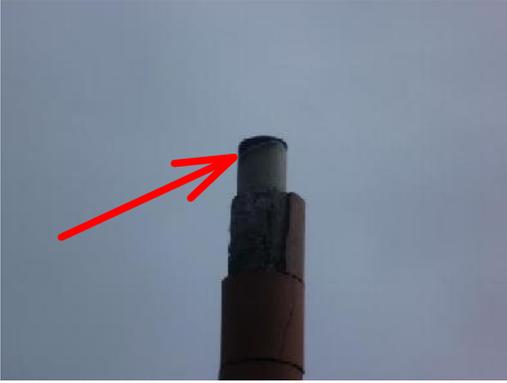
9. **Chimney Chimney/s and Flues:** Rendered chimney. Asbestos flue to living room fireplace.

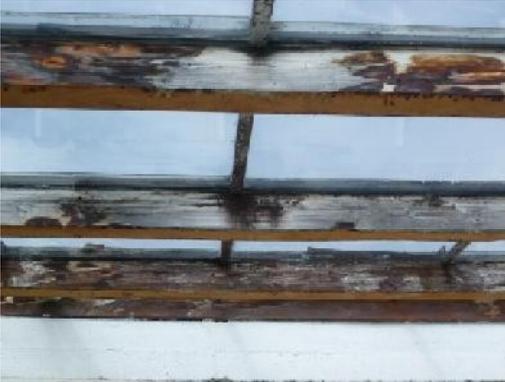
10. **Attic: Roof Timbers:** Traditional cut roof timbers. No attic space, ceilings in all rooms extending up to underside of roof. Staining to roof purlins, see sunroom.

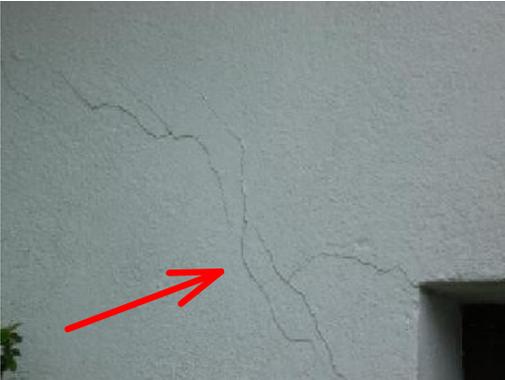
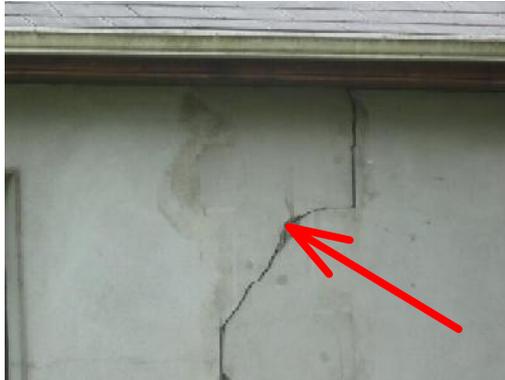
12. **Description of walls to front of property:** Cement rendering. Budget to repair cracks to all exteriors walls, front, back and side walls.

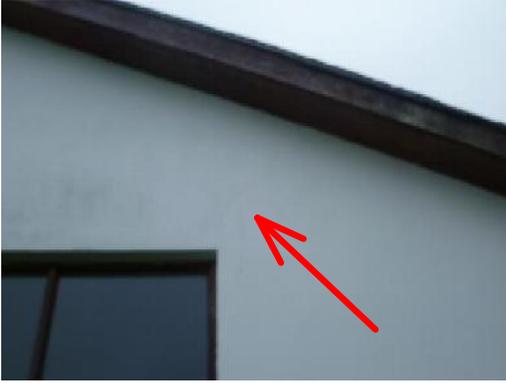
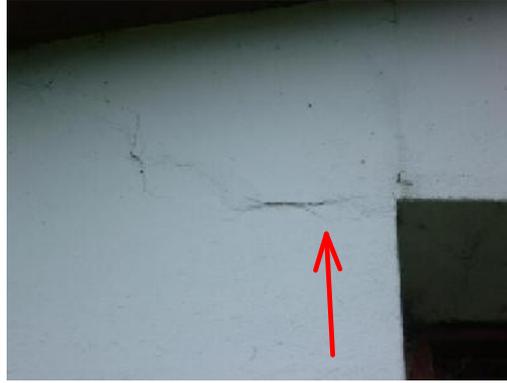
13. **Description of walls to left of property:** Cement rendering. The cracks would appear to be the result of normal thermal drying / shrinkage in the masonry walls.

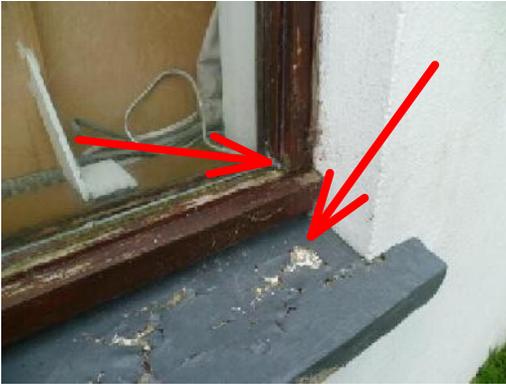
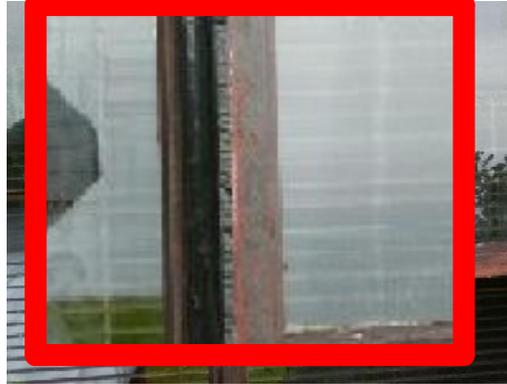
14. **Type of Structure to Extension.** Masonry structure Floor lifting in side sunroom extension, likely pyrite expansion.
15. **Entry Doors:** Timber front door, Timber back door. Delayed maintenance to door, budget to repair / replace.
16. **Windows:** Timber frames., Single glazing. Delayed maintenance to timber window frames.

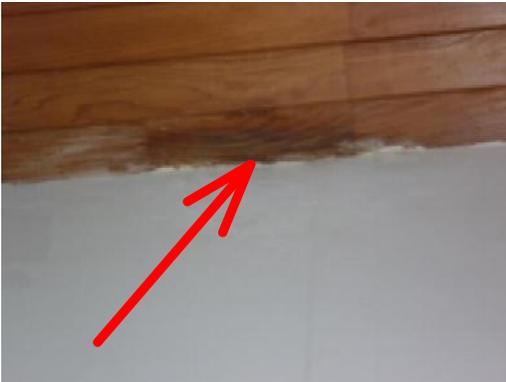
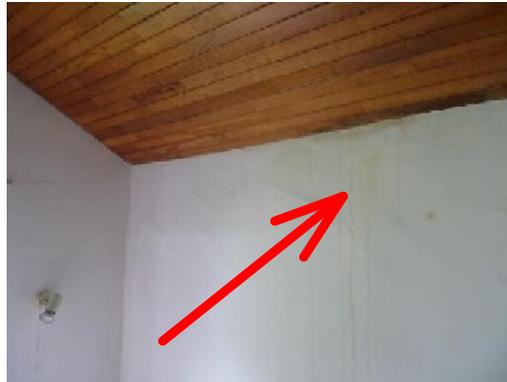
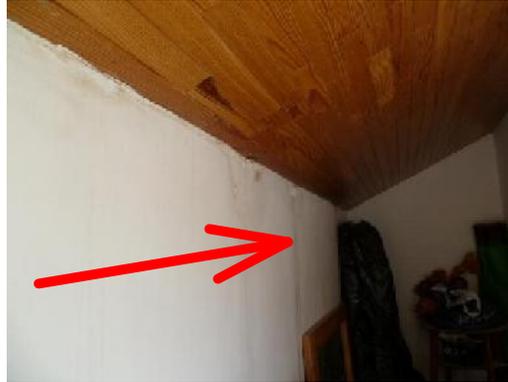
17. **Interior: Walls:** Skim finish. The interior walls would benefit from redecoration. Mold present-potential health concern-needs removal/correction.

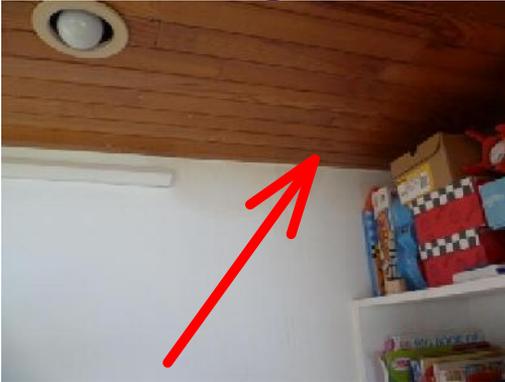
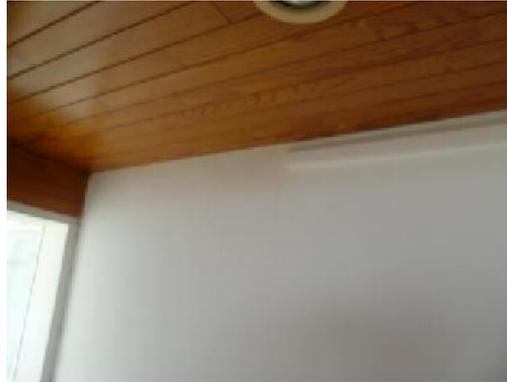
18. **Interior: Ceilings:** Timber panelled ceiling. Numerous old leaks from roof.

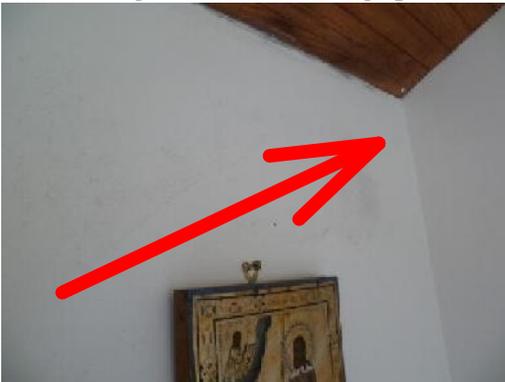
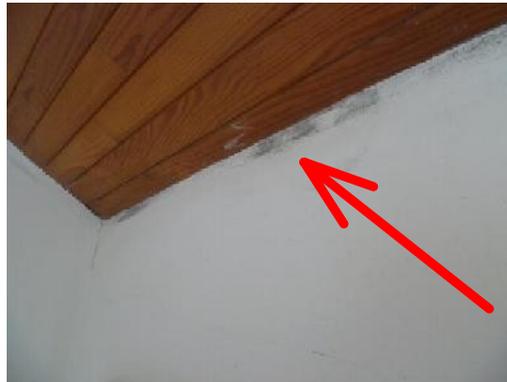
19. **Interior: Ventilation:** No vents opening fitted, ventilation through old windows not closing to frames, gaps.

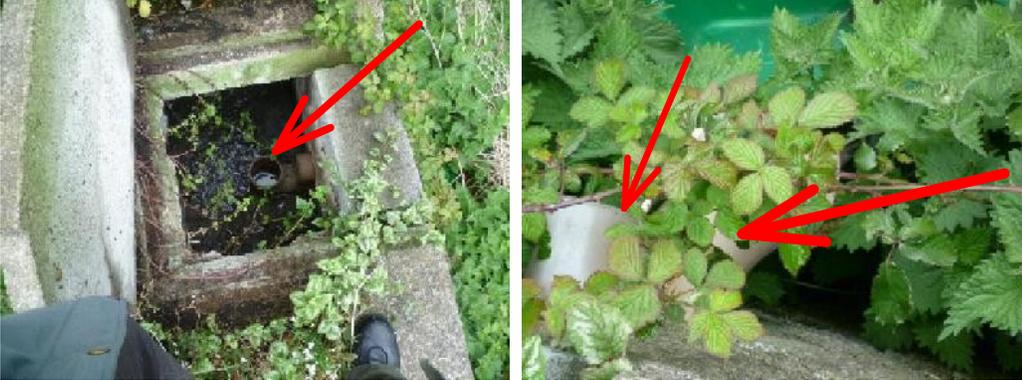
34. **Septic: Location of Percolation Area:** Septic tank percolation area would appear to be outside the fence.
