Confidential Property Survey Report

42 Old Street, Dublin

Inspection prepared for: Mr A Sample
Date of Inspection: 14/4/2015

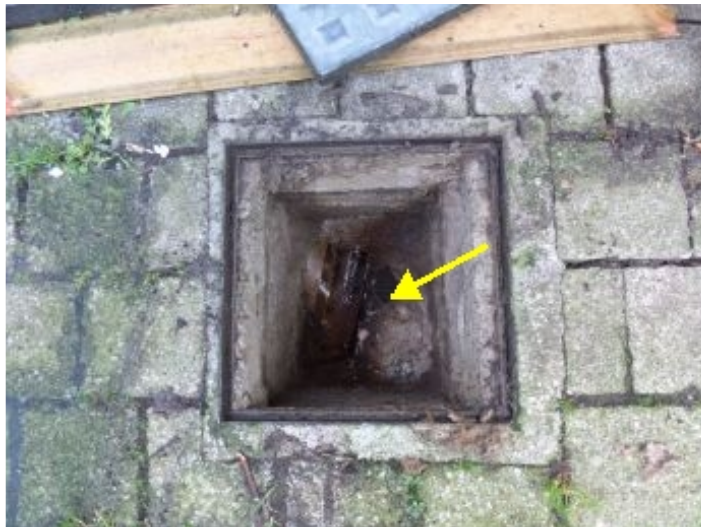
1.1. The cement finish around the foul sewer gullies and rain water gullies are poorly formed with gaps present. This can allow water seep into the ground around the walls of the house.

The cement finish around the foul sewer gullies and rain water gullies are poorly formed with gaps present. This can allow water seep into the ground around the walls of the house.

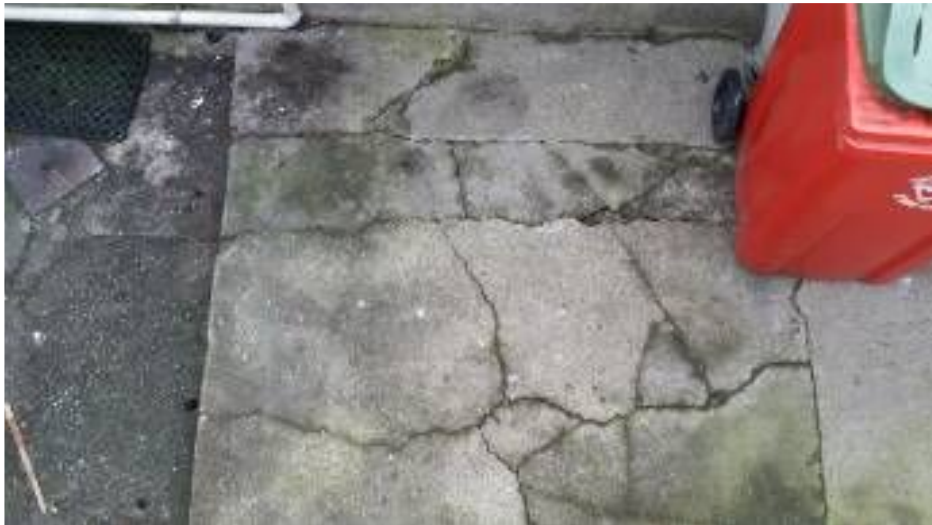
3.1. Delayed maintenance to paths.

Cracking in path.

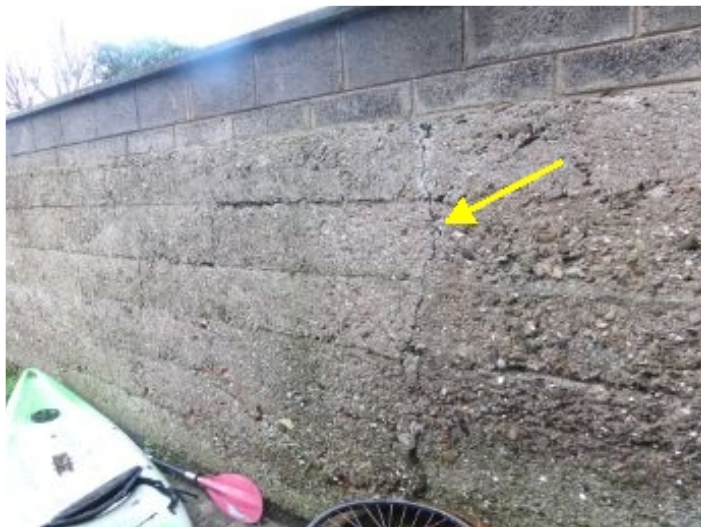
4.1. Delayed maintenance to boundary walls / fences.

Crack in boundary wall.

4.2. Recommendation: Repair cracks in boundary walls.

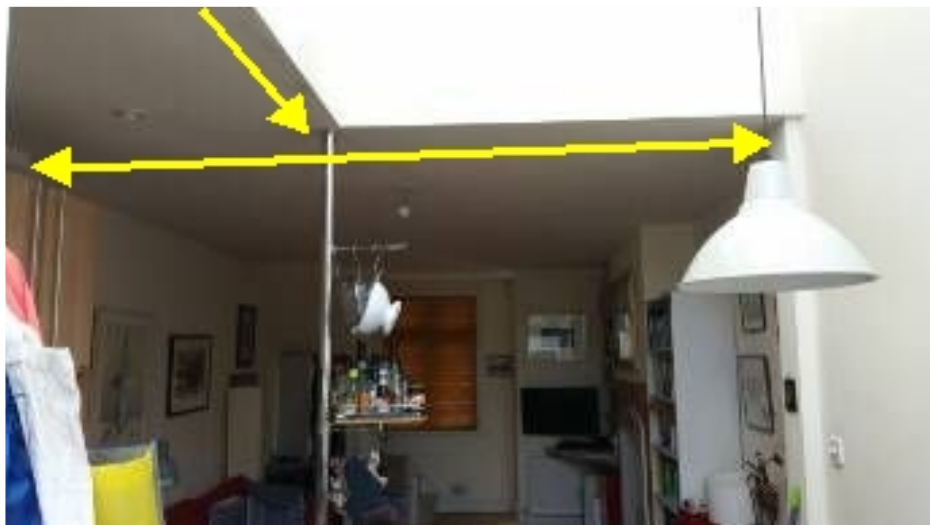
2.1. The interior wall between kitchen and livingroom has been removed. Minor movement noted in this area would appear to have ceased, monitor.

I cannot confirm the sizing or adequacy of the structural beam/s support inserted where the opening has been formed as the building works have been closed up.

2.2. Recommendation: I cannot confirm the sizing or adequacy of the structural beam/s support inserted where the opening has been formed as the building works have been closed up. It is important to confirm that the beam support over this opening was designed by a qualified engineer.

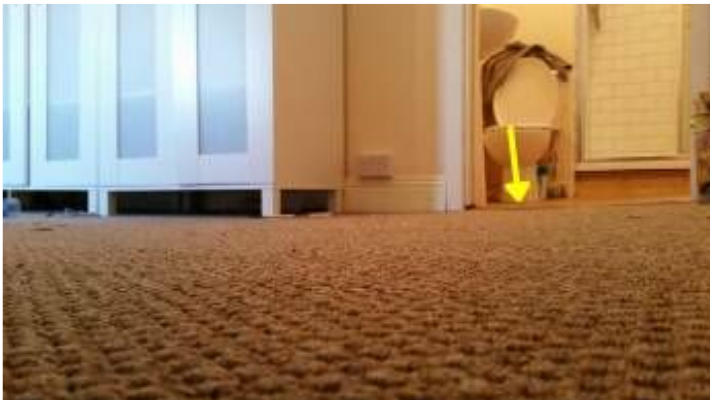
Slight slope in floor to upstairs bedroom.

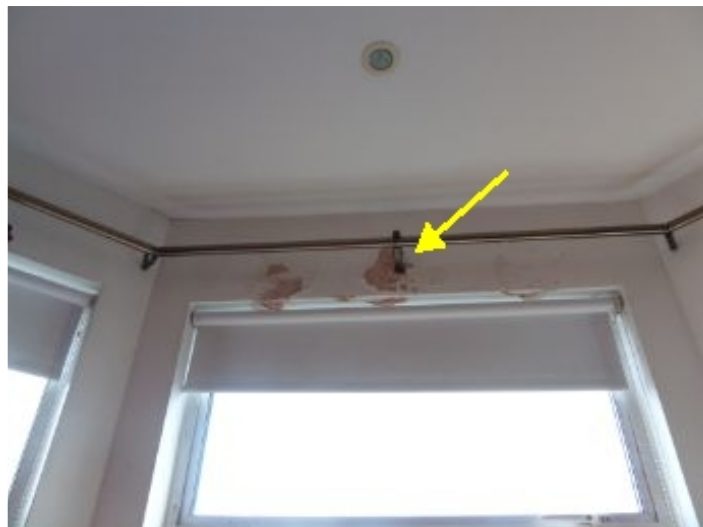
8.1. Moisture penetration through exterior wall over front window.

Moisture penetration through exterior wall.

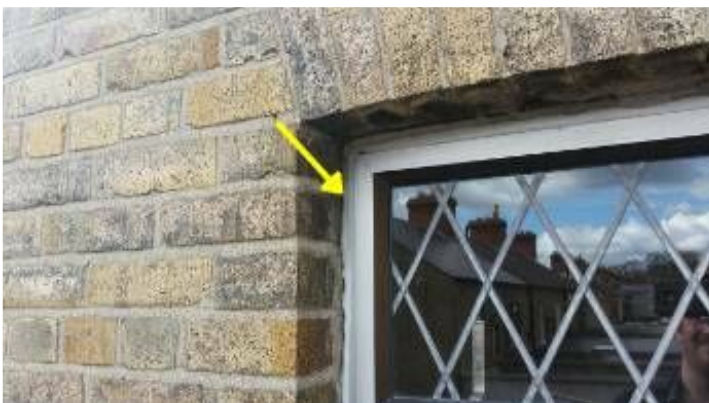
3.1. **Re-seal** around all window frames to walls.

Re-seal around window frames to walls.

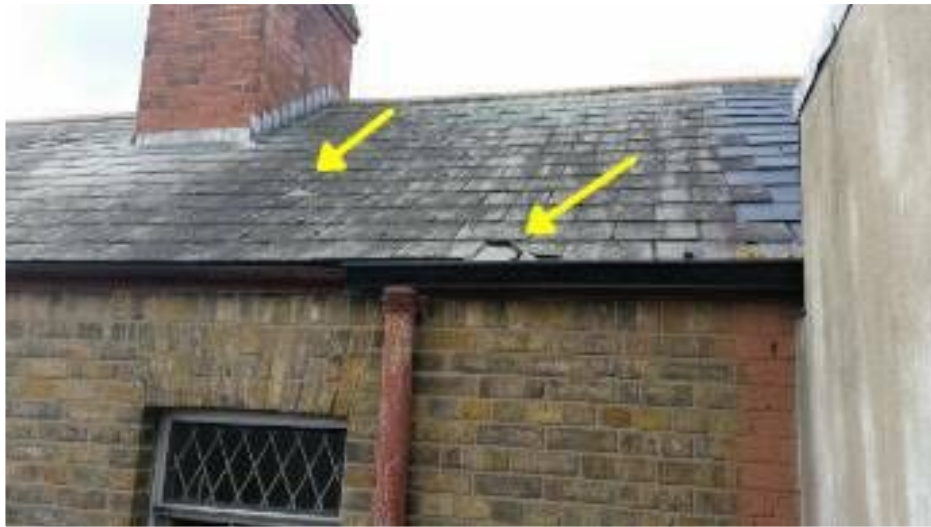
1.1. Numerous slipped slates over main roof, repair in the short term.

Slipped roof coverings.

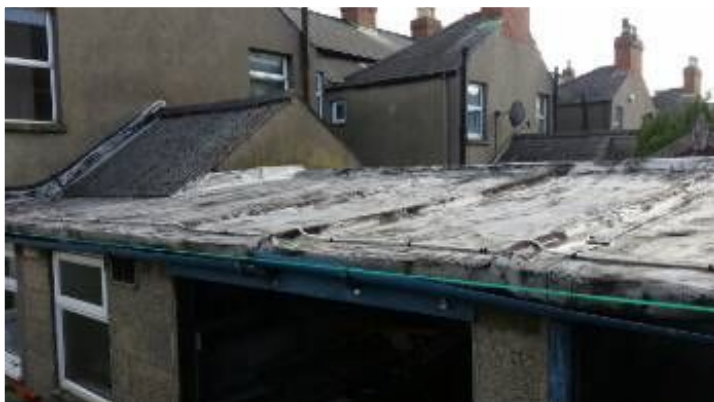
2.1. The felt roof covering is at the end of it's natural life, budget to replace.

Roof covering aging.

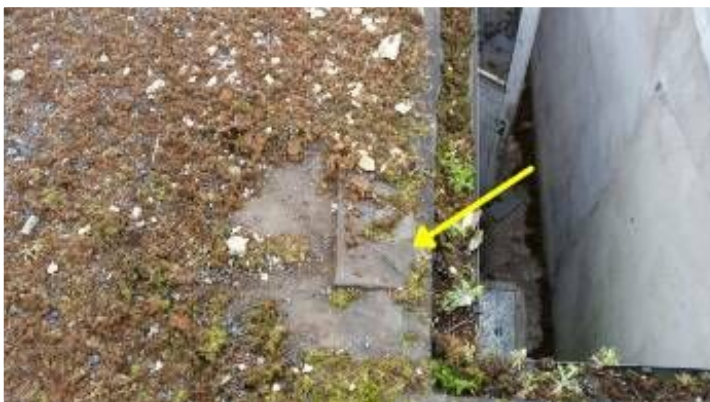
Previous repairs to flat roof.

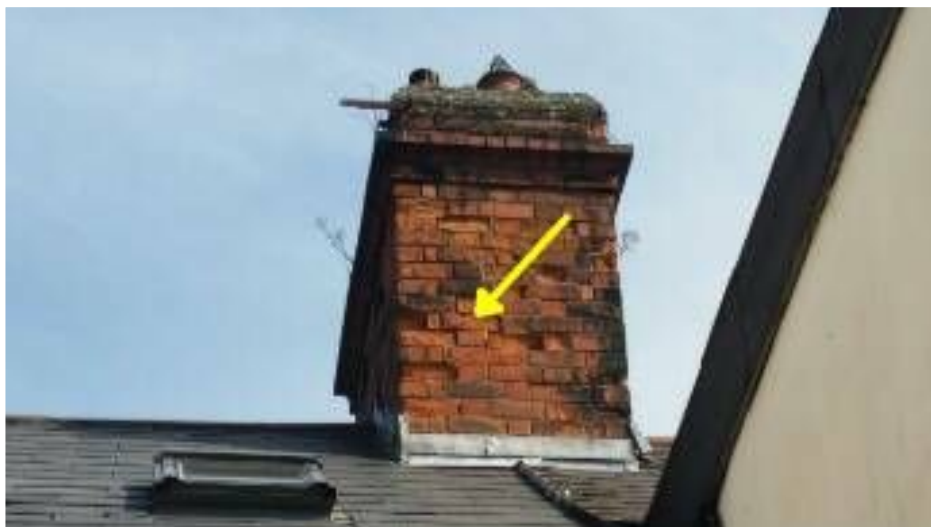
3.1. Some weather proofing and repointing of the chimney stack will be required to ensure that it remains water tight.

Spalling bricks.

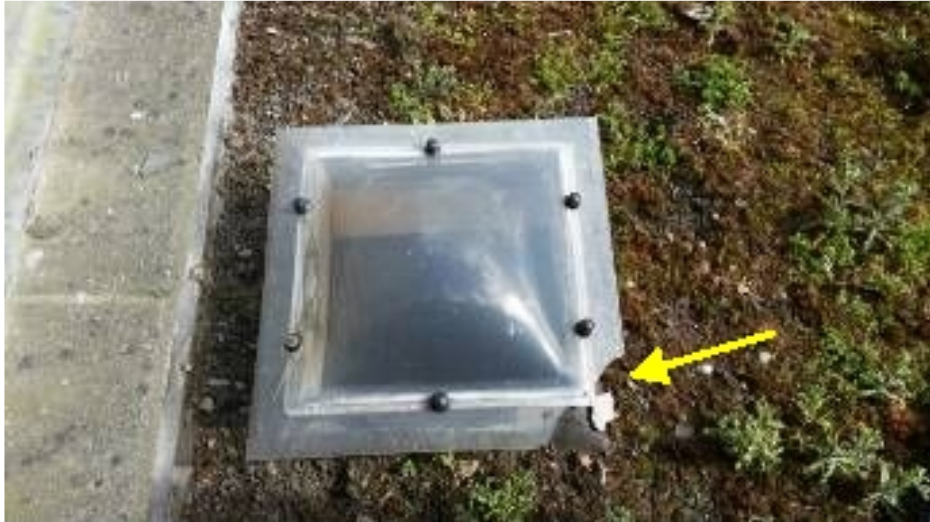
8.1. Damaged skylight over flat roof.

Damaged skylight.

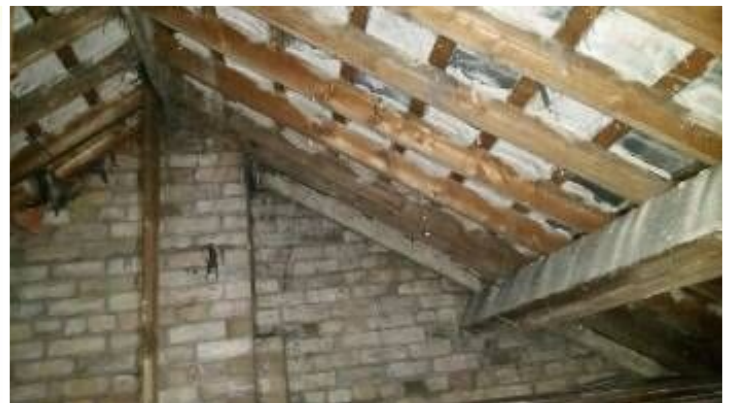
No collars fitted between roof rafters in roof structure, fit collars.

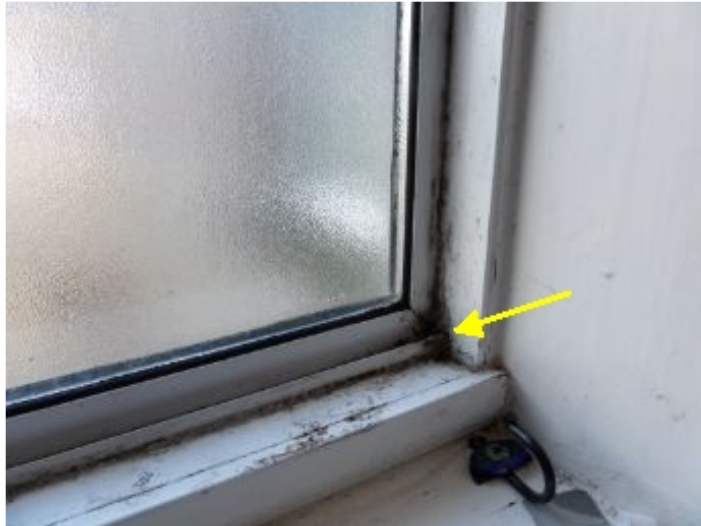
1.1. Condensation noted to interior walls around window frames, upgrade insulation and ventilation.

Mould around window frames.

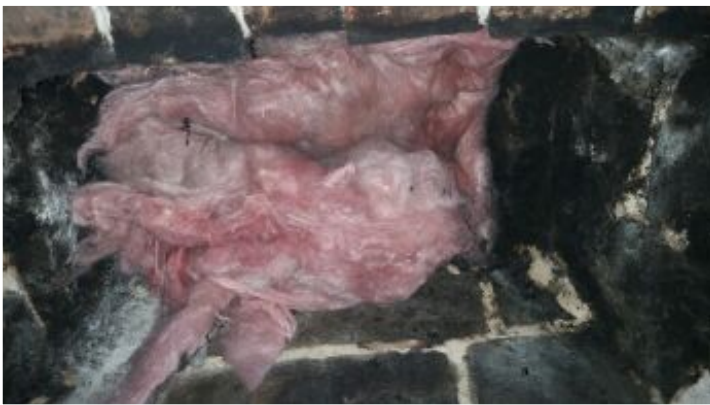
6.2. Fibreglas insulation fitted as fire proofing / fire blocking between fire surround and flue, replace with fire proof grade material.

Fibreglas insulation stuffed up chimney. Clean out before use.

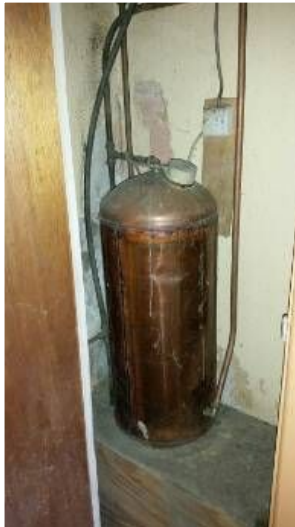
Aging copper cylinder.

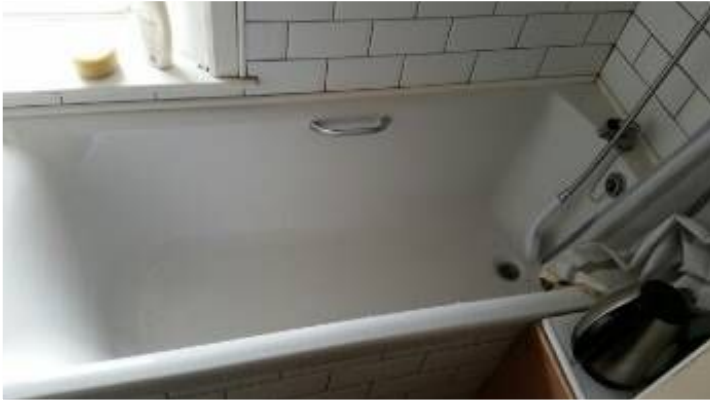
Re-seal around bathtub.

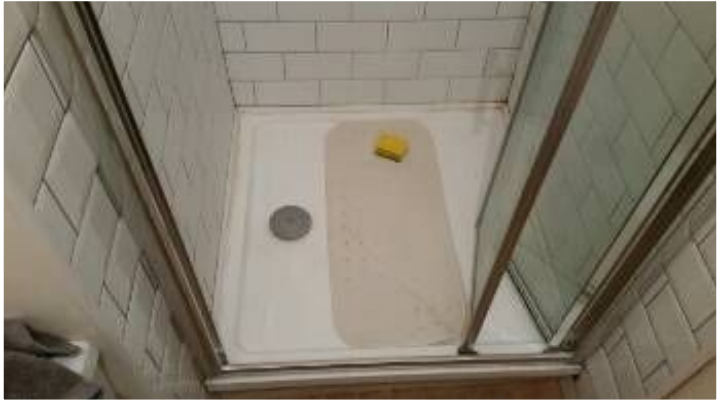
Re-seal around shower tray.

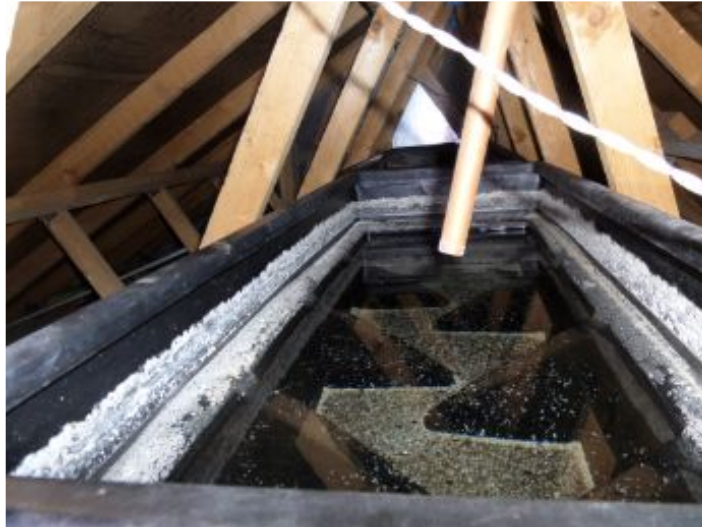
- 5.1. **PVC** water storage tank.
- 5.2. Cover required over water storage tank.

Cover required over water storage tank.

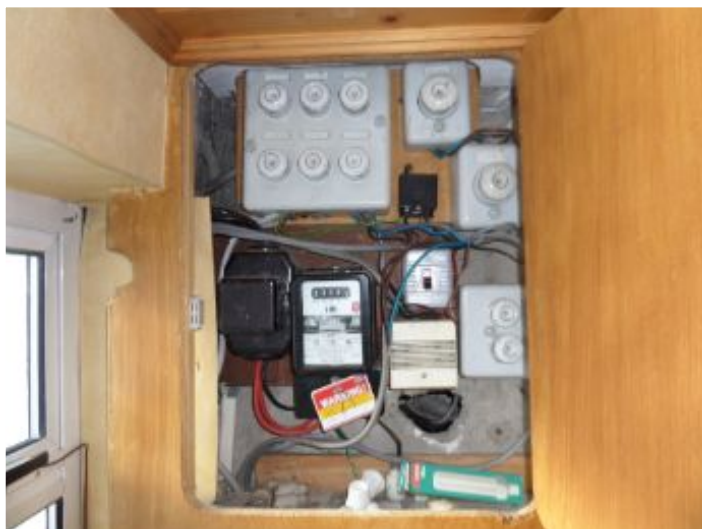
3.1. Replace aging fuse panel with a modern breaker panel.

Main fuse panel.
