Confidential Property Survey Report

Apt 241 Sunview Apartments, Dublin

**Inspection prepared for: Mr A Sample
Date of Inspection: 13/4/2015**

**Inspector: David Usher
B.Sc. (Hons) Building Surveying
Phone: 01-6281040
Email: info@propertyhealthcheck.ie**

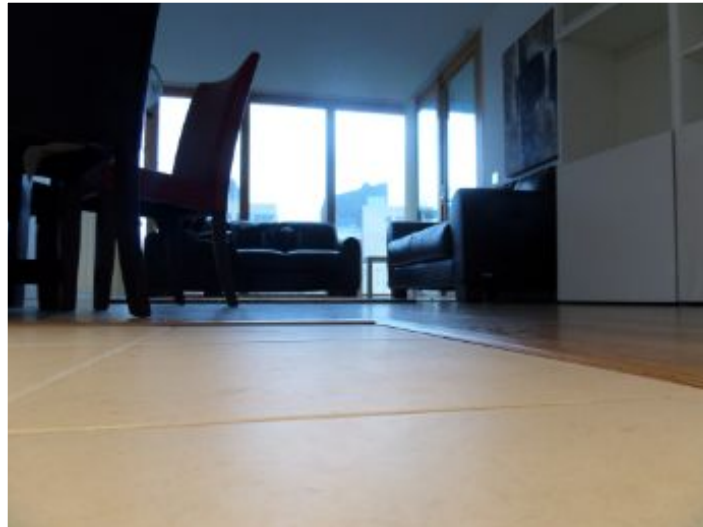
5.1. No unusual sloping / deflection was noted in the floors at the time of inspection.

No unusual sloping / deflection was noted in the floors at the time of inspection.

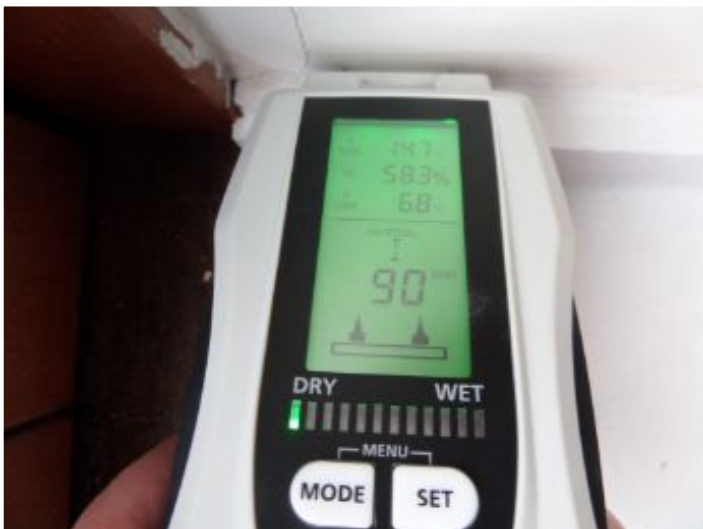
No moisture penetration through exterior walls.

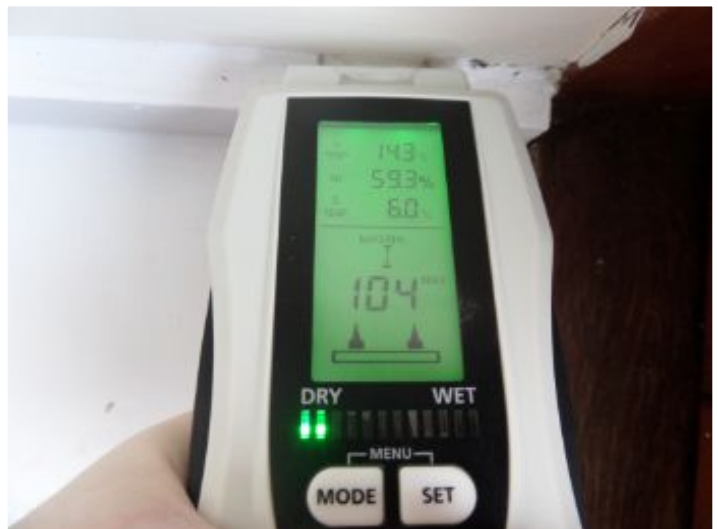
No moisture penetration through exterior walls.

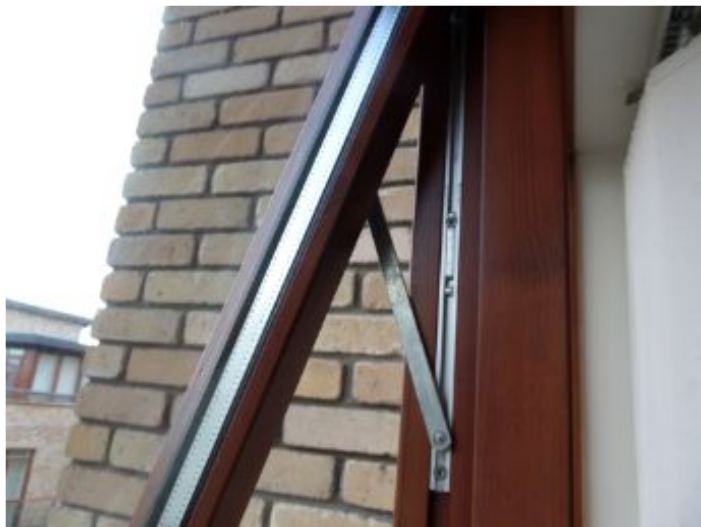
3.2. Hinges to windows will require lubrication, this will over time prevent windows from closing flush to window frames.

Window hinges require lubrication.

3.1. **Re-seal** around window frames to walls.

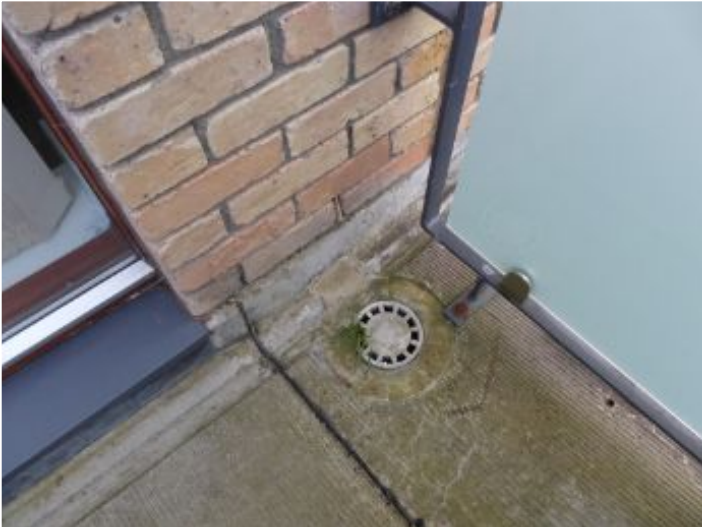
Keep drain in balcony free of debris.

4.1. Keep drain in balcony free of debris.

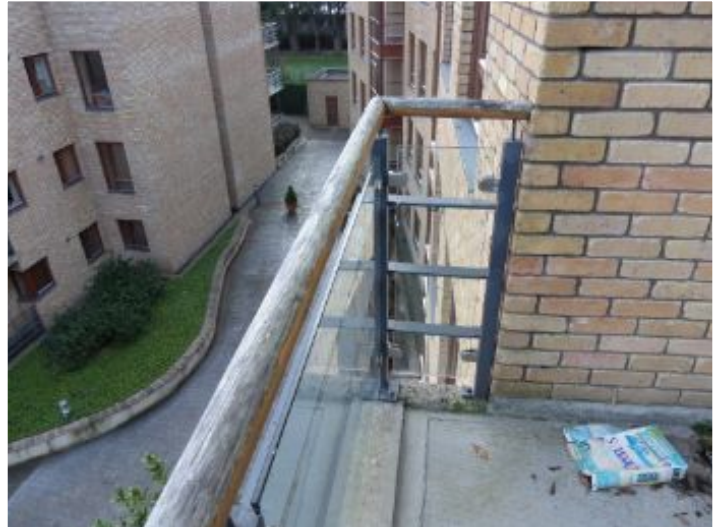
Sand down and re-paint timber handrail.

4.2. Sand down and re-paint timber handrail to back balcony.

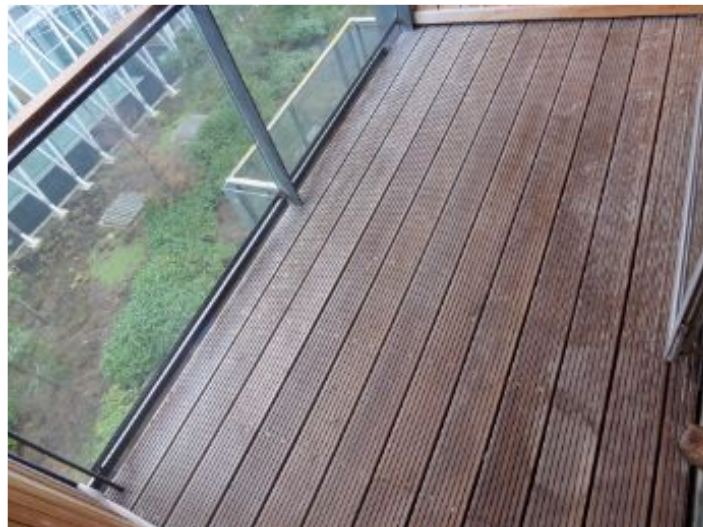
Timber decks are a safety hazard for slipping on when wet / damp.

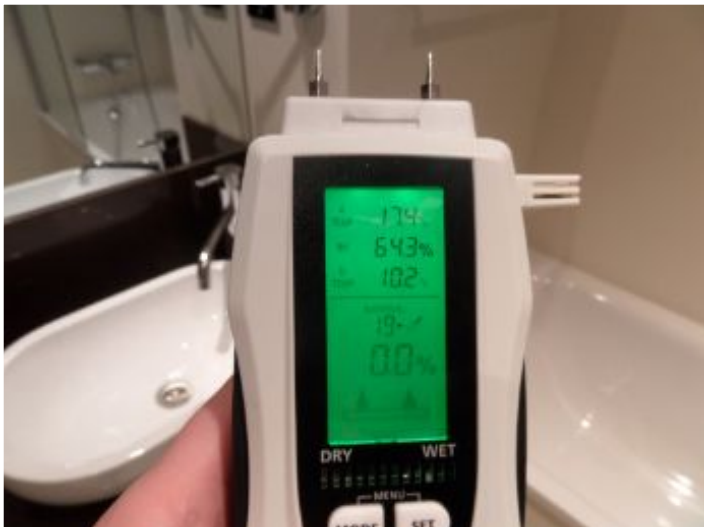
- 1.1. Marginal **Ventilation in property**.
- 1.2. Consider installing automatic sensor controlled vents in bathroom and kitchen.

RH level in bathroom, c, 64 %

| Term | Definition |
|---|--|
| Ventilation in property | Ideal humidity in most cases is c, 50-55% humidity, however if occupants of properties have certain medical conditions, doctors may recommend a different humidity level. |

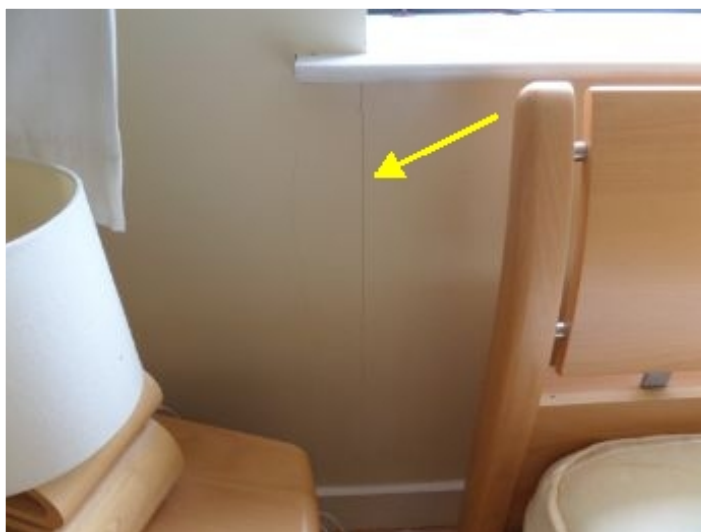
Drying cracks to interior walls.

- 2.1. Repair and re-decorate drying cracks to interior walls.

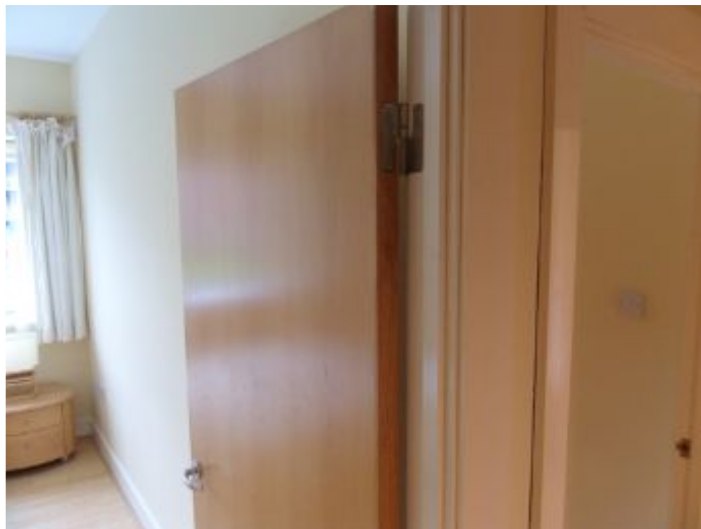
4.2. No automatic door closers fitted to fire doors.

4.3. Fire / smoke draft seals not fitted to door frames.

No automatic door closers fitted to fire doors.

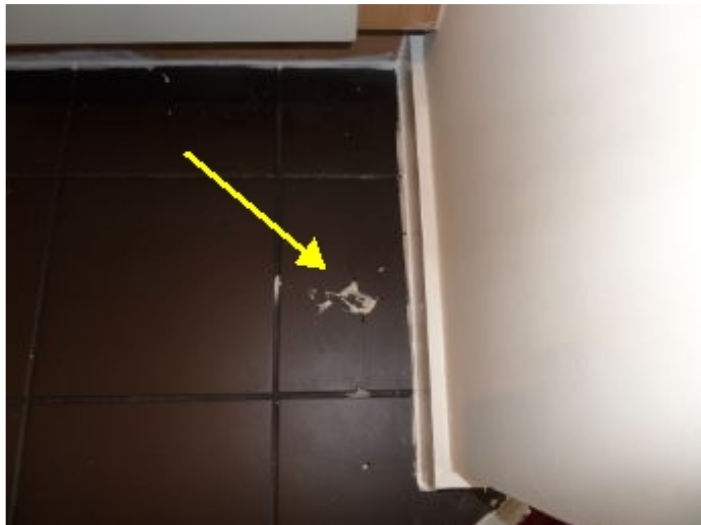
Replace cracked floor tile in kitchen.

5.1. Replace cracked floor tile in kitchen

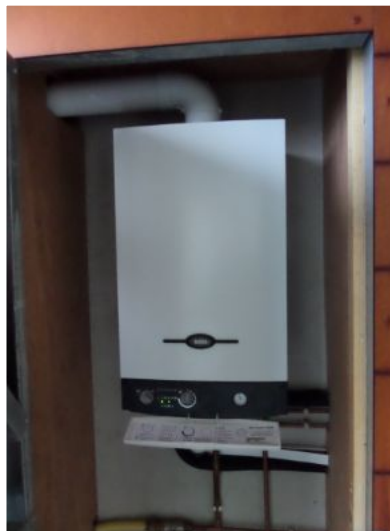
1.2. System would appear to be a gas fired central heating system

1.3. Burner operating at time of inspection.

Normal service required.

1.1. The heating system is now probably due for a service and therefore before you purchase, I recommend that you ask a qualified heating engineer to check and service the heating system or arrange for the owners to do this and then you should set in hand an annual maintenance agreement.

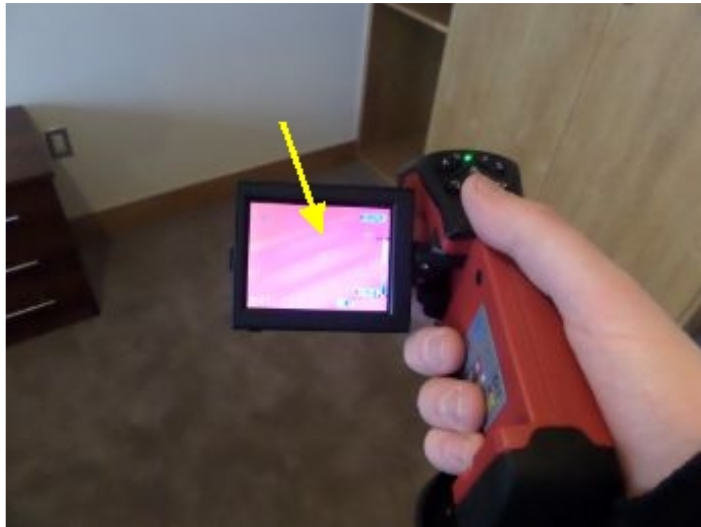
Under floor heating operating at time of inspection.

4.2. Recommendation: Under floor heating system should be serviced before closing.

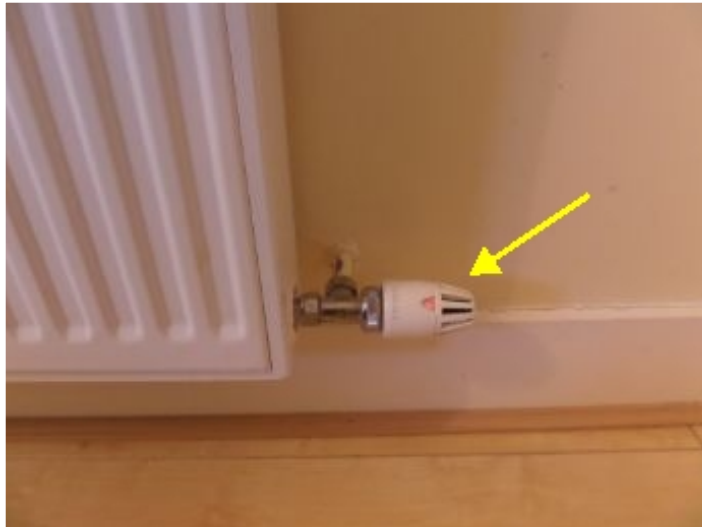
TRV 's fitted to radiators.

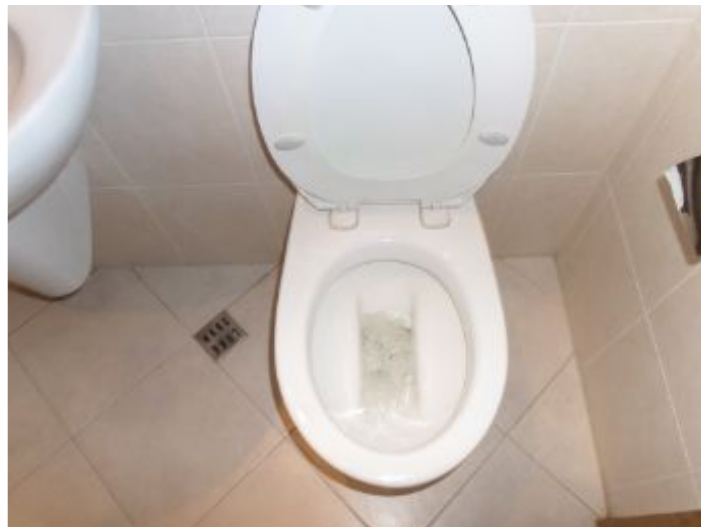
Toilet operating normally.

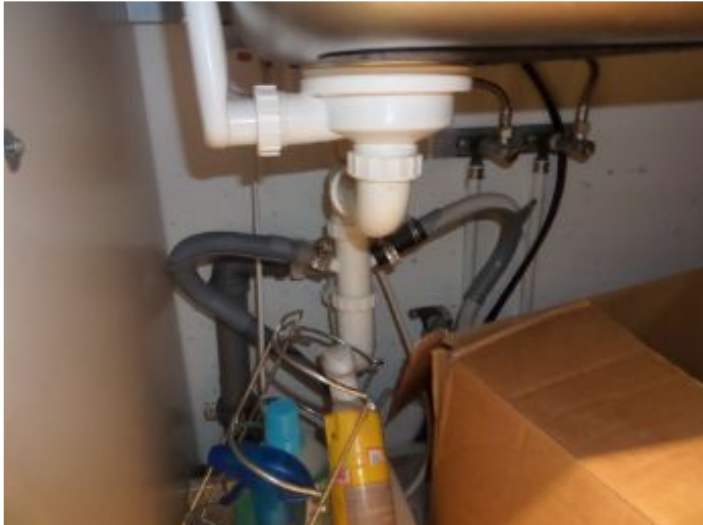
Plumbing pipes where visible would appear to be in a reasonable condition.

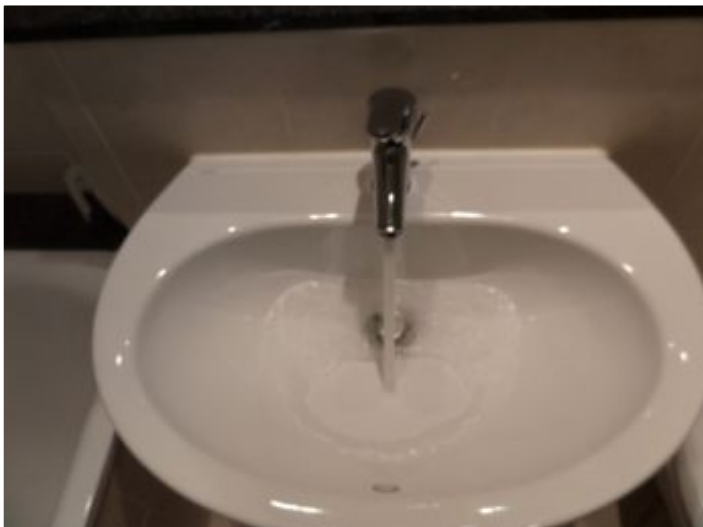
The taps are operating normally.

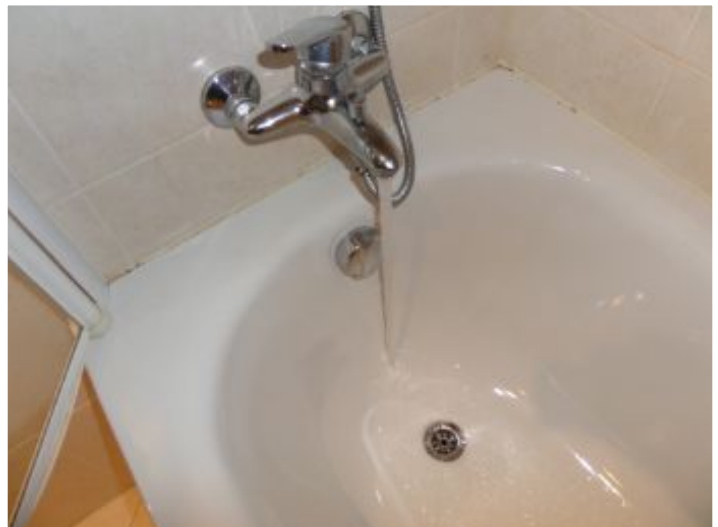
The taps are operating normally.

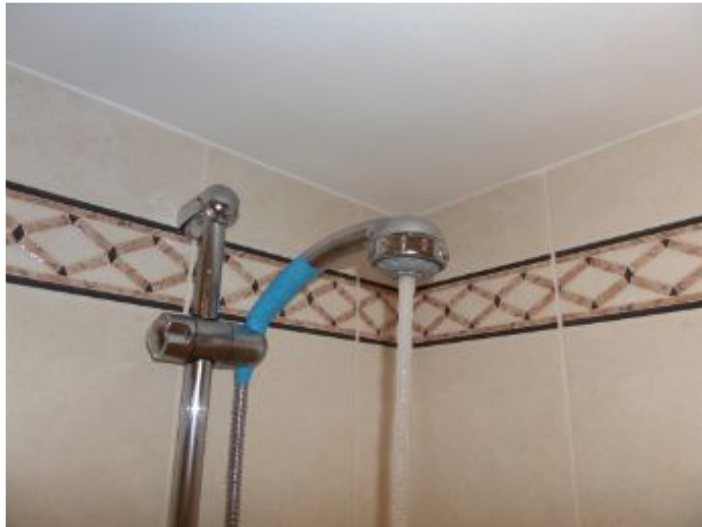
Shower operating normally.

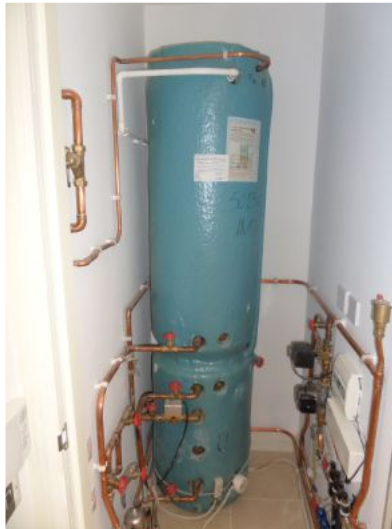
6.1. Water storage tank in hotpress would appear to be in a reasonable condition.

Water storage tank located in hotpress.

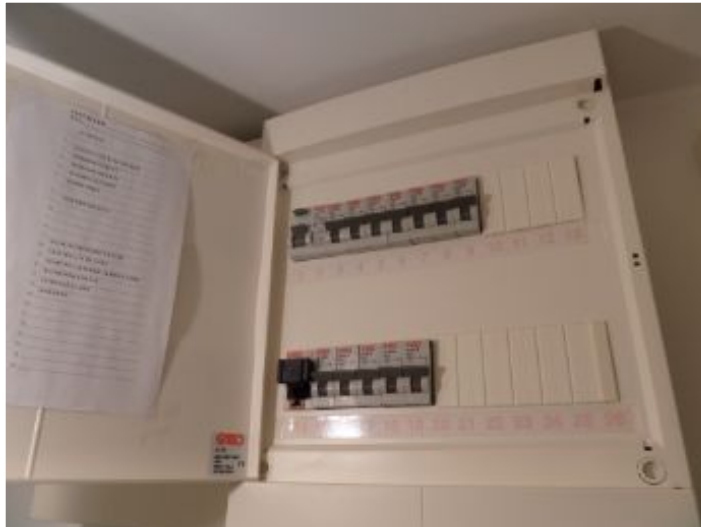
Main breaker panel.

3.1. Electrical panel would appear to be in a reasonable condition.

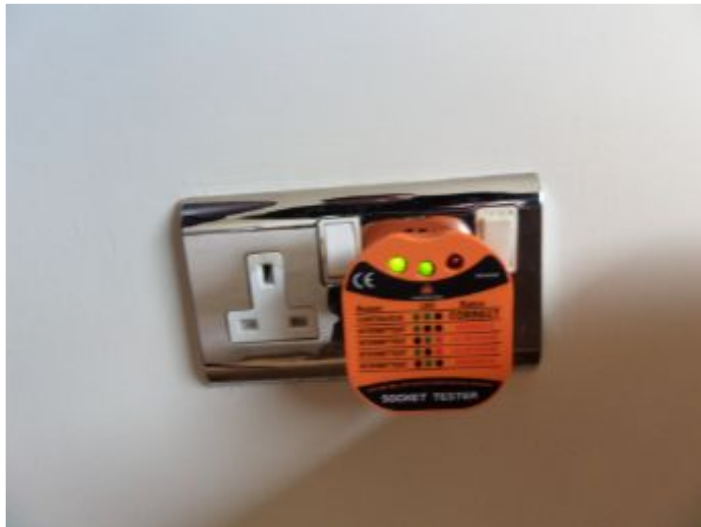
Wiring to plug sockets is earthed.
