Confidential Property Survey Report

12 New Street, Dublin

**Inspection prepared for: Mr. A Sample
Date of Inspection: 13/4/2015**

**Inspector: David Usher
B.Sc. (Hons) Building Surveying
Phone: 01-6281040
Email: info@propertyhealthcheck.ie**

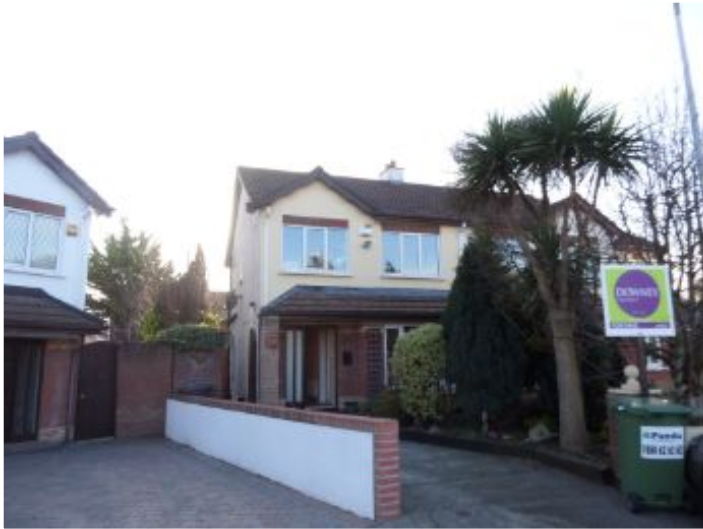
Front of property.

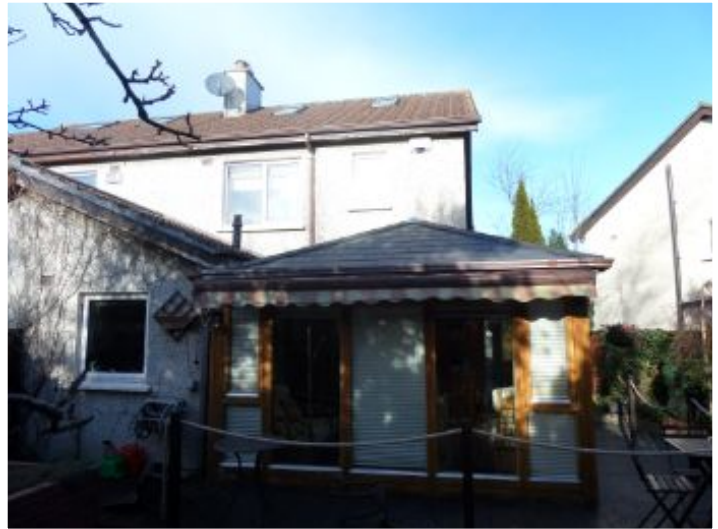
Back of Property.

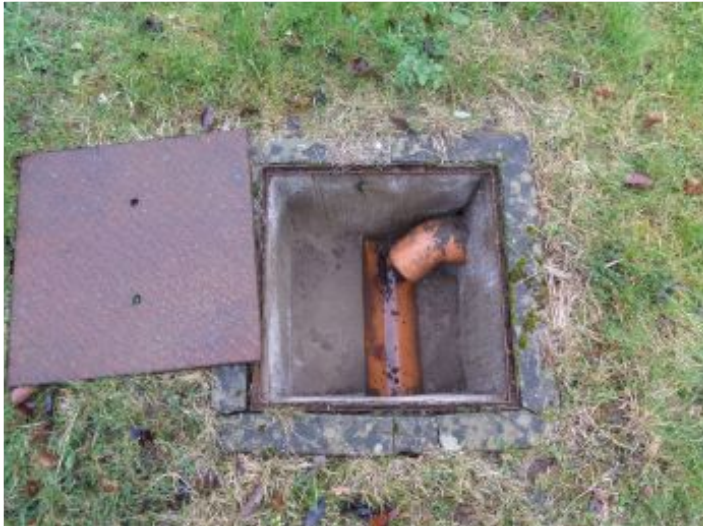
Drains in a reasonable condition.

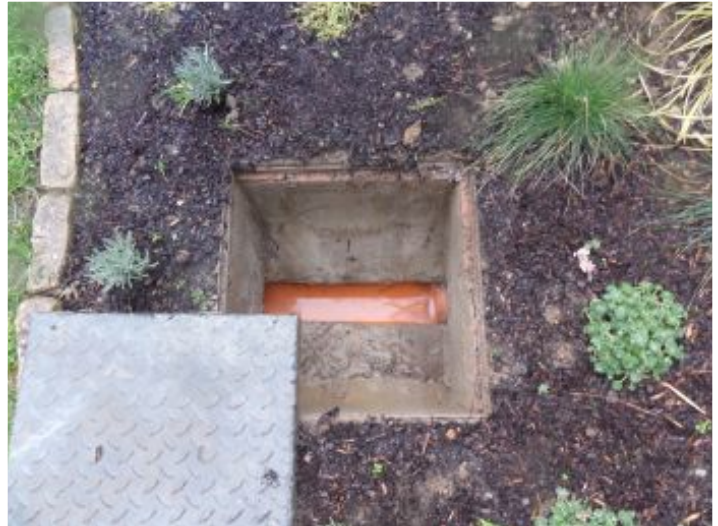
Drains in a reasonable condition.

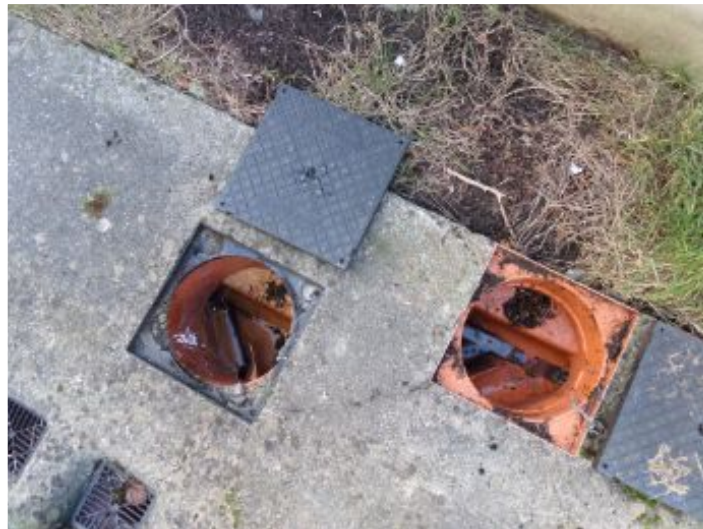
Drains in a reasonable condition.

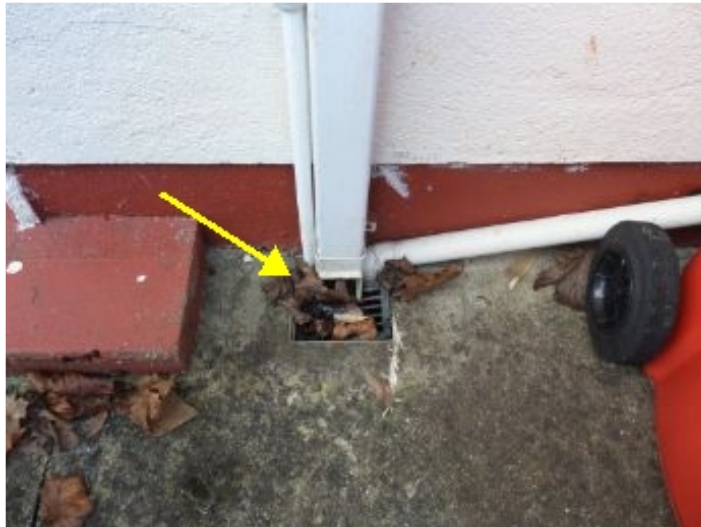
2.1. **Foul and rain water discharging into same drain** at back of property.

Foul and rain water discharging into same drain.

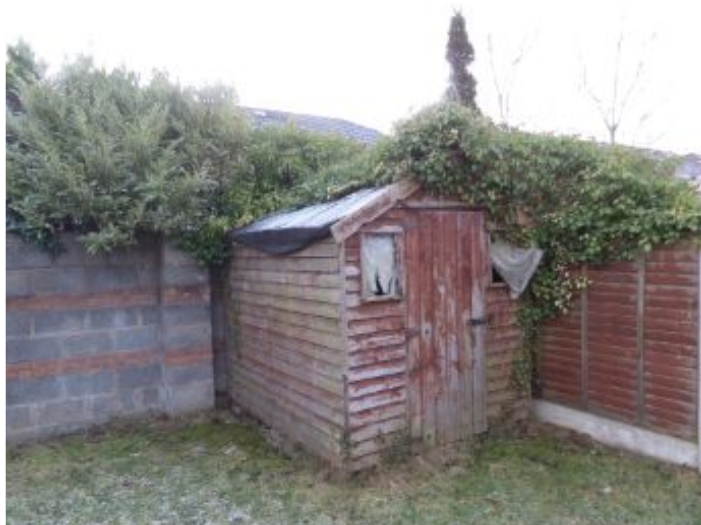
4.2. Shed is in a poor condition.

Timber shed.

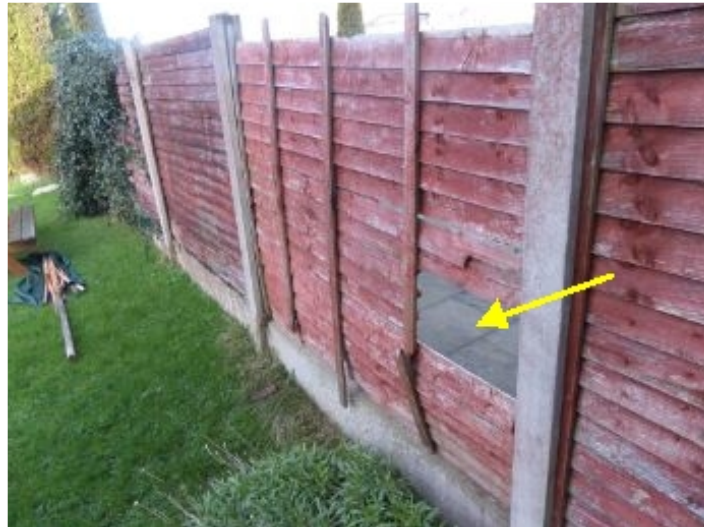
Delayed maintenance to timber fences.

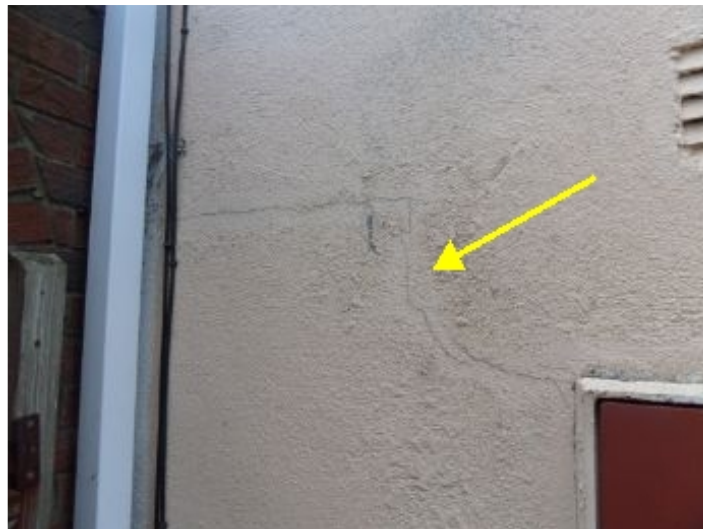
- 3.1. No settlement noted in structural masonry walls.
- 3.2. **Thermal cracking** in cement rendered walls.

Thermal cracking in cement rendered walls.

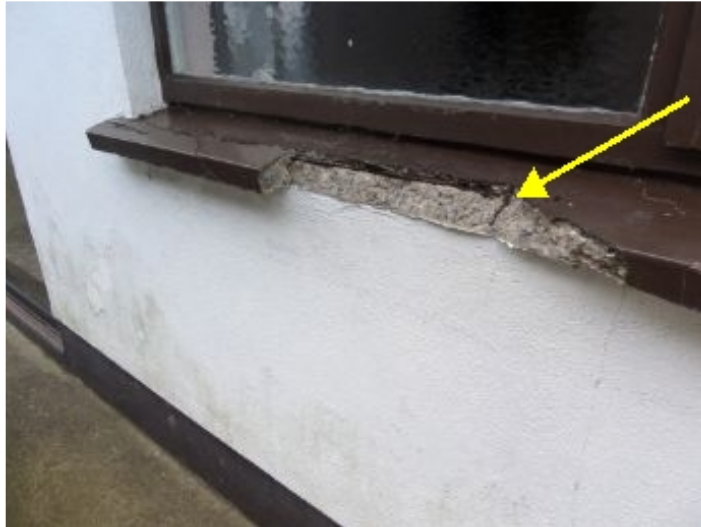
Window sill cracking to right side of house.

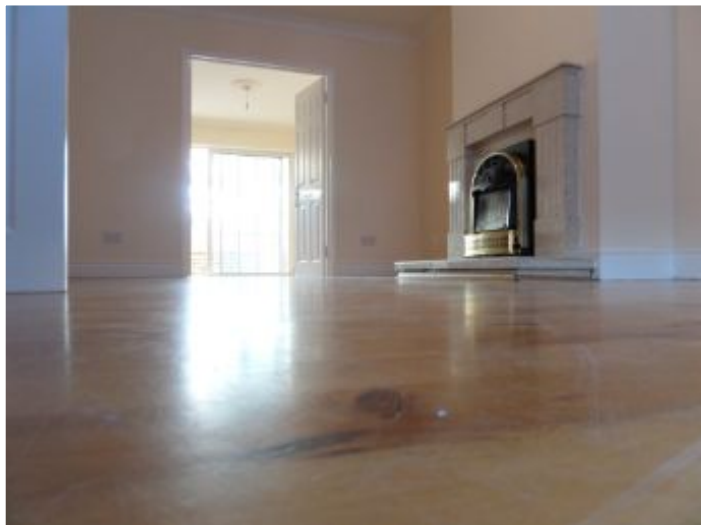
No unusual sloping / deflection was noted in the floors at the time of inspection.

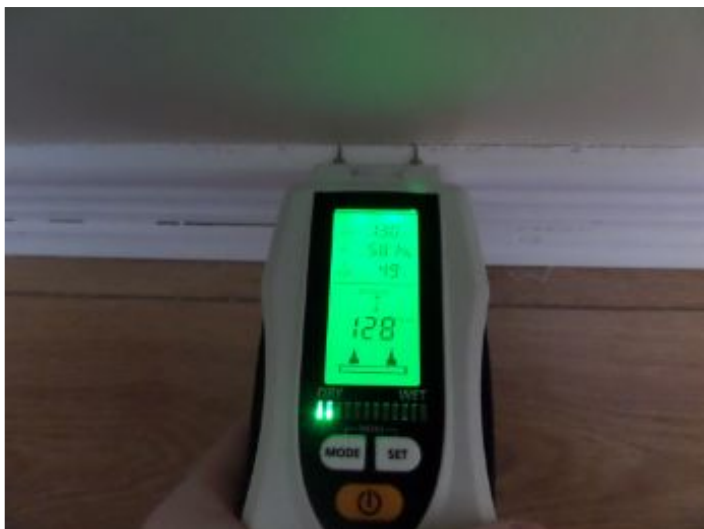
Dampness :Damp proof course is effective.

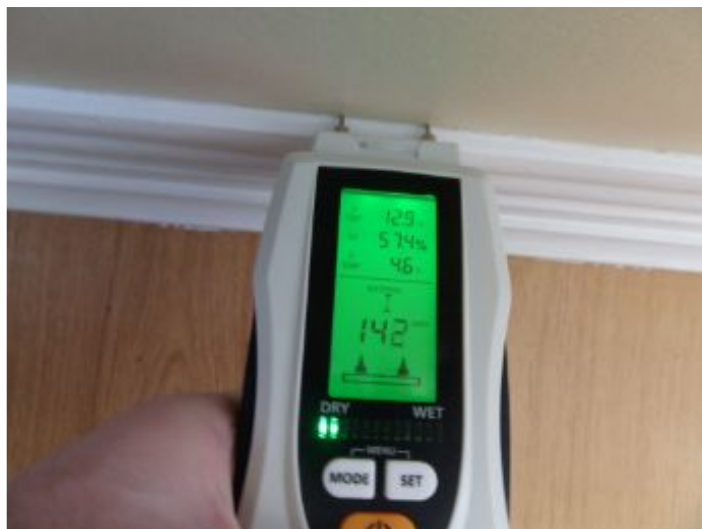
Dampness :Damp proof course is effective.

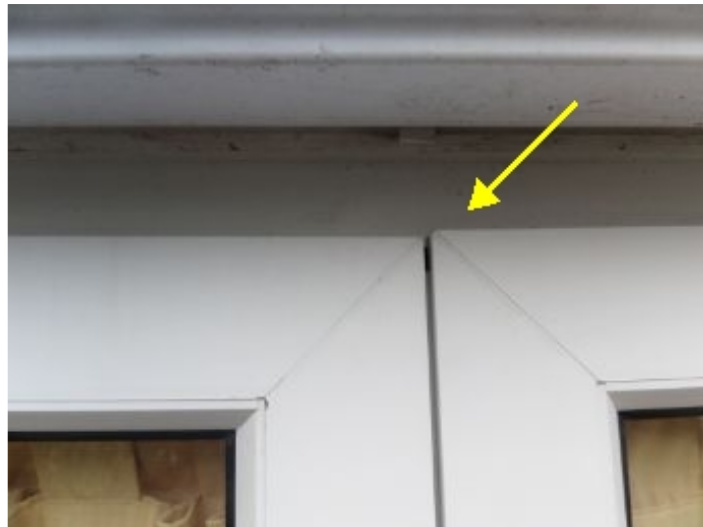
Back doors required re-alignment.

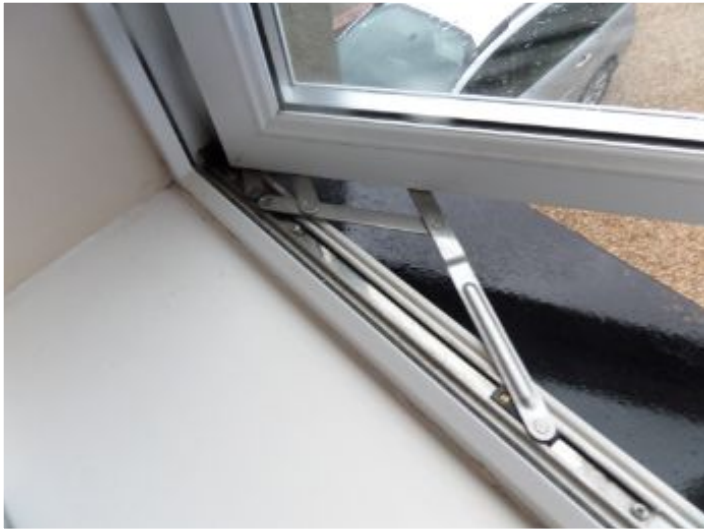
3.1. Window hinges require lubrication, will prevent windows from closing flush to window frames.

Window hinges require lubrication.

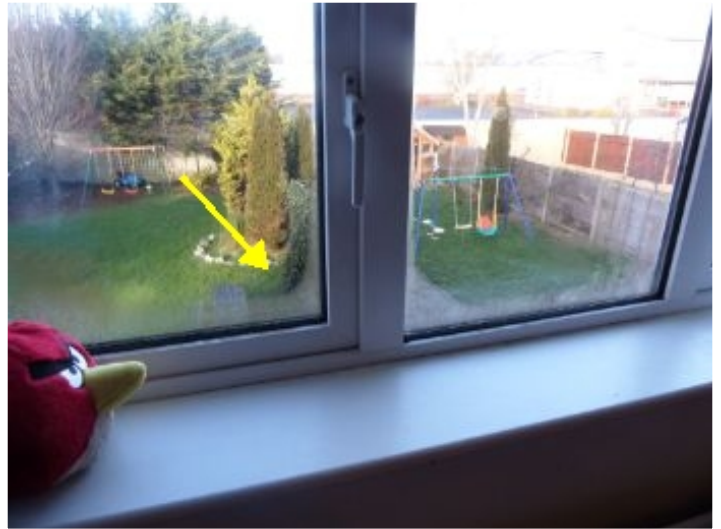
Window seals failing in double glazing at back of house, condensation noted.

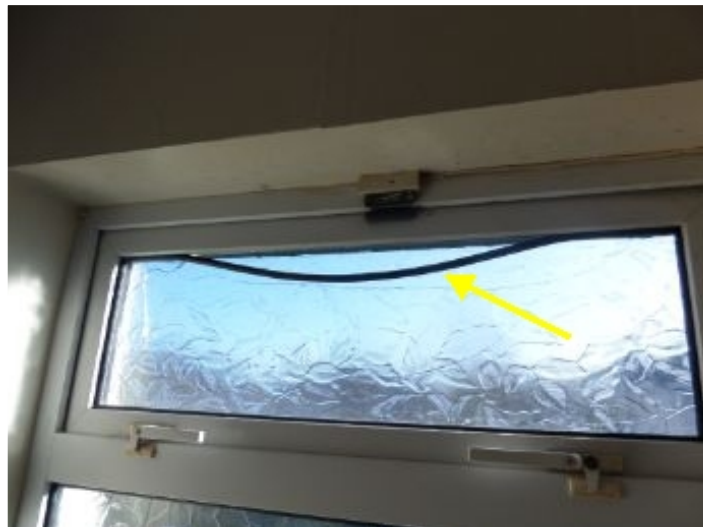
Window seal failing in double glazing to bathroom window.

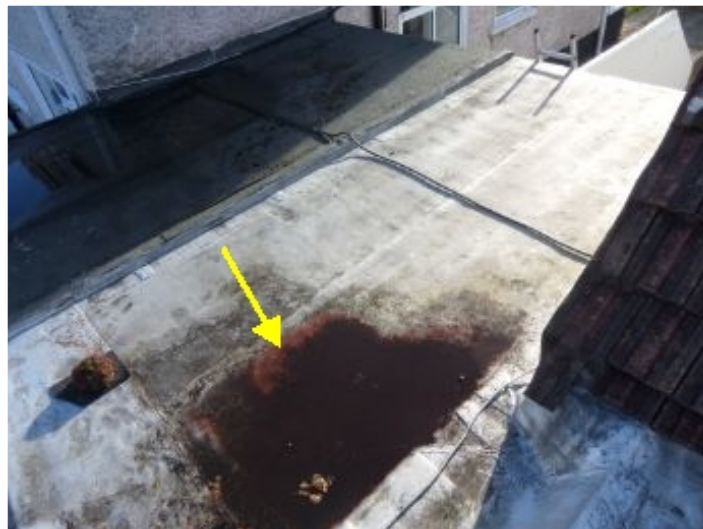
1.1. Flat roof covering aging over side extension.

Water ponding on flat roof.

1.2. Recommendation: The felt roof covering is towards the end of it's natural life, budget to replace.

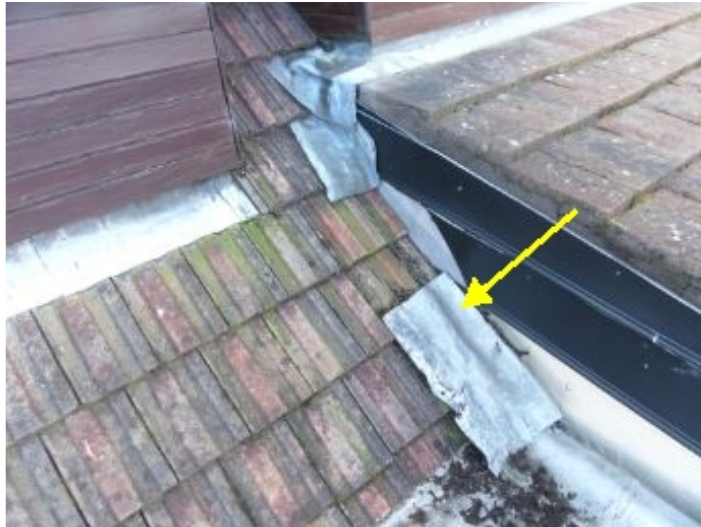
Flashing slipped / loose.

4.1. Secure slipped flashing between inspected property and neighbouring property.

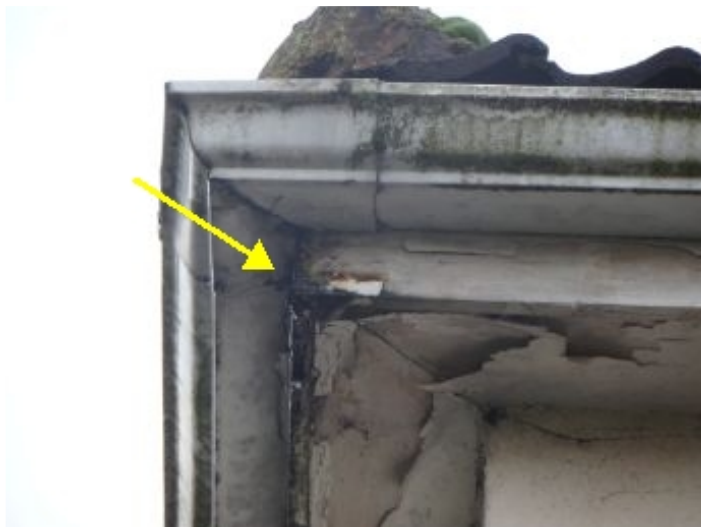
5.1. Wood rot at corners of roof eaves.

Rotting roof eaves.

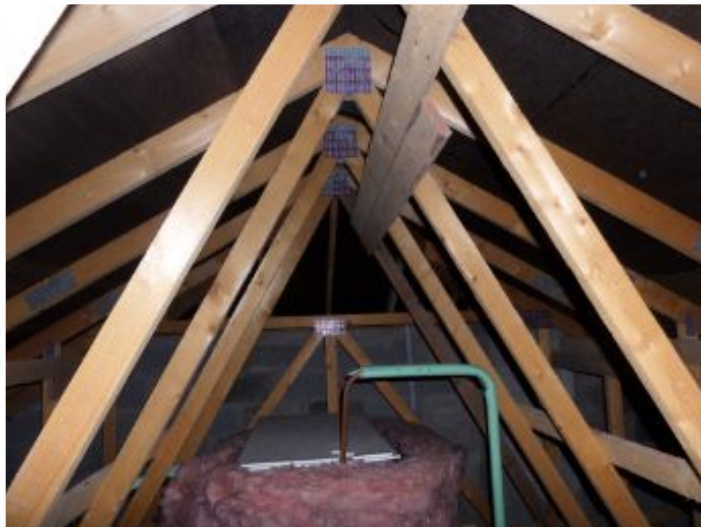
Main roof is constructed of factory engineered and manufactured timber roof trusses

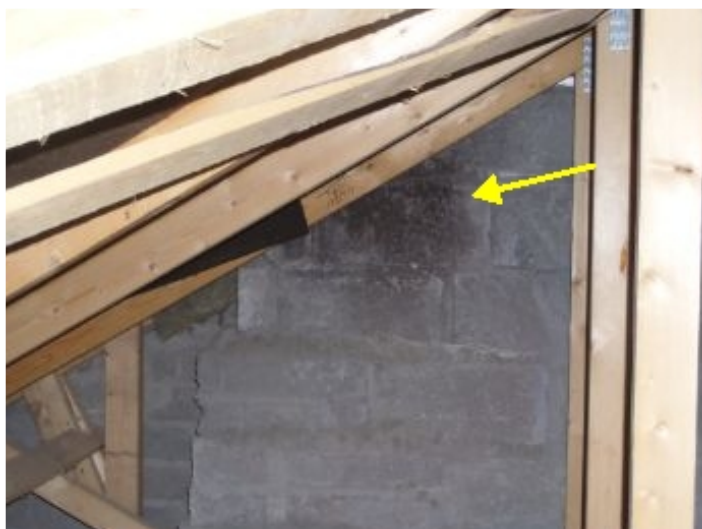
3.1. Moisture leaking around chimney (see damp chimney brest in attic).

- 3.1. Damp chimney brest in attic.

Damp chimney breast.

A ventilation gap should be allowed for around the damp chimney brest if considering converting the attic.

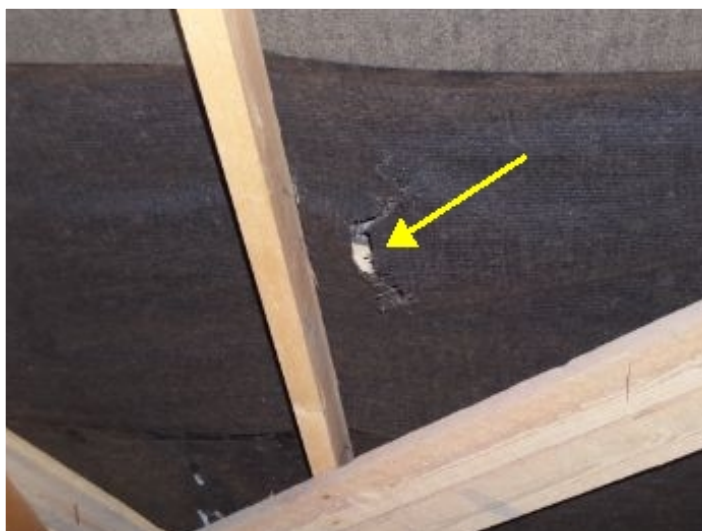
4.2. Holes / tears in roof felt.

Hole / tear in roof felt.

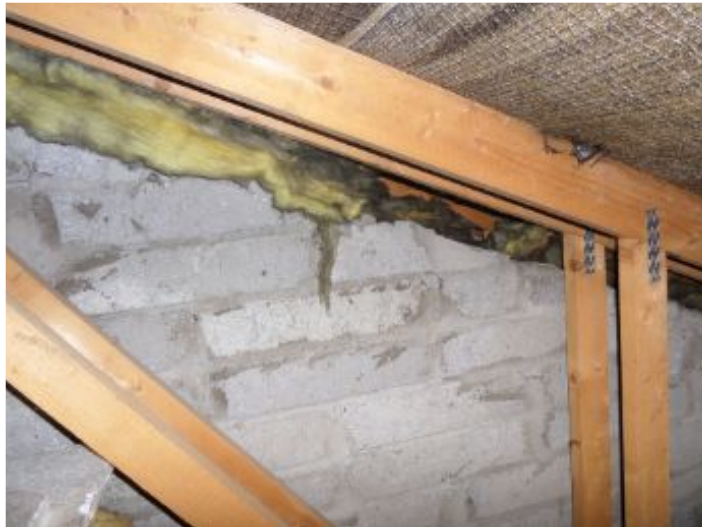
Fiberglas insulation fitted as fire proofing / fire blocking, replace with fire proof grade rockwool.

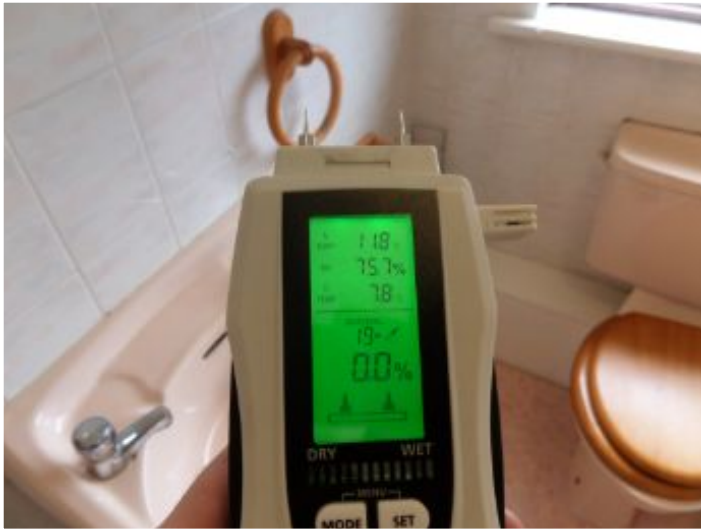
1.3. Inadequate **Ventilation in property.**

RH level in bathroom, c, 75 %

1.1. Consider installing automatic sensor controlled vents in bathroom and kitchen.

1.2. Vent openings required in all rooms.

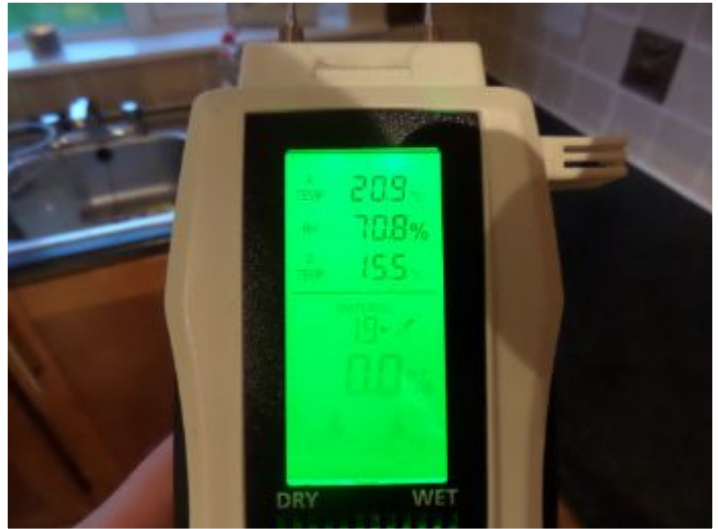
RH level in kitchen, c, 70 %

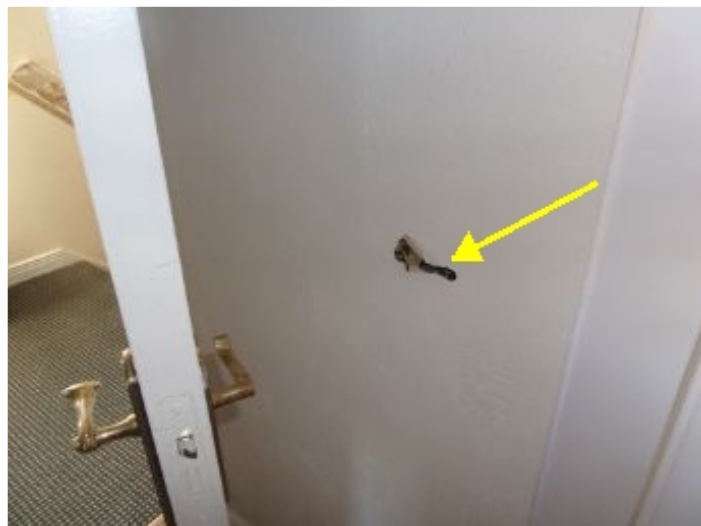
The interior walls of the property would benefit from redecoration.

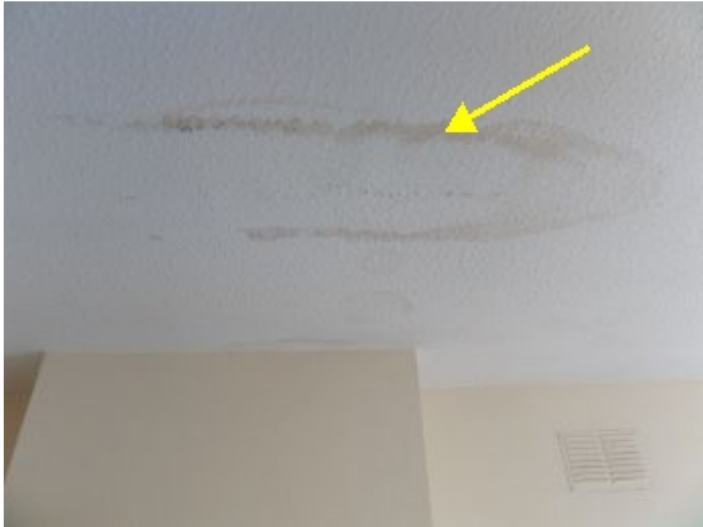
Moisture stain in ceiling at chimney.

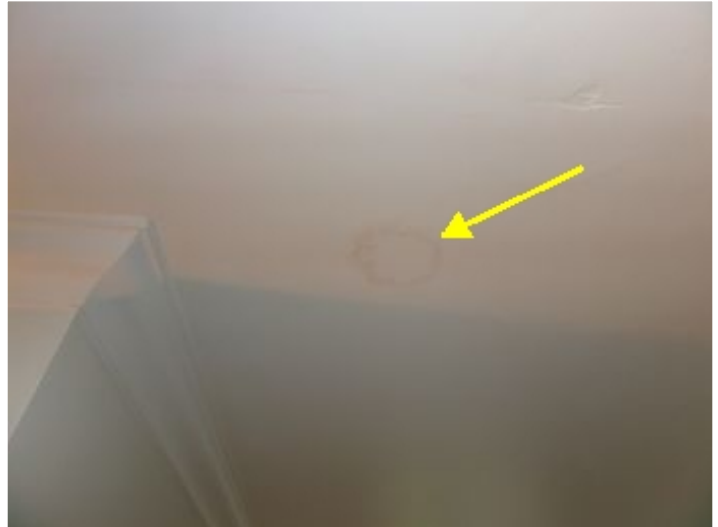
Moisture stains under bathroom.

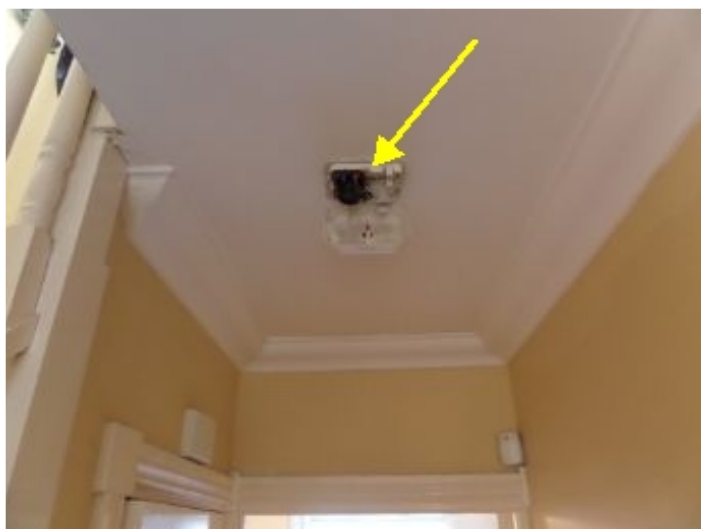
Replace batteries in smoke alarms.

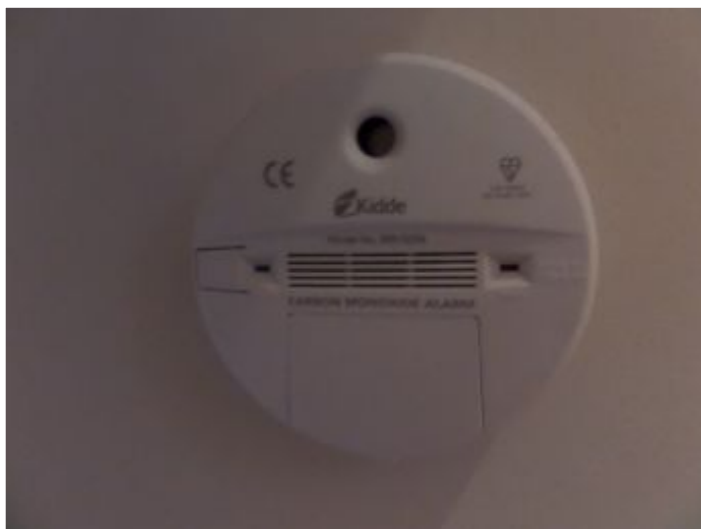
Carbon mon-oxide alarm should be tested when moving into property and at least weekly thereafter.

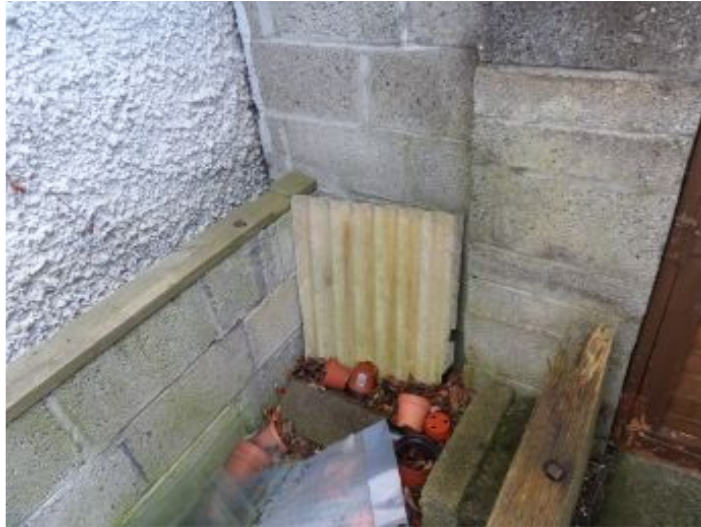
Asbestos panel noted in back garden.

Term	Definition
Asbestos	The removal of any material containing asbestos is a specialist and complex procedure and so must be carried out by a specialist contractor. In many situations if the asbestos material is not going to be disturbed then it can be a better solution to maintain rather than replace.
Dampness	Dampness in properties can come from various sources. Rising dampness is as a result of capillary action whereby ground moisture rises up through the walls due to the lack of any effective damp proof barrier. Penetrating dampness can come from a number of sources such as defects with seals around windows and doors, chimneys, flashings, roofs, rainwater goods and external joinery. Penetrating dampness can also come via defects with external render, pointing and plaster finishes as well as high external ground levels. Plumbing leaks from hot and cold water systems will also result in dampness and condensation and is another source that needs to be considered in addition to rain water penetration.
