Confidential Property Survey Report

12 New Street, Dublin

**Inspection prepared for: Mr. A Sample
Date of Inspection: 13/4/2015**

**Inspector: David Usher
B.Sc. (Hons) Building Surveying
Phone: 01-6281040
Email: info@propertyhealthcheck.ie**

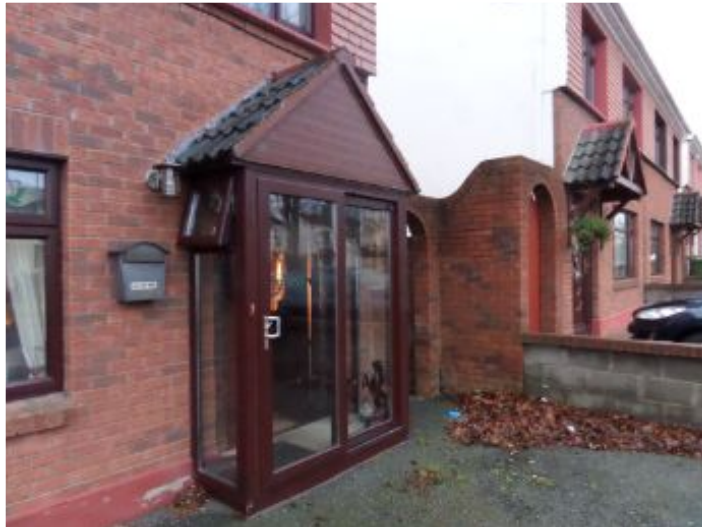
2.1. Front porch enclosed.

Front porch enclosed.

2.2. I would recommend that a Certificate of Exemption from Planning Permission and compliance with Building Regulations be obtained from the vendor for change/s listed above. Any certification available regarding interim inspections which may have been carried out during the course of the works should also be obtained.

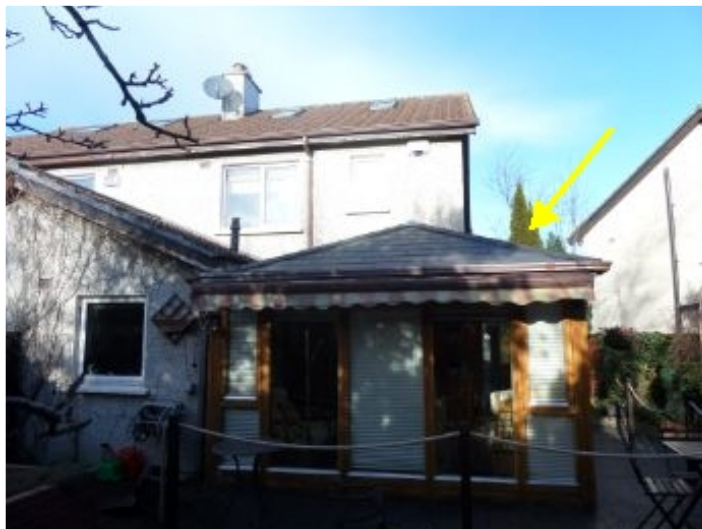
3.1. Rear extension extending beyond the left side of house.

Rear extension extending beyond side of house.

3.2. I would recommend that a Certificate of Compliance with Planning Permission and compliance with Building Regulations be obtained from the vendor for the work/s listed above. Any certification available regarding interim inspections which may have been carried out during the course of the works should also be obtained.

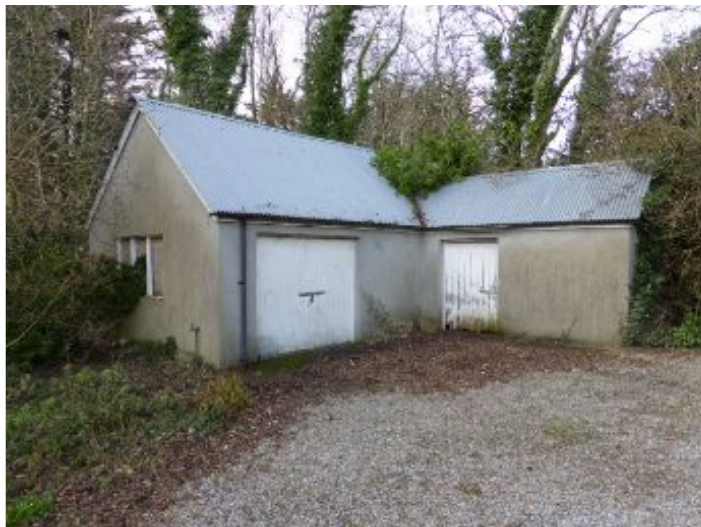
7.1. Masonry shed.

7.2. Note. The (footprint) area of the shed is greater than 25 meters squared. Obtain certificate of compliance with Planning Permission.

Masonry shed.

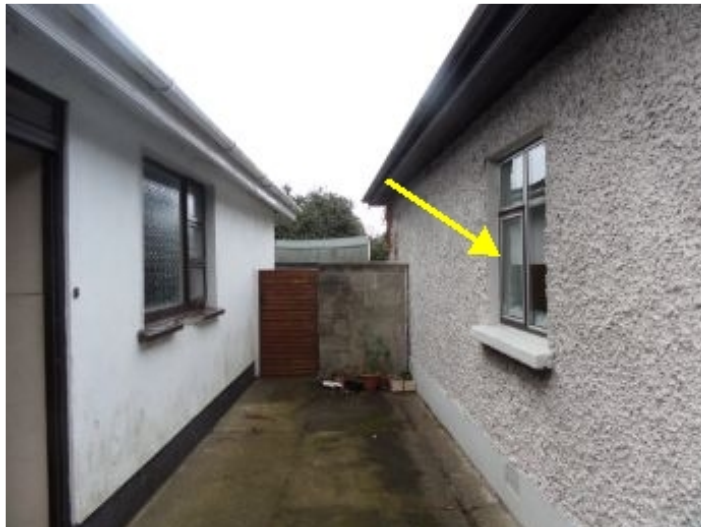
10.1. The neighbours window is overlooking the right side of inspected property.

The neighbours window is overlooking the right side of inspected property.

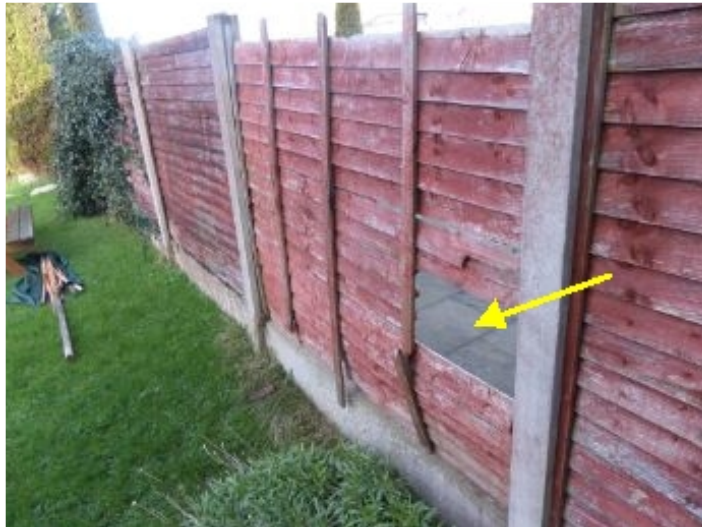
5.1. Delayed maintenance to timber fences.

Delayed maintenance to timber fences.

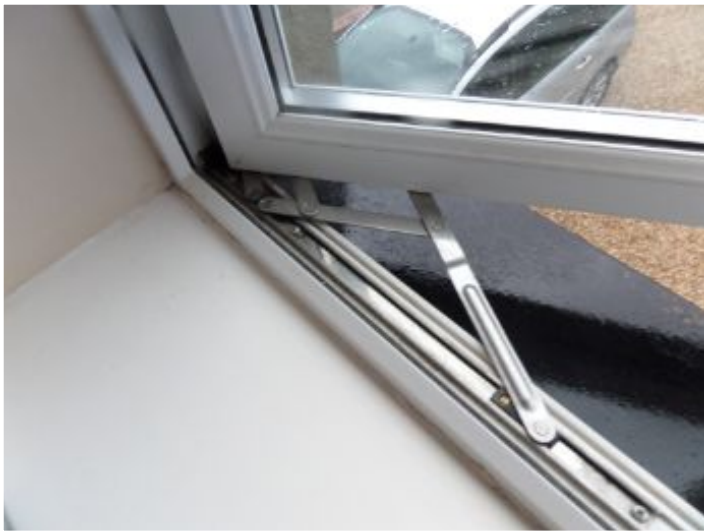
3.1. Window hinges require lubrication, will prevent windows from closing flush to window frames.

Window hinges require lubrication.

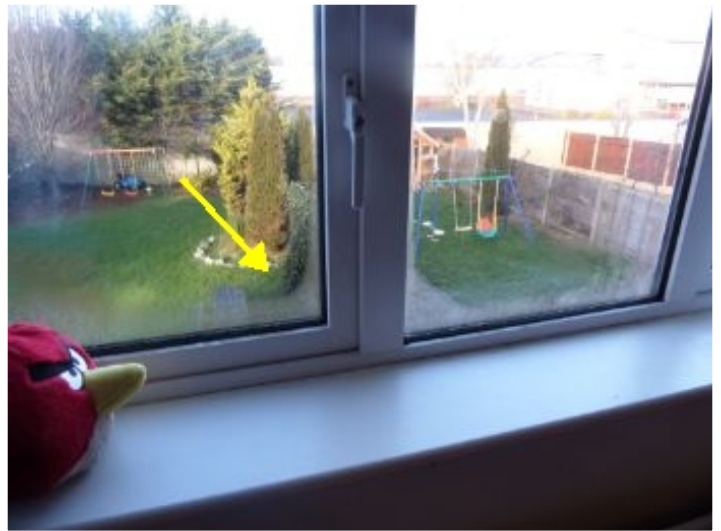
3.2. Window seals failing in double glazing at back of house and in bathroom.

Window seals failing in double glazing at back of house, condensation noted.

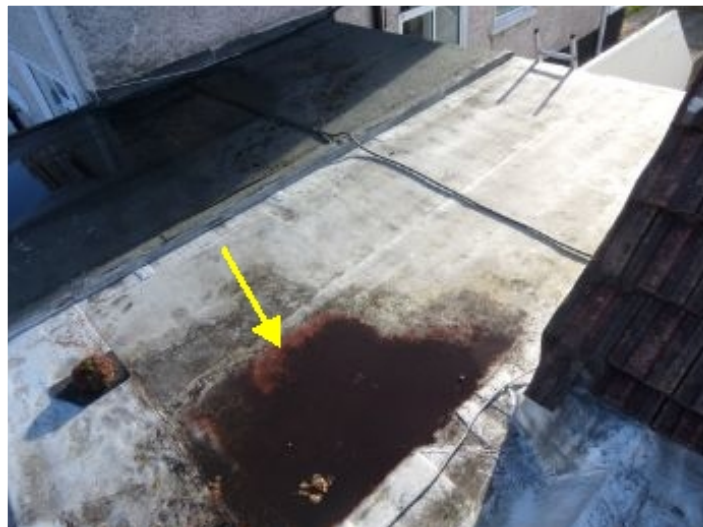
1.1. Flat roof covering aging over side extension.

Water ponding on flat roof.

1.2. Recommendation: The felt roof covering is towards the end of it's natural life, budget to replace.

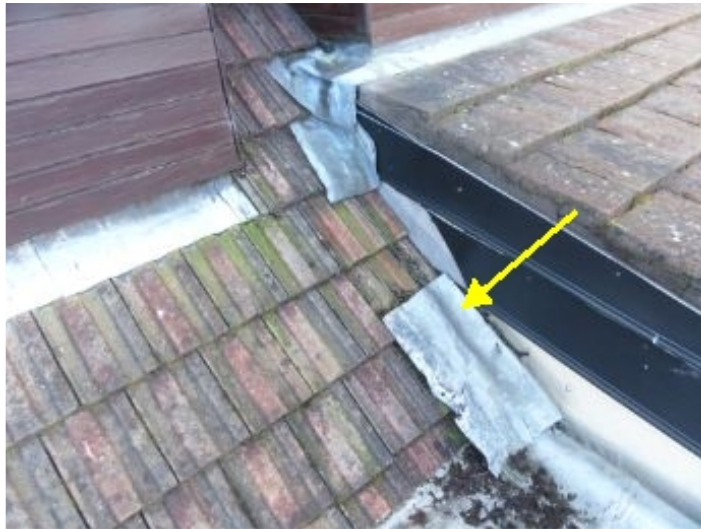
Flashing slipped / loose.

4.1. Secure slipped flashing between inspected property and neighbouring property. No leaks noted at time of inspection, monitor.

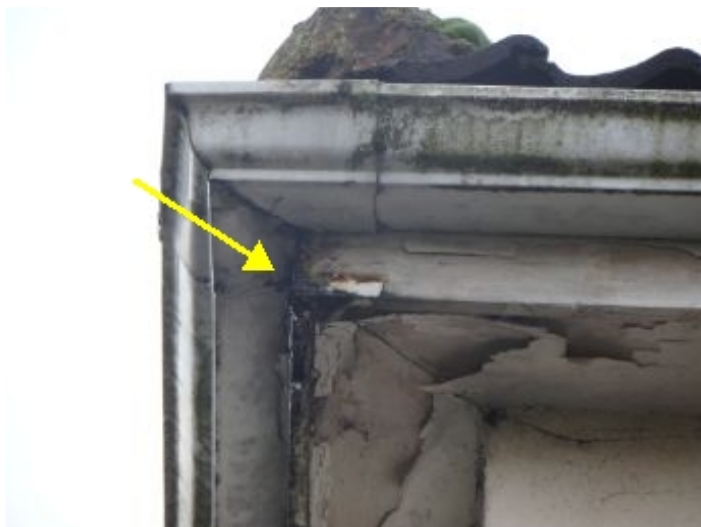
5.1. Wood rot at corners of roof eaves.

Rotting roof eaves.

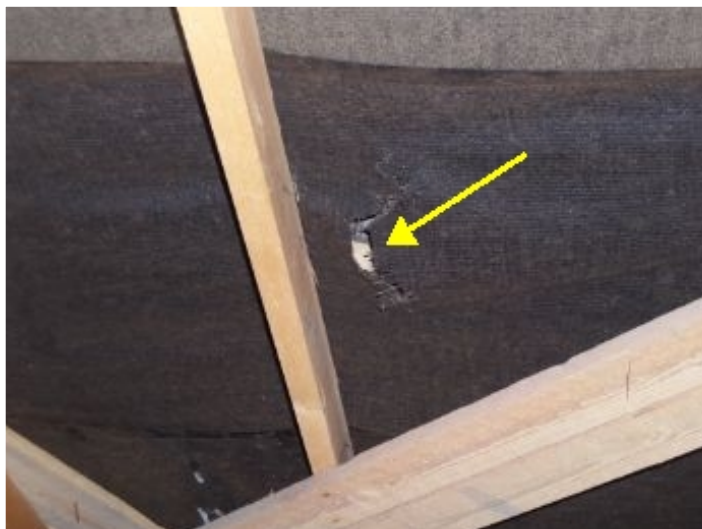
4.2. Holes / tears in roof felt.

Hole / tear in roof felt.

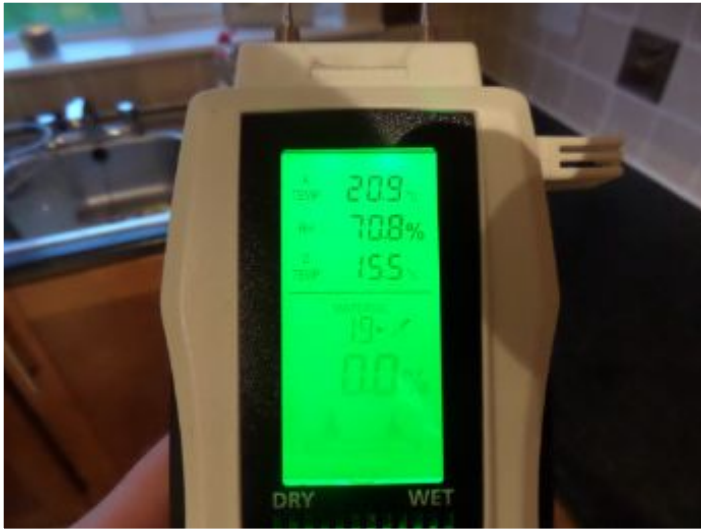
1.3. Inadequate **Ventilation in property.**

RH level in kitchen, c, 70 %

1.2. Vent openings required in all rooms.

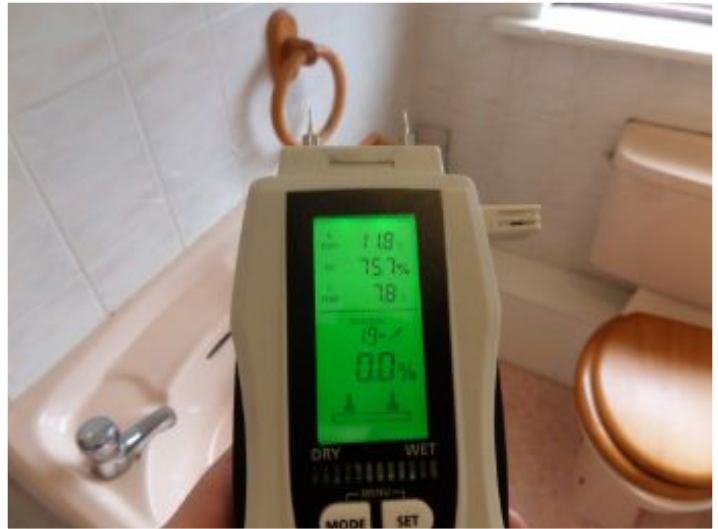
RH level in bathroom, c, 75 %

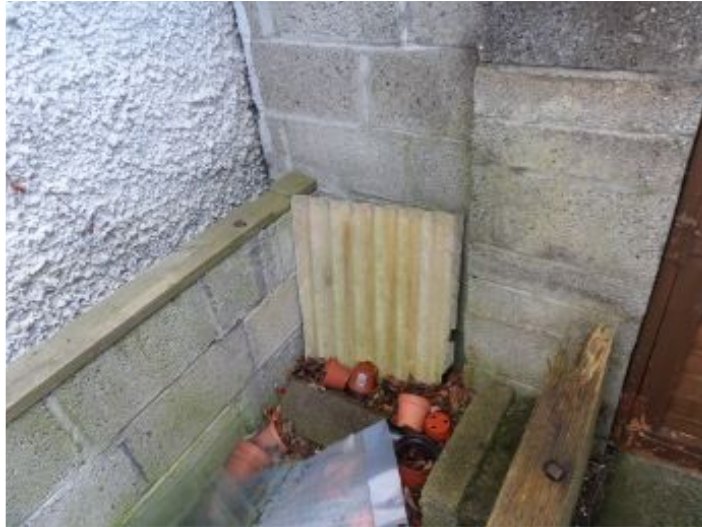
1.1. **Asbestos** panel noted in back garden.

Asbestos panel noted in back garden.

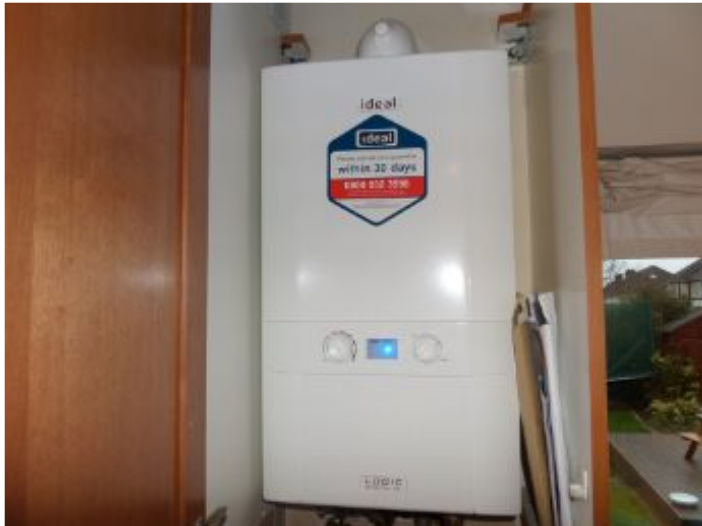
Full service required.

1.1. The heating system is now probably overdue for a service and therefore before you purchase, I recommend that you ask a qualified heating engineer to check and service the heating system or arrange for the owners to do this and then you should set in hand an annual maintenance agreement.

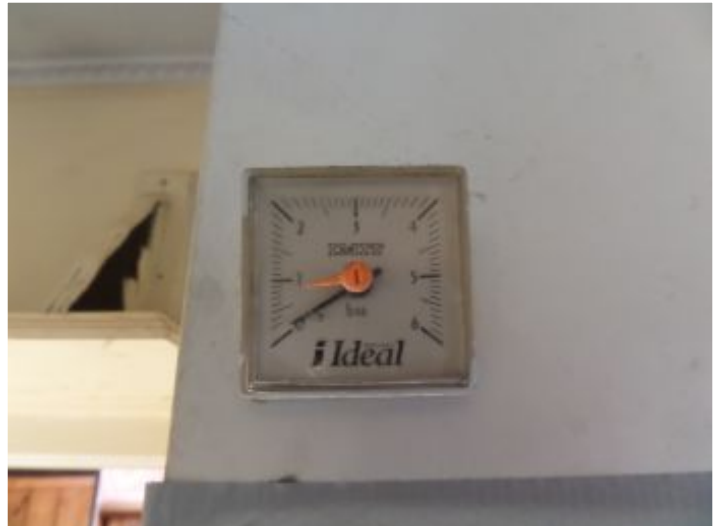
1.4. Low water pressure to heating system.

Low water pressure to heating system.

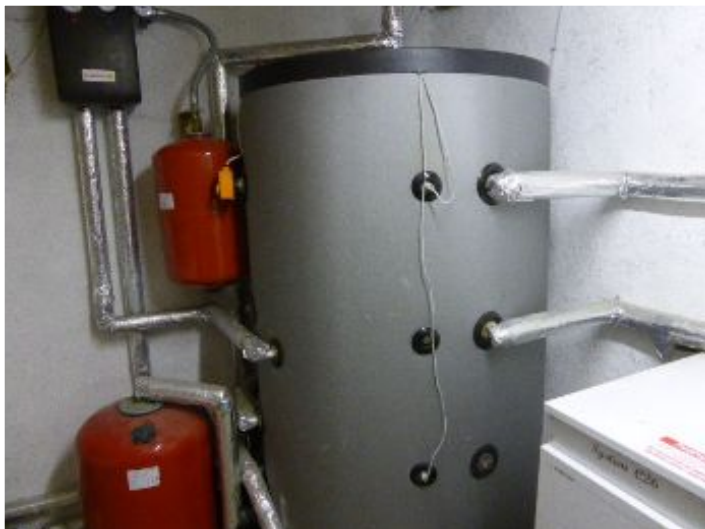
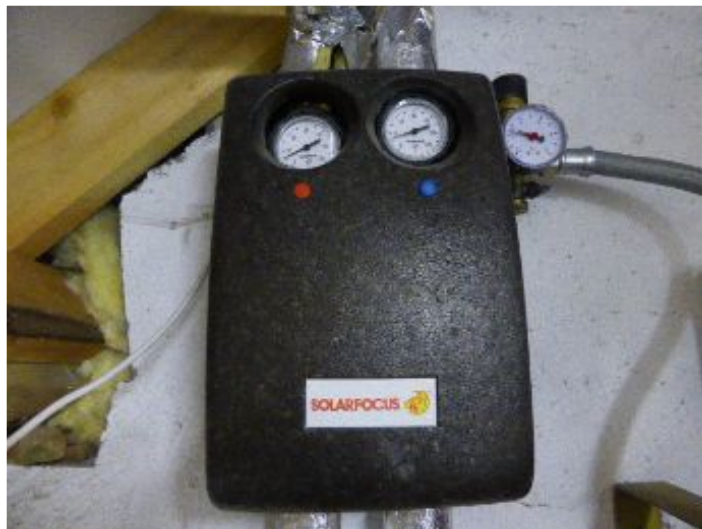
Solar panel system should be commissioned before closing.

6.1. Solar panel system should be commissioned before closing.

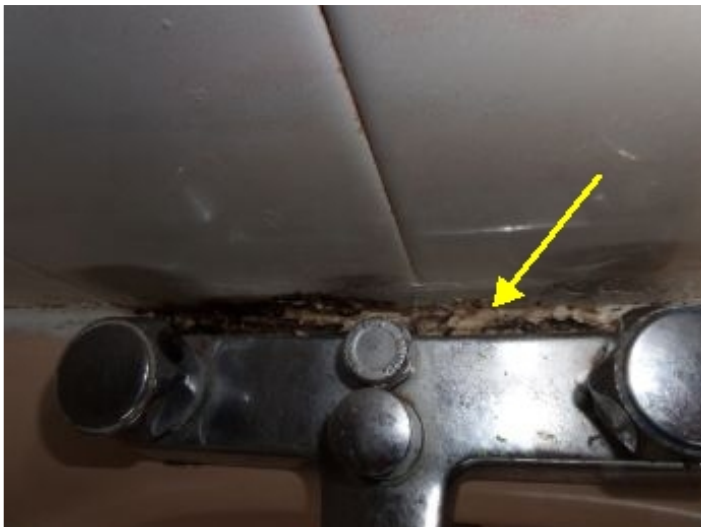
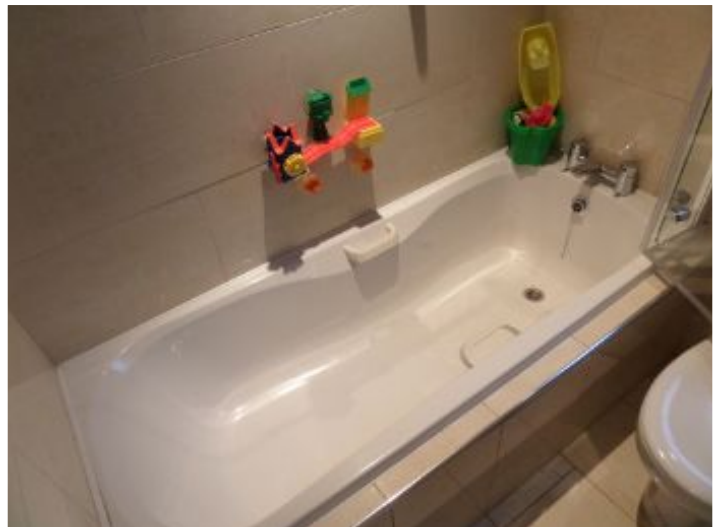
Re-seal around bathtub.

3.1. **Re-seal** around bathtub to wall in bathroom.

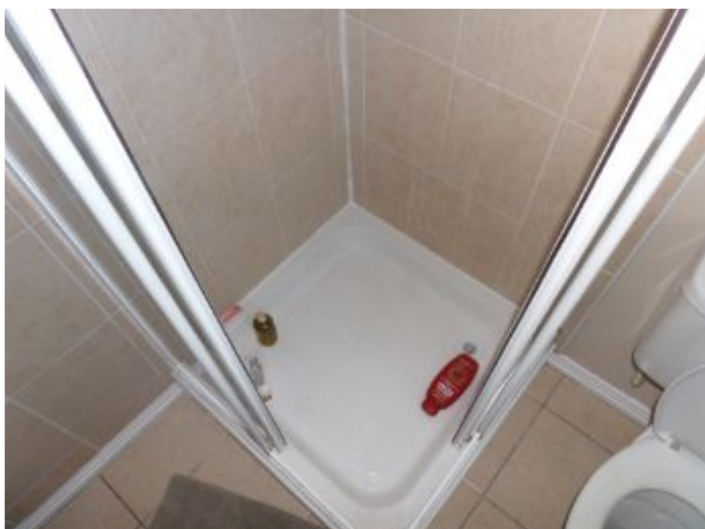
Re-seal around shower tray.

3.2. **Re-seal** around shower tray to wall in ensuite.

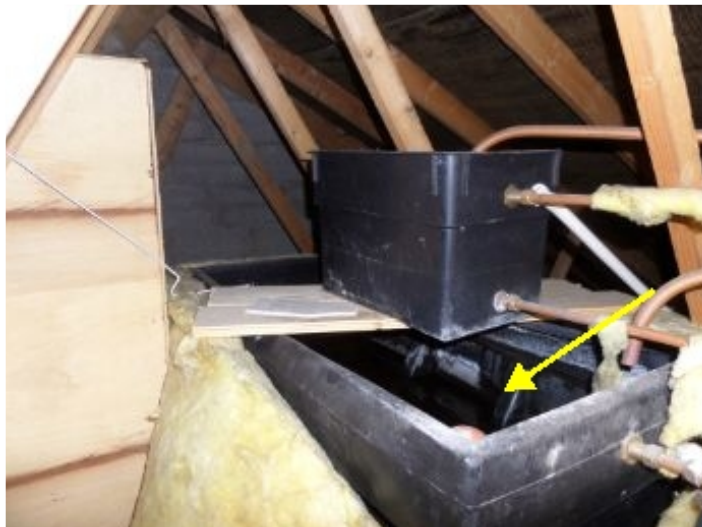
6.2. Cover required over water storage tank.

Cover required over water storage tank.

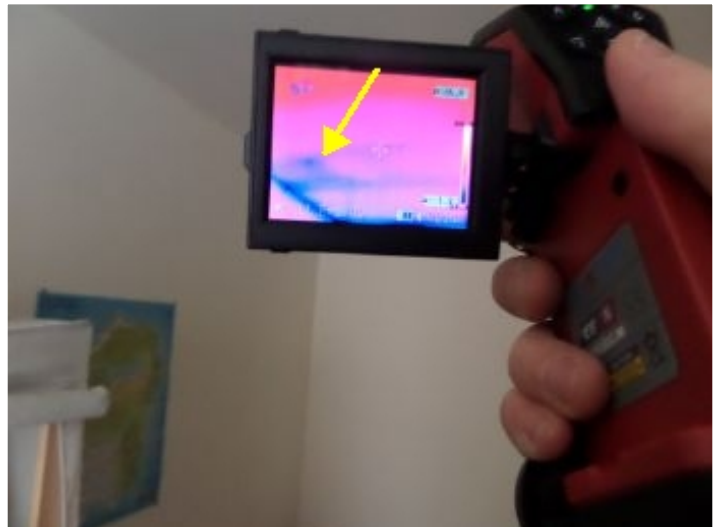
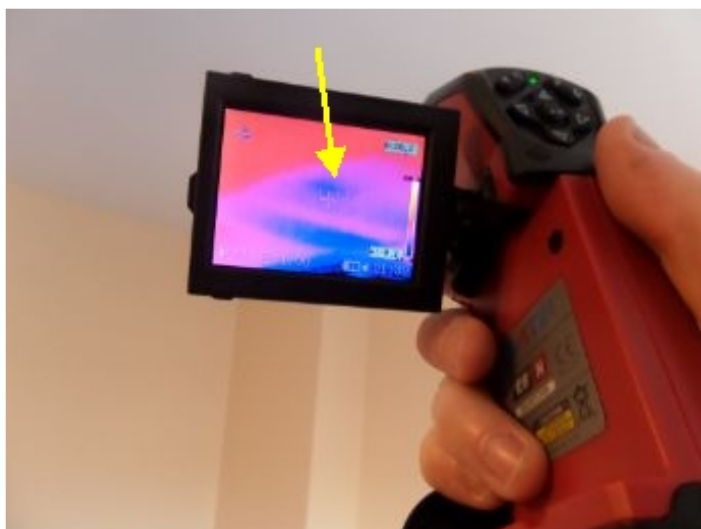
3.2. Sections of insulation missing / poorly fitted on attic floor.

Sections of insulation missing / poorly fitted on attic floor.

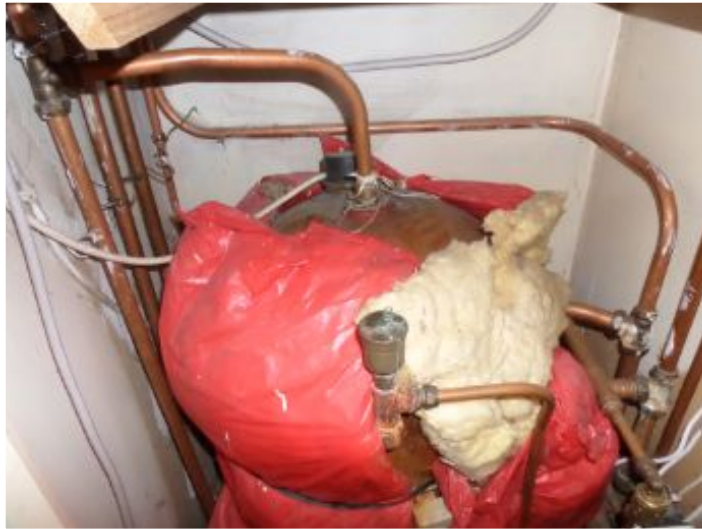
The hot water cylinder is lagged with a loose jacket.

8.1. The hot water cylinder is lagged with a loose jacket. Consider upgrading this to a foam lagged modern cylinder to reduce potential leaks as well as to significantly reduce heat losses.
