# Confidential Property Survey Report

42 Old Street, Dublin

Inspection prepared for: Mr A Sample  
Date of Inspection: 14/4/2015

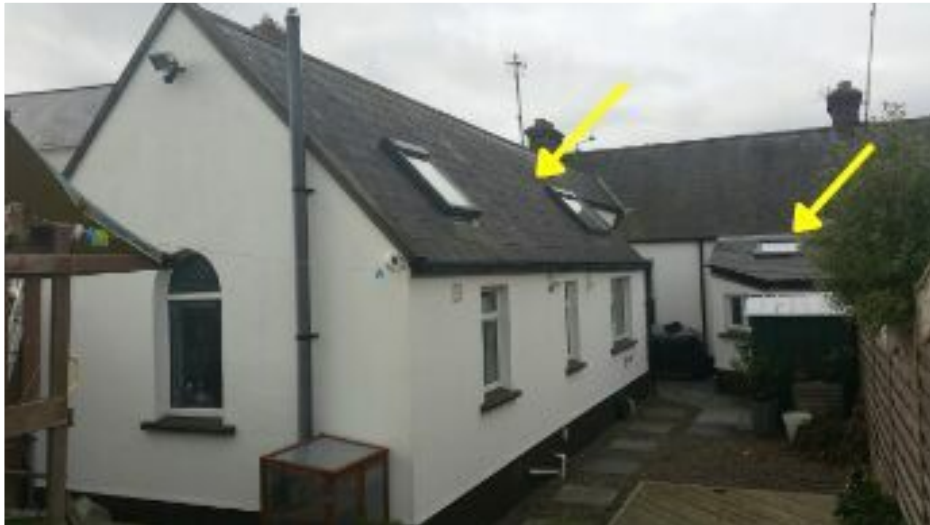
3.2. Total extensions exceeds 40 meters squared.

Rear extensions added.

3.3. I would recommend that a Certificate of Compliance with Planning Permission and compliance with Building Regulations be obtained from the vendor for the work/s listed above. Any certification available regarding interim inspections which may have been carried out during the course of the works should also be obtained.

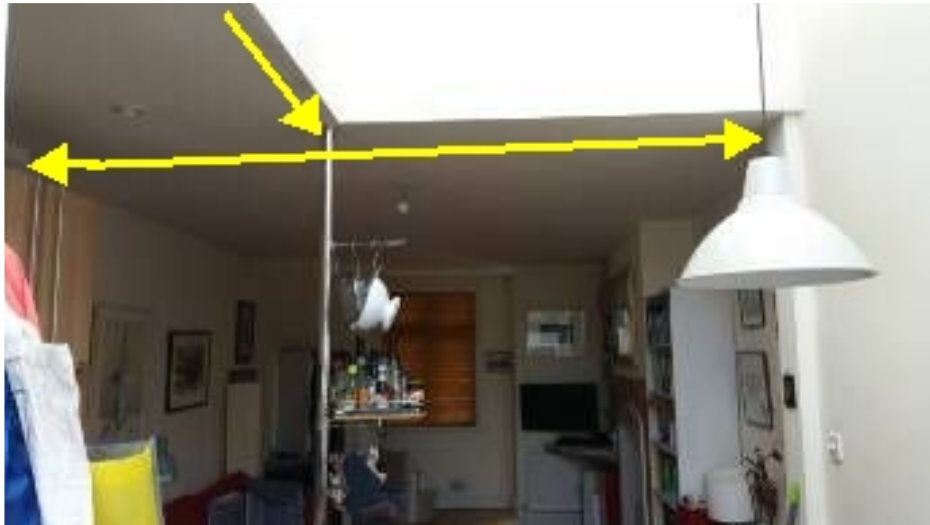
4.1. The interior wall between kitchen and livingroom has been removed.

I cannot confirm the sizing or adequacy of the structural beam/s support inserted where the opening has been formed as the building works have been closed up.

4.2. I cannot confirm the sizing or adequacy of the structural beam/s support inserted where the opening has been formed as the building works have been closed up. It is important to confirm that these works were designed and supervised by a qualified person.

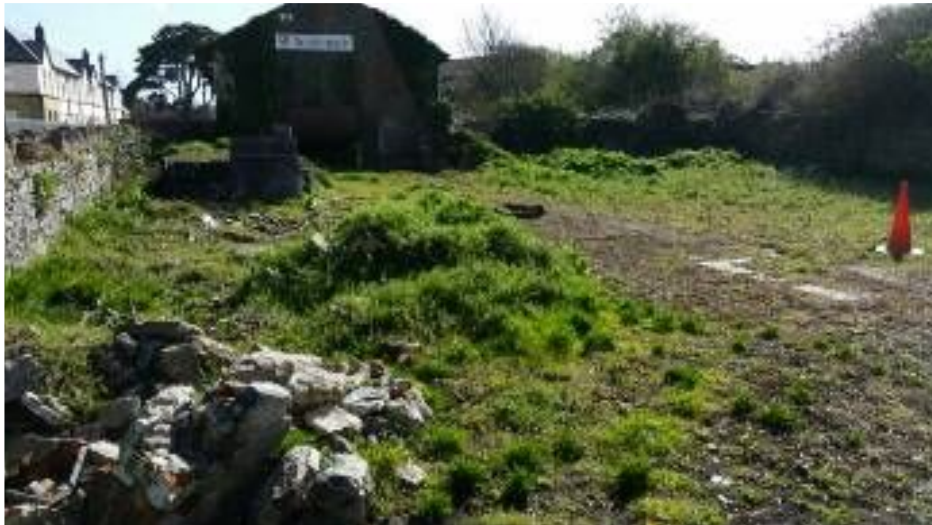
8.1. The Boundary lines to the rear of the property are not clearly defined.

Boundary line not clear in back garden.

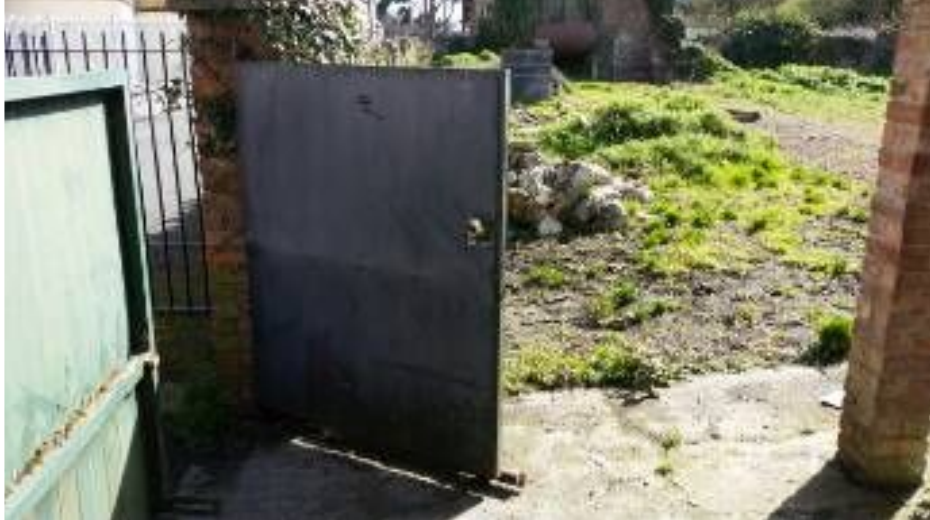
10.1. Possible right of way from gate at rear of property to neighbouring garden.

Possible right of way from gate at rear of property to neighbouring garden.

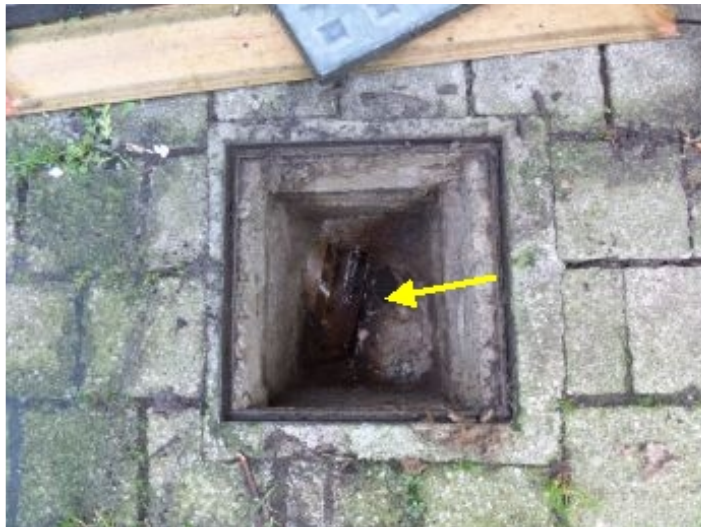
- 1.1. The cement finish around the foul sewer gullies and rain water gullies are poorly formed with gaps present. This can allow water seep into the ground around the walls of the house.
- 1.2. Limited access to exterior drains. Easy access should be made available in case of blockage.

The cement finish around the foul sewer gullies and rain water gullies are poorly formed with gaps present. This can allow water seep into the ground around the walls of the house.

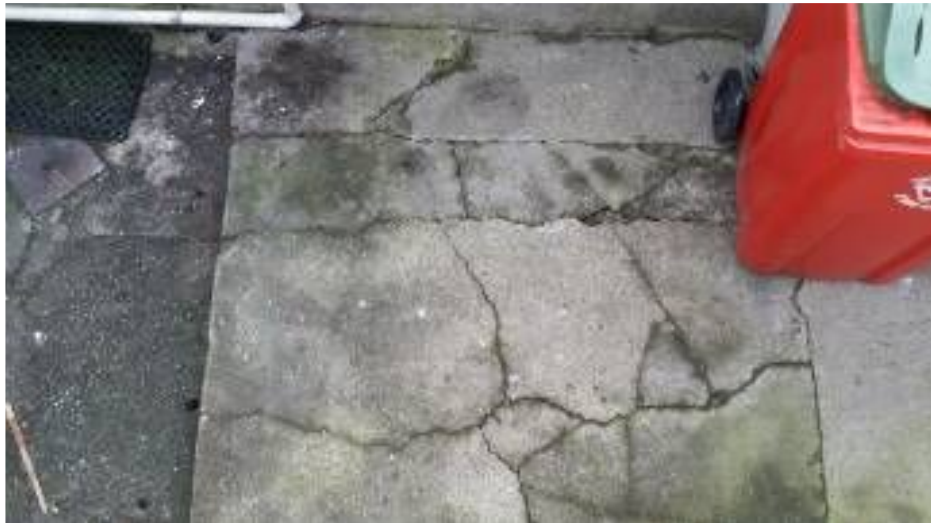
- 3.1. Delayed maintenance to paths.

Cracking in path.

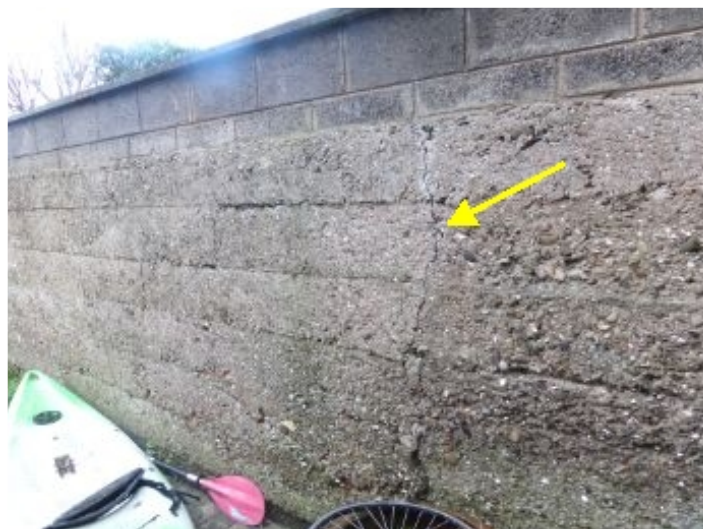
4.1. Delayed maintenance to boundary walls / fences.

Crack in boundary wall.

4.2. Recommendation: Repair cracks in boundary walls.

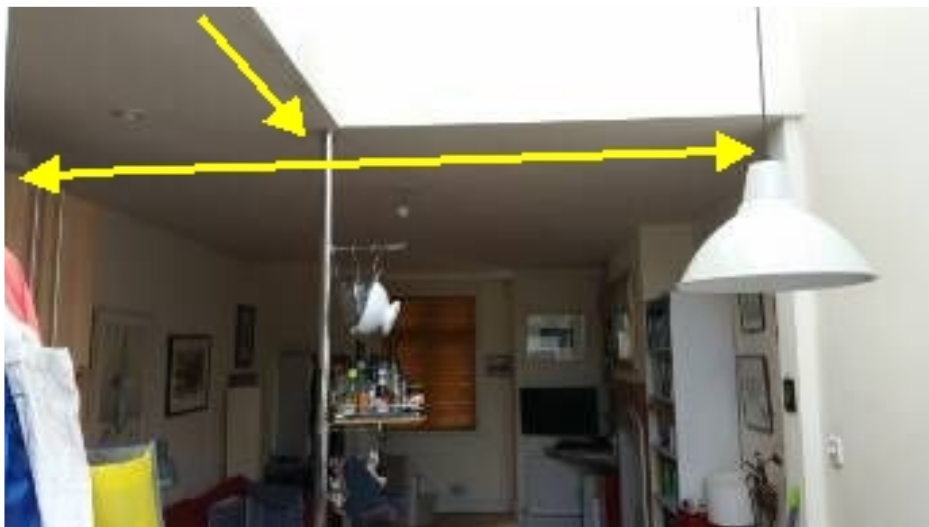
2.1. The interior wall between kitchen and livingroom has been removed. Minor movement noted in this area would appear to have ceased, monitor.

I cannot confirm the sizing or adequacy of the structural beam/s support inserted where the opening has been formed as the building works have been closed up.

2.2. Recommendation: I cannot confirm the sizing or adequacy of the structural beam/s support inserted where the opening has been formed as the building works have been closed up. It is important to confirm that the beam support over this opening was designed by a qualified engineer.

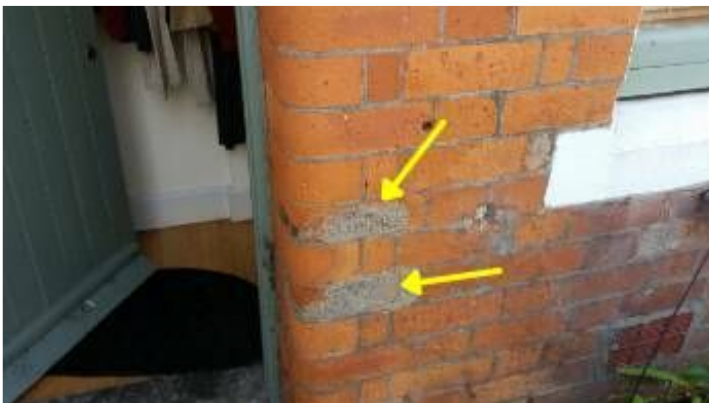
- 3.1. A limited number of bricks are spalling, this is where the face of the brick is failing.
- 3.2. The exterior brickwork has been repointed to a fair standard to the front of the house. Pointing loose in places. The thickness of the existing point is c, 5mm deep. Re - pointing of brickworks is recommended to be 12.5 - 25mm deep between bricks.
- 3.3. The cracks in the wall between the original structural and the extension are likely to be the result of differential settlement between the newer extension and the original building.
- 3.4. **Thermal cracking** in cement rendered walls.

Bricks spalling.

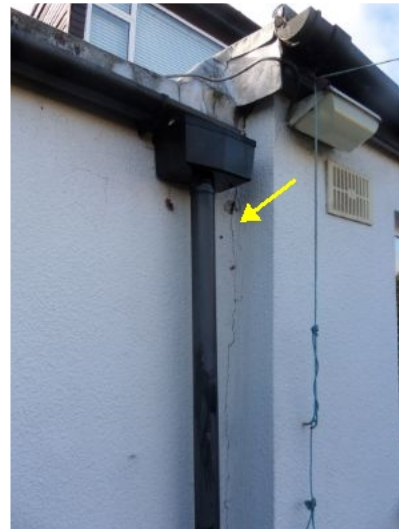
Cracks between the newer extension and the original building.

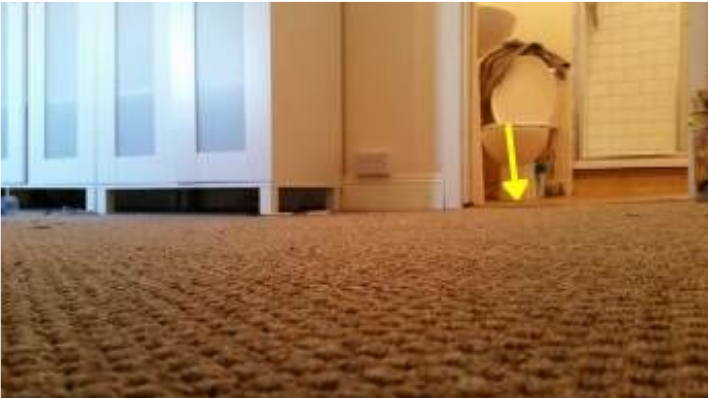
Slight slope in floor to upstairs bedroom.

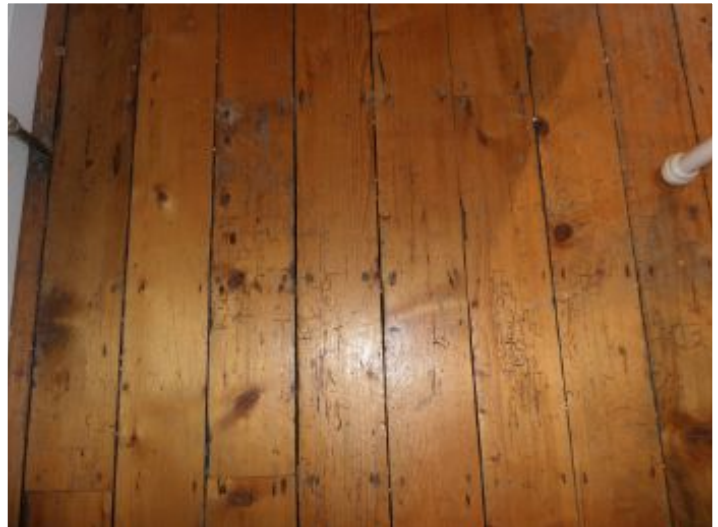
5.4. Dormant woodworm in floors.

Dormant woodworm in floors.

5.5. Recommendation: Spraying recommended to floors as a precaution to eradicate common furniture beetle or other wood-boring insects often found in such buildings of this age. Quote to be sought from specialist with guarantee.

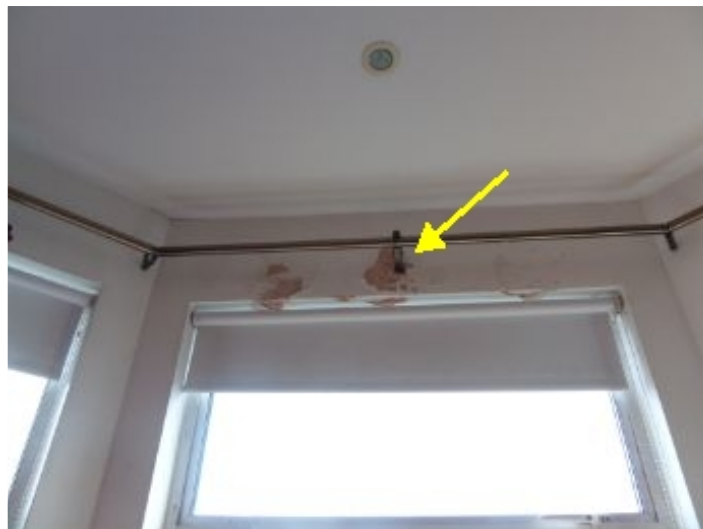
8.1. Moisture penetration through exterior wall over front window.

Moisture penetration through exterior wall.

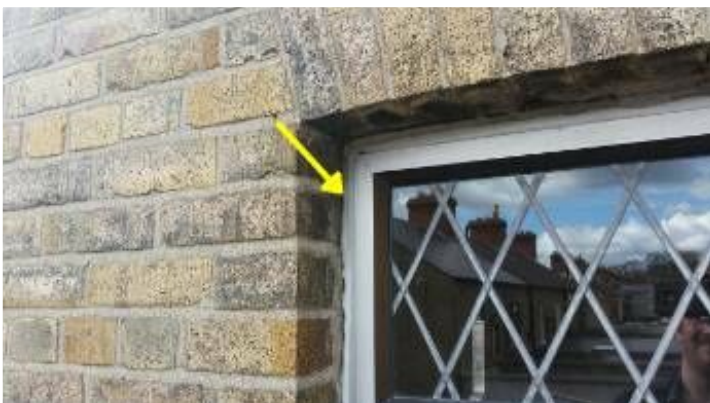
Re-seal around window frames to walls.

3.1. **Re-seal** around all window frames to walls.

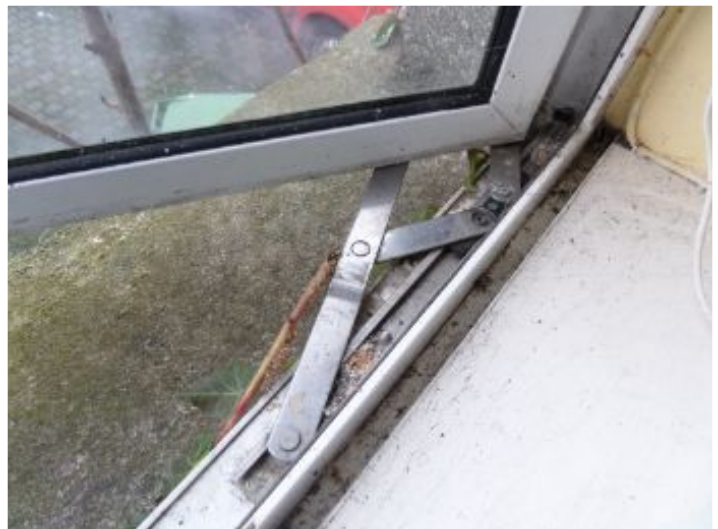
3.2. Window hinges require lubrication, will prevent windows from closing flush to window frames.

Window hinges require lubrication.

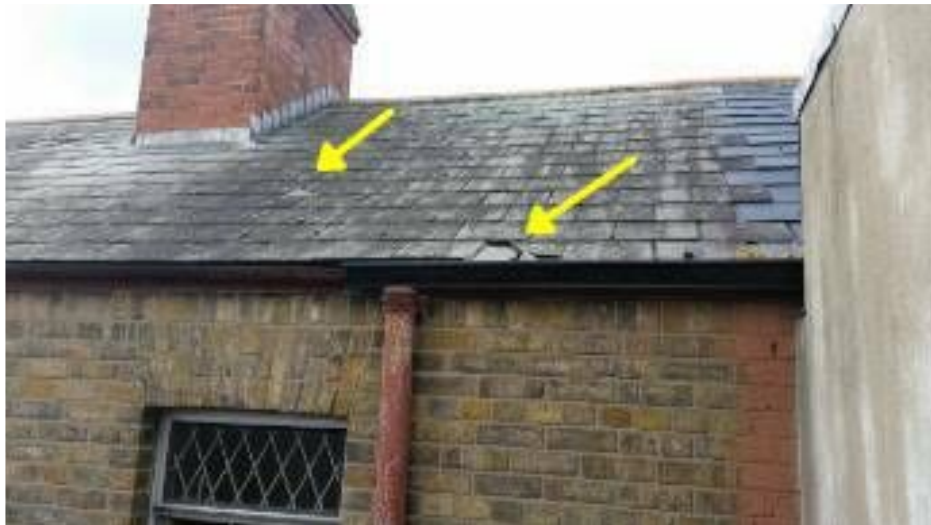
1.1. Numerous slipped slates over main roof, repair in the short term.

Slipped roof coverings.

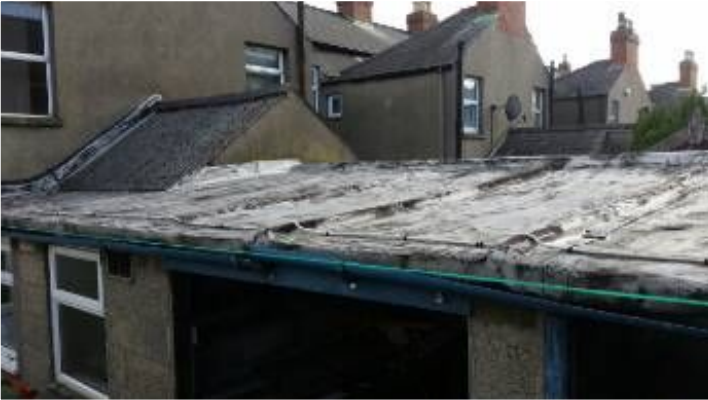
2.1. The felt roof covering is at the end of its natural life, budget to replace.

Roof covering aging.

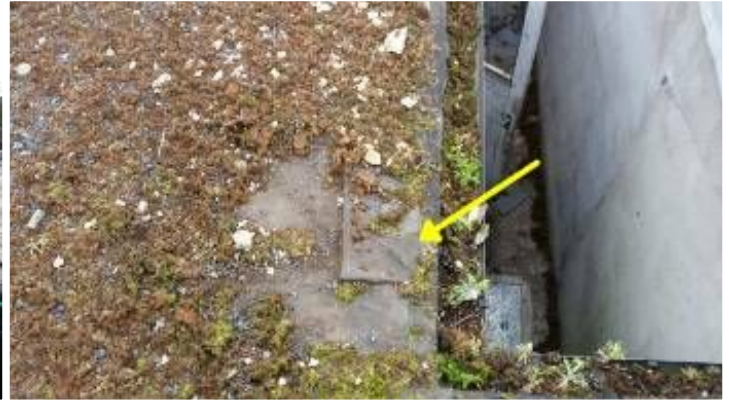
Previous repairs to flat roof.

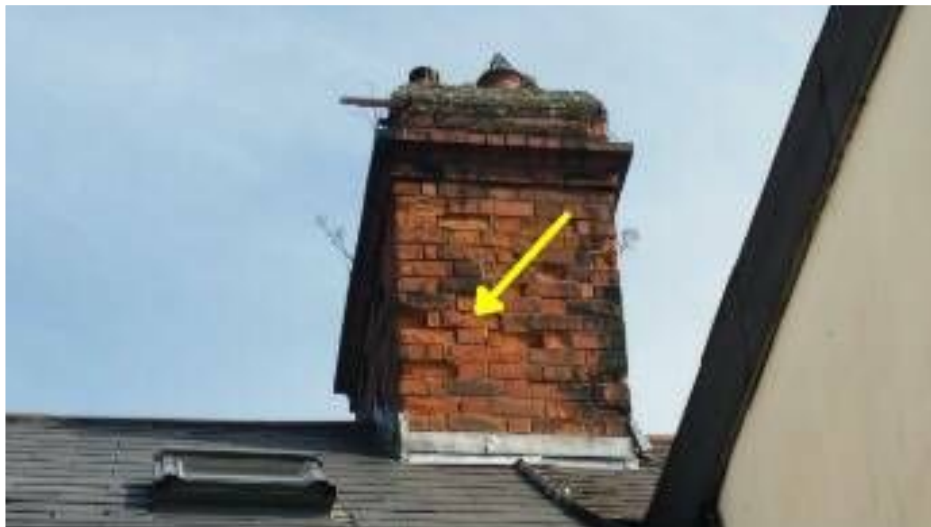
Spalling bricks.

- 3.1. Some weather proofing and repointing of the chimney stack will be required to ensure that it remains water tight.
- 3.2. Remove vegetation from chimney stack.

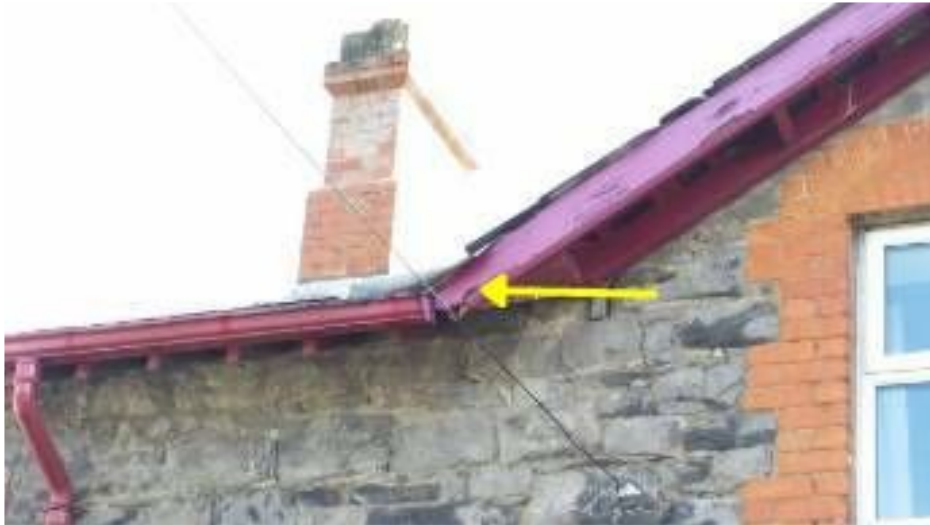
- 6.1. Wood rot at corners of roof eaves.

Rotting roof eaves.

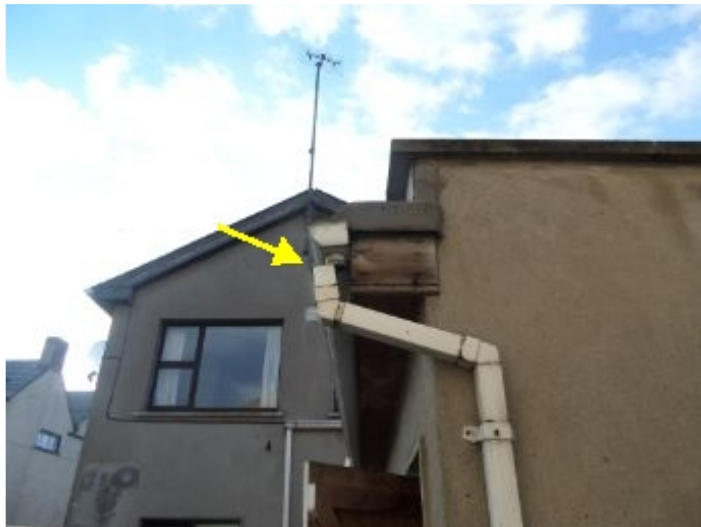
- 7.1. Secure downpipe at rear of house.

Secure downpipe at rear of house.

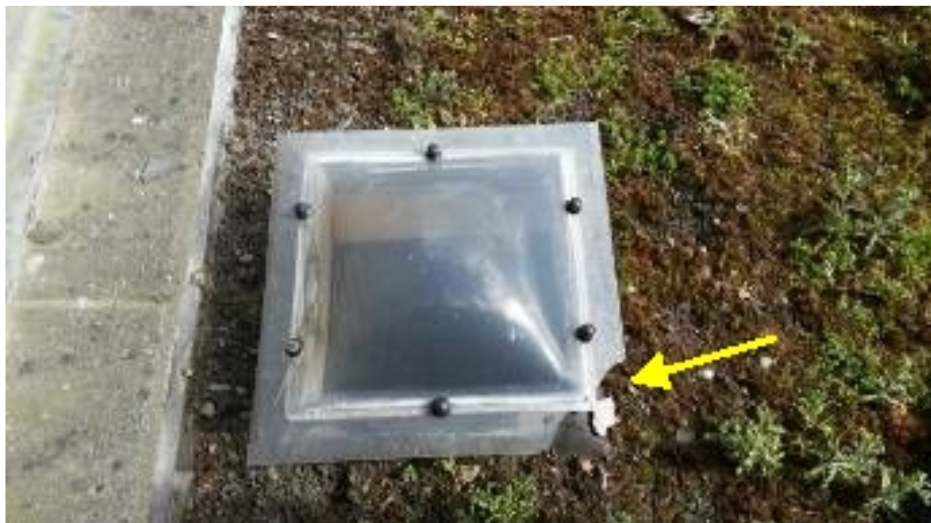
#### 8.1. Damaged skylight over flat roof.

Damaged skylight.

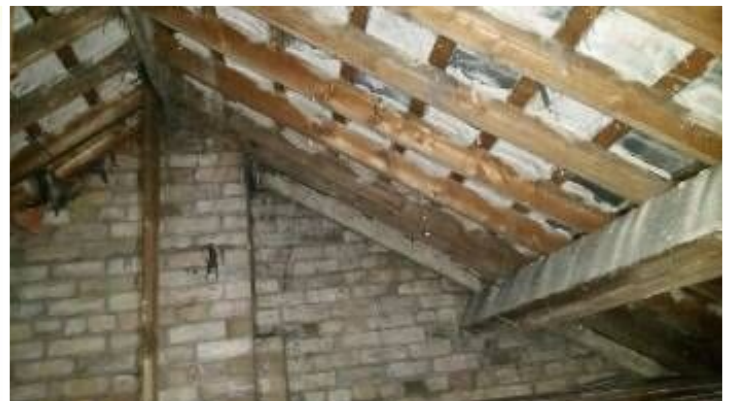
No collars fitted between roof rafters in roof structure, fit collars.

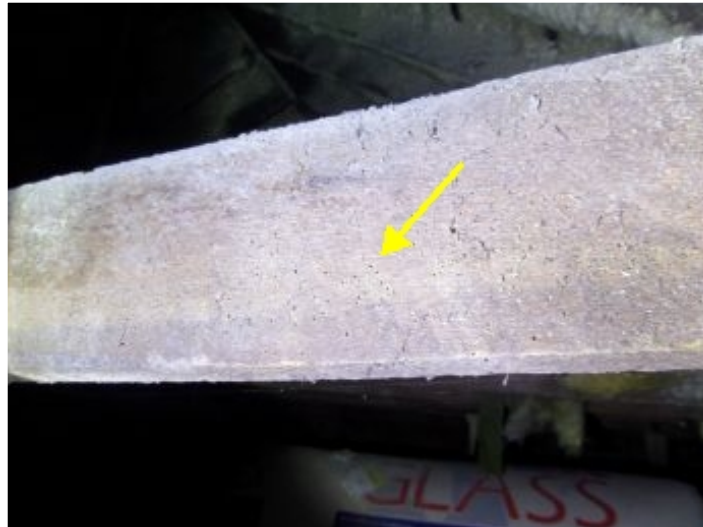
2.4. Dormant woodworm noted in structural timbers.

Dormant woodworm.

2.5. Recommendation: Spraying recommended to roofspace as a precaution to eradicate common furniture beetle or other wood-boring insects often found in such buildings of this age. Quote to be sought from specialist with guarantee.

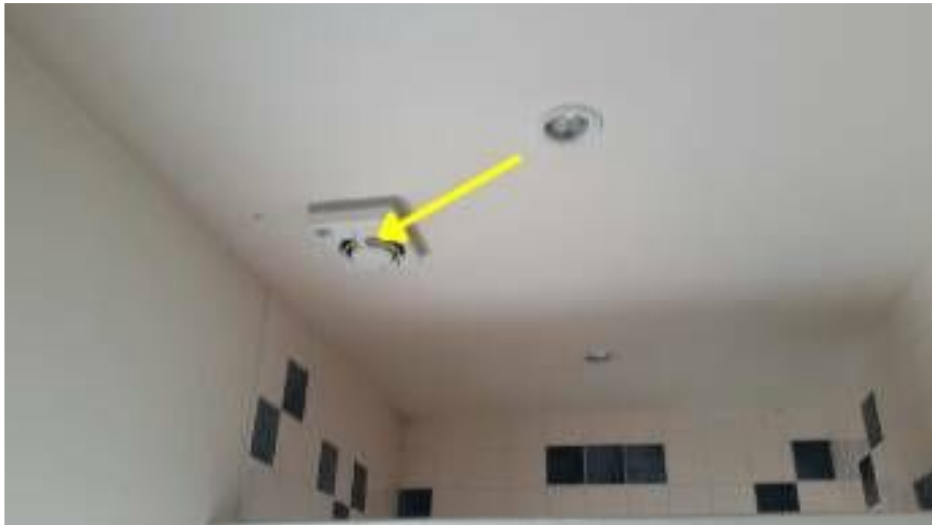
5.1. Vent from bathroom venting directly into attic, should vent out of attic space.

Vent from bathroom venting directly into attic, should vent out of attic space.

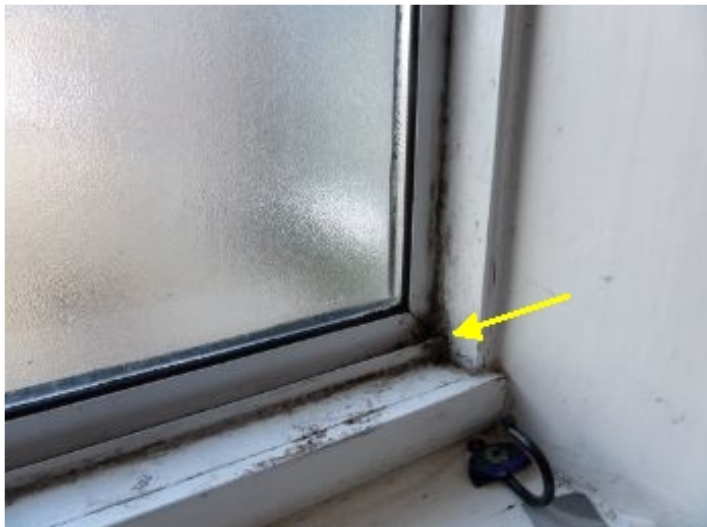
1.1. Condensation noted to interior walls around window frames, upgrade insulation and ventilation.

Mould around window frames.

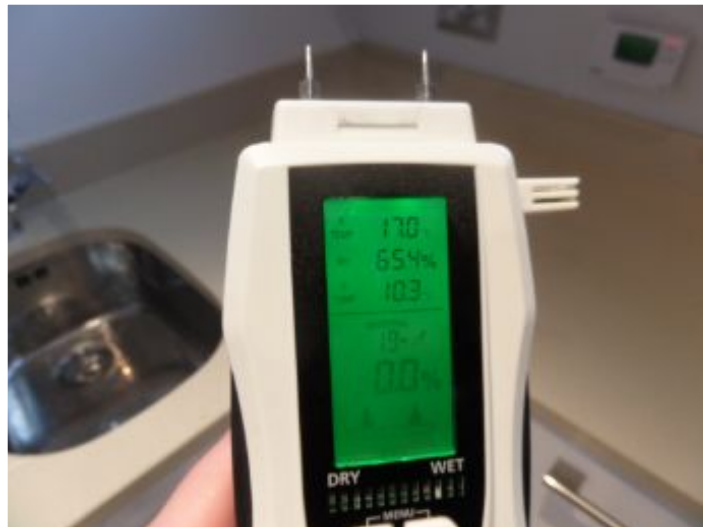
1.2. Inadequate **Ventilation in property**, vent openings required in all rooms.

RH level in kitchen, c, 65 %

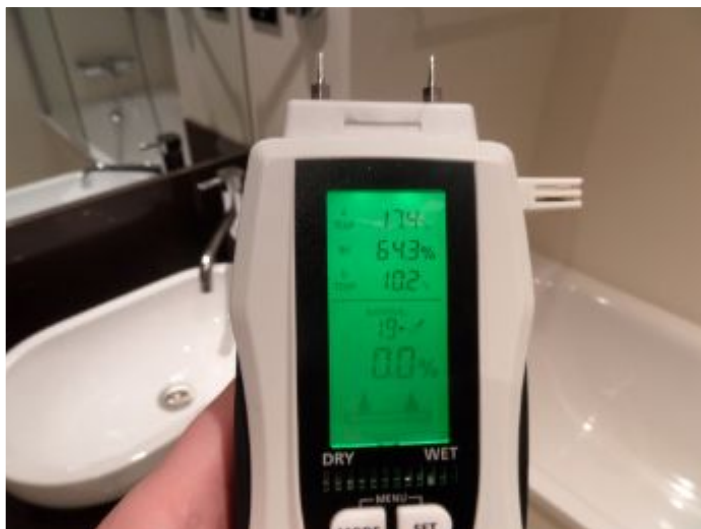
RH level in bathroom, c, 64 %

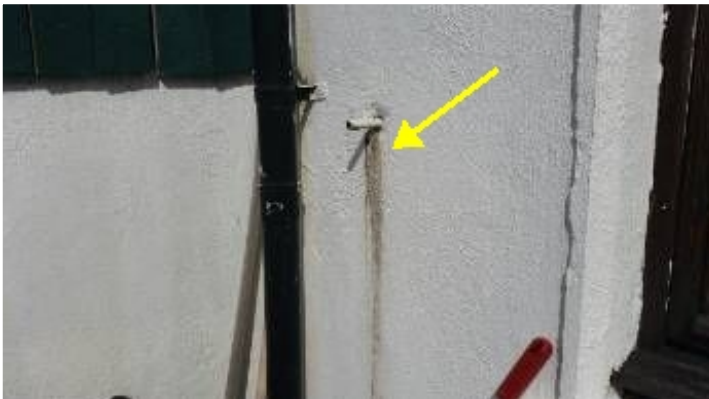
1.5. Water dripping out of pressure relief valve, indication of water over heating, service required.

Water dripping out of pressure relief valve, indication of water over heating, service required.

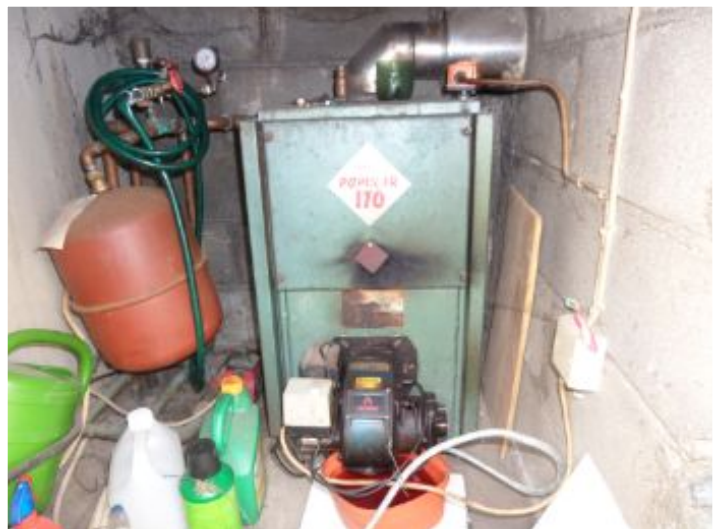
1.4. Burner aging.

Full service required.

1.1. The heating system is now probably overdue for a service and therefore before you purchase, I recommend that you ask a qualified heating engineer to check and service the heating system or arrange for the owners to do this and then you should set in hand an annual maintenance agreement.

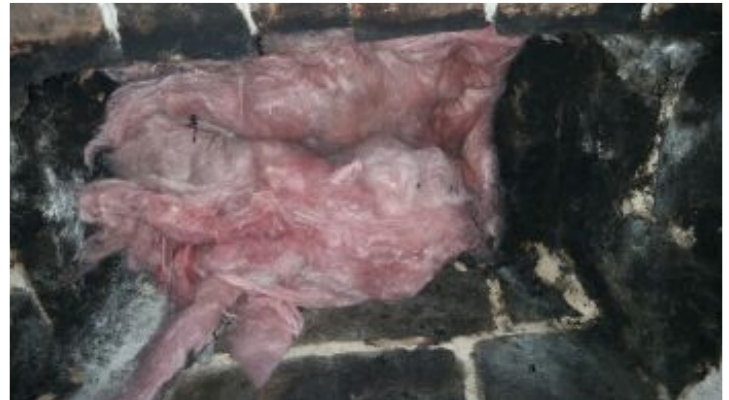
6.2. Fibreglas insulation stuffed up chimney. Clean out before use.

Fibreglas insulation stuffed up chimney. Clean out before use.

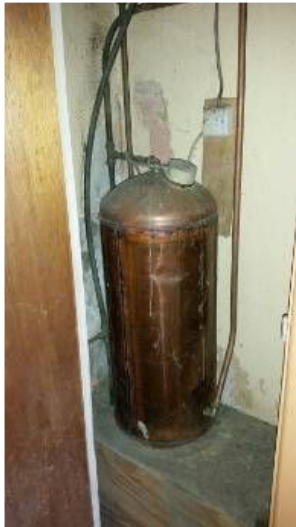
Aging copper cylinder.

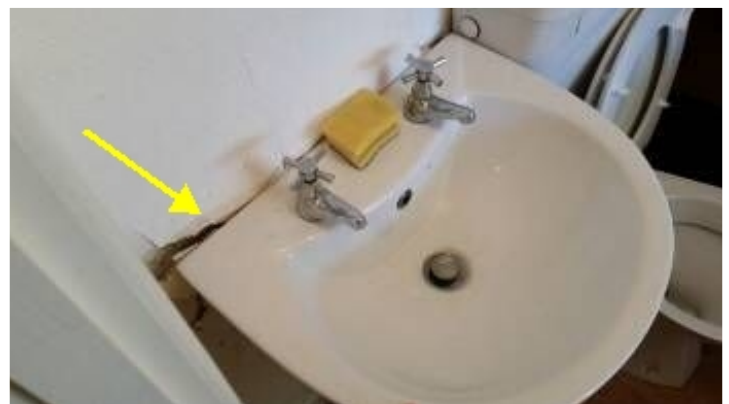
Secure loose w/h basin in in downstairs bathroom.

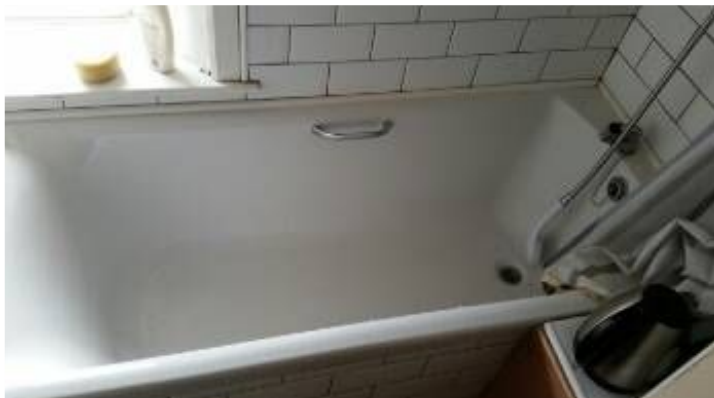
Re-seal around bathtub.

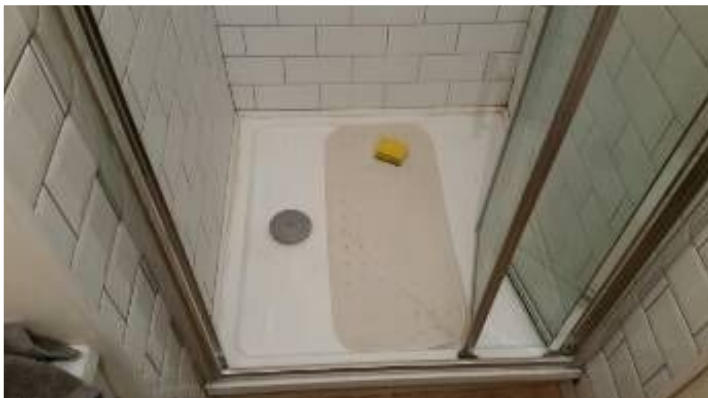
Re-seal around shower tray.

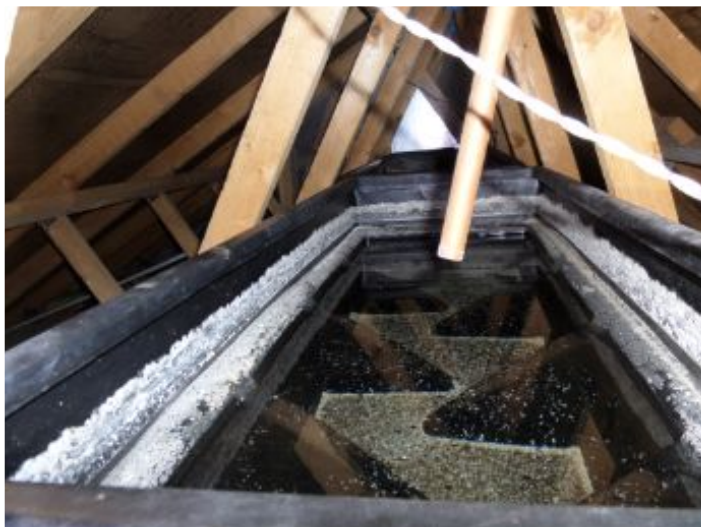
- 5.1. **PVC** water storage tank.
- 5.2. Cover required over water storage tank.

Cover required over water storage tank.

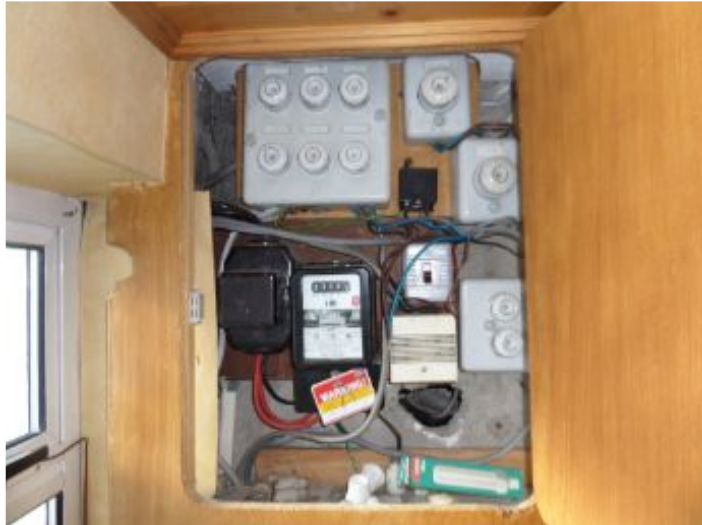
Main fuse panel.

3.1. Replace aging fuse panel with a modern breaker panel.

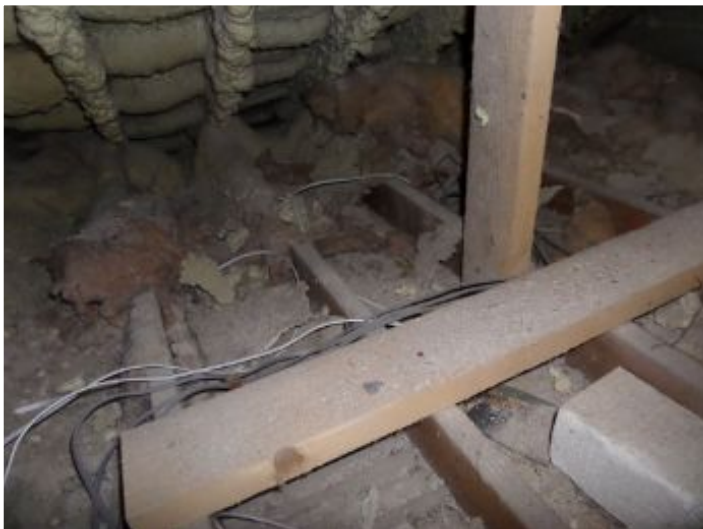
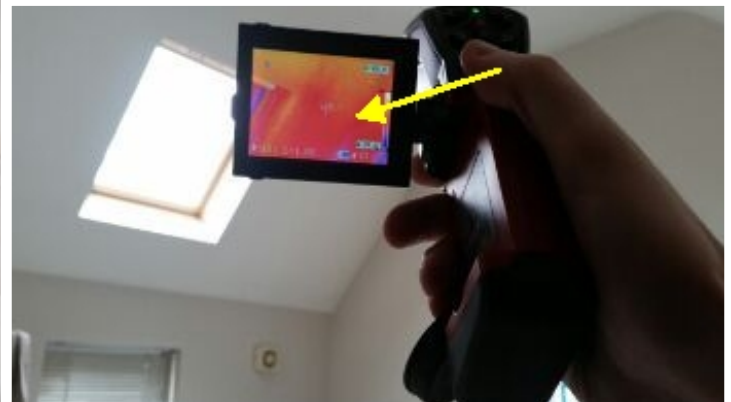
3.2. Sections of insulation missing / poorly fitted in sloped ceilings.

Insulation poorly fitted in sloped ceilings.

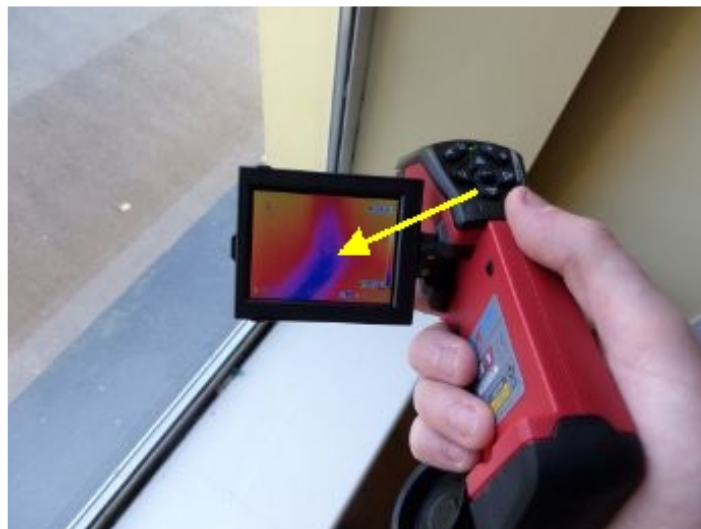
6.1. Single glazing, minimum insulation value.

Single glazing, minimum insulation value.

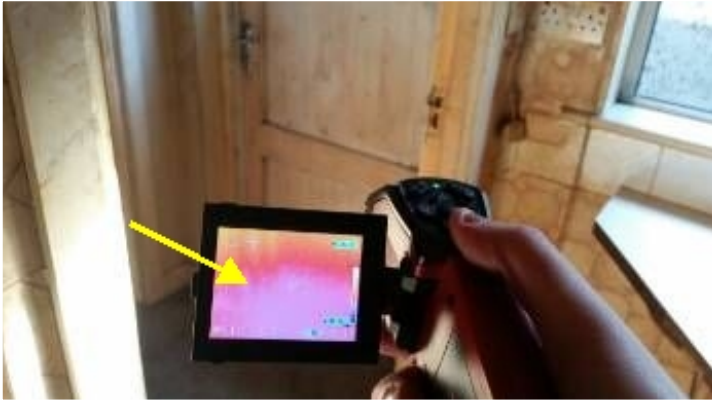
7.1. Minimum insulation to exterior doors.

Minimum insulation to exterior doors.

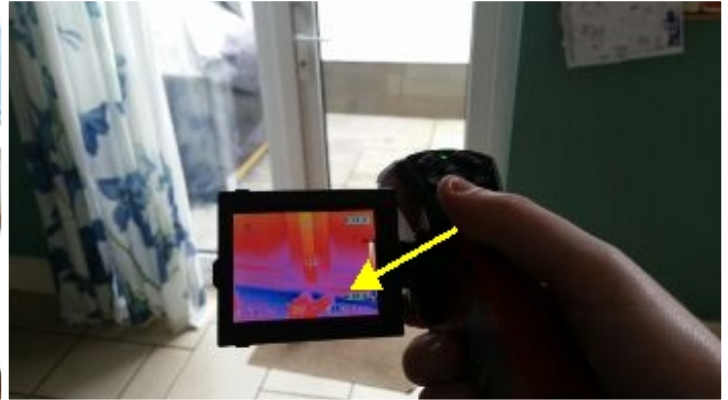
Minimum insulation to exterior doors.

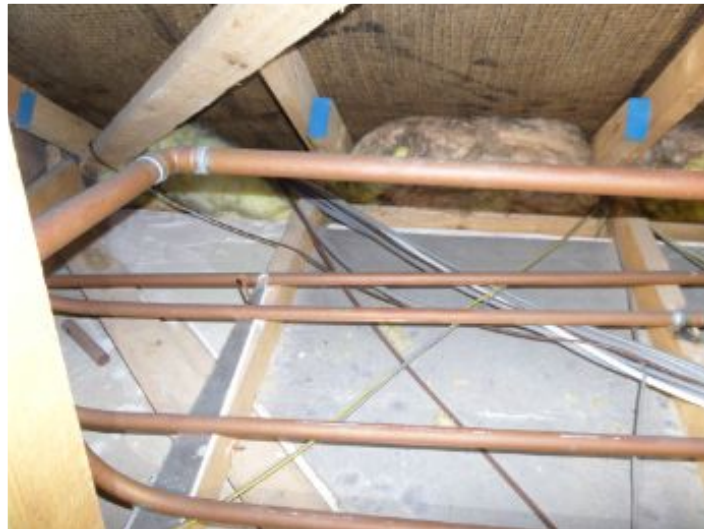
8.1. Insulate all plumbing pipes in attic.

Insulate all plumbing pipes in attic.
