# Confidential Property Survey Report

42 Old Street, Dublin

Inspection prepared for: Mr A Sample  
Date of Inspection: 14/4/2015

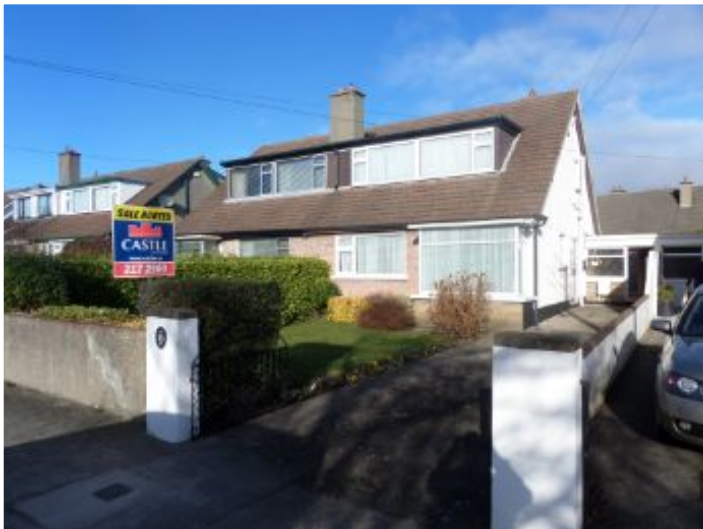
Front of property.

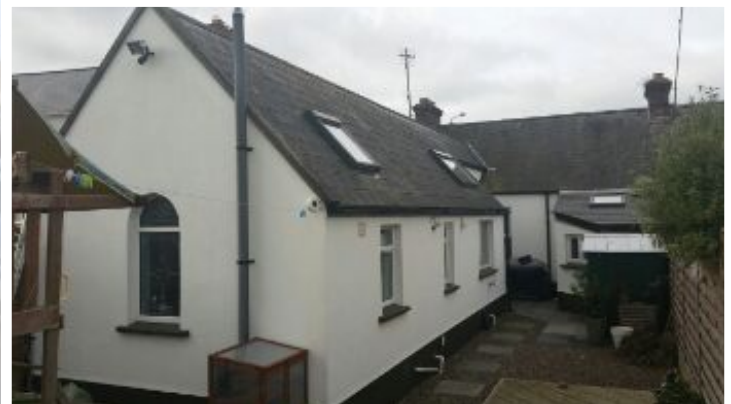
Back of Property.

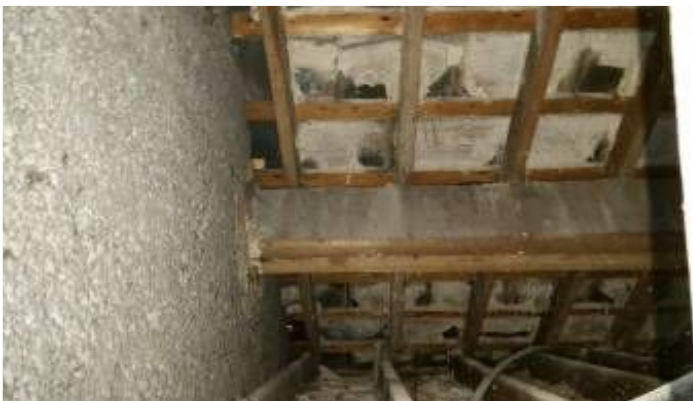
2.4. Dormant woodworm noted in structural timbers.

Main roof is constructed of traditional cut roof timbers.

2.5. Recommendation: Spraying recommended to roofspace as a precaution to eradicate common furniture beetle or other wood-boring insects often found in such buildings of this age. Quote to be sought from specialist with guarantee.

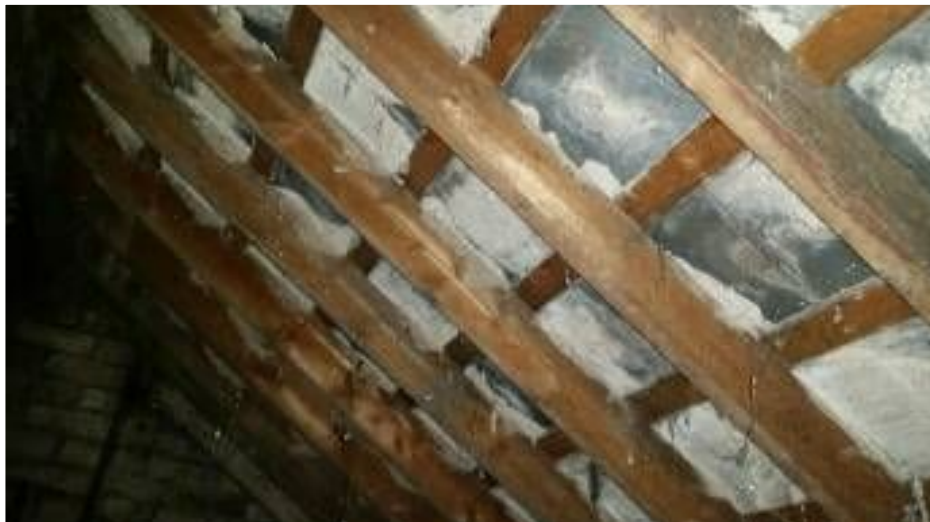
4.1. A cement/lime mortar fillet to underside of timber battens holding slates. this is an early form of sarking felt to additionally wind and weatherproof the roof.

A cement/lime mortar fillet to underside of timber battens holding slates. this is an early form of sarking felt to additionally wind and weatherproof the roof.

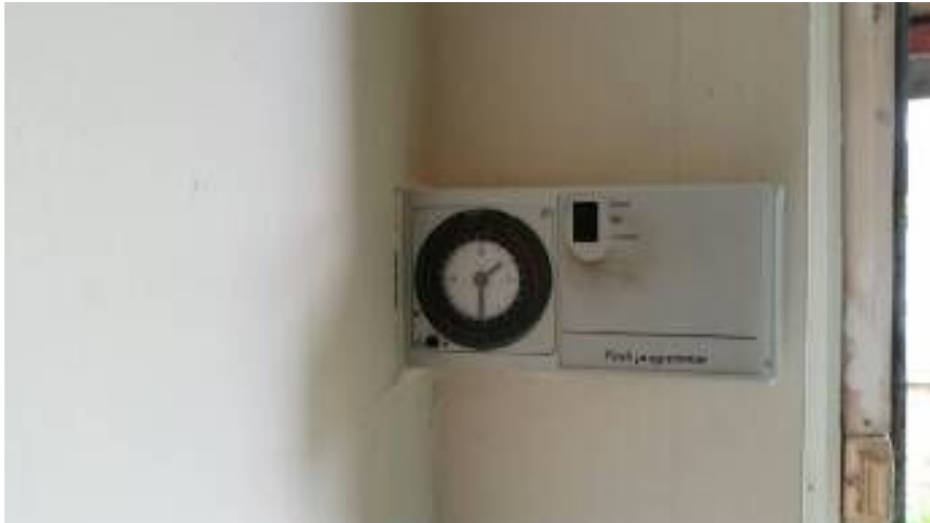
- 4.1. There is a basic programmer controlling the boiler.
- 4.2. No **IRV** /s fitted to radiators.

There is a basic programmer controlling the boiler.

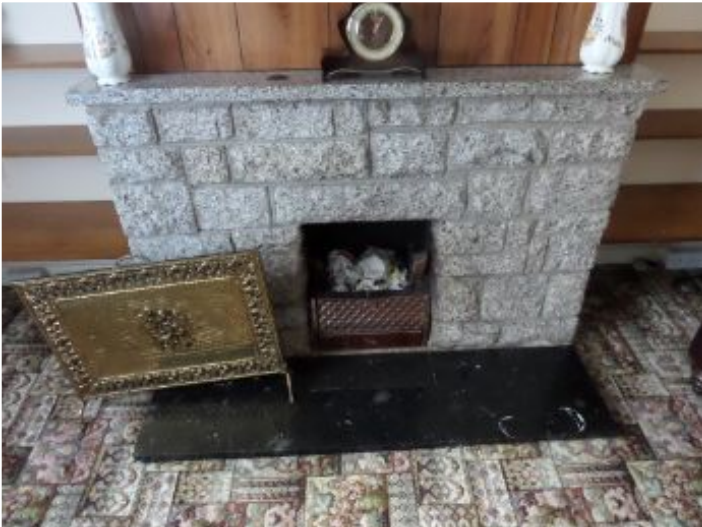
6.1. The fireplace/s would appear to be in a fair to reasonable condition where visible. However, in older properties such as this it would be expected that there would be some deterioration present in the chimney flue/s.

6.2. Fibreglas insulation stuffed up chimney. Clean out before use.

The fireplace/s would appear to be in a fair to reasonable condition where visible.

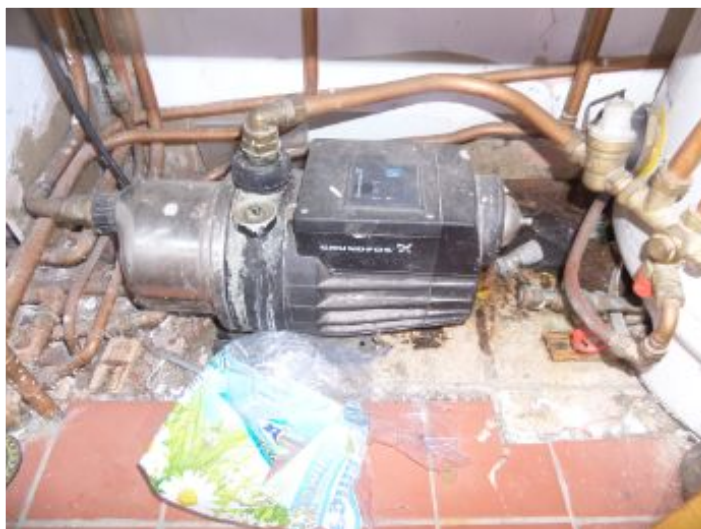
Water pump.

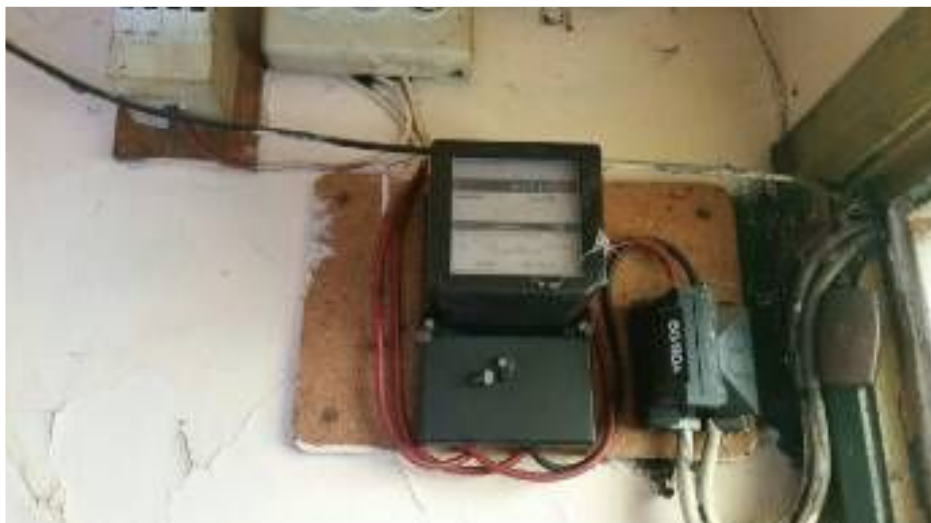
2.1. Single phase electrical supply.

ESB meter.

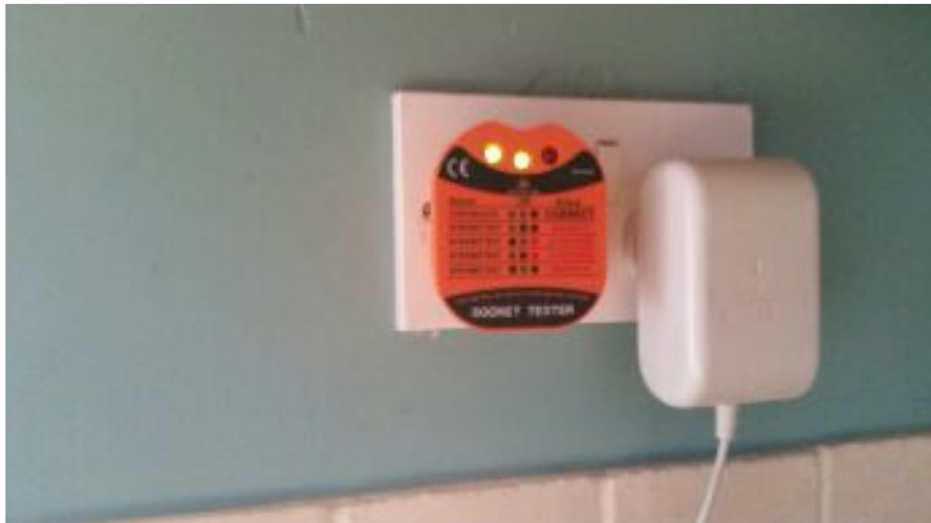
4.1. Wiring to plug sockets is earthed.

4.2. Limited number of electrical circuits for modern standards.

Wiring to plug sockets is earthed.

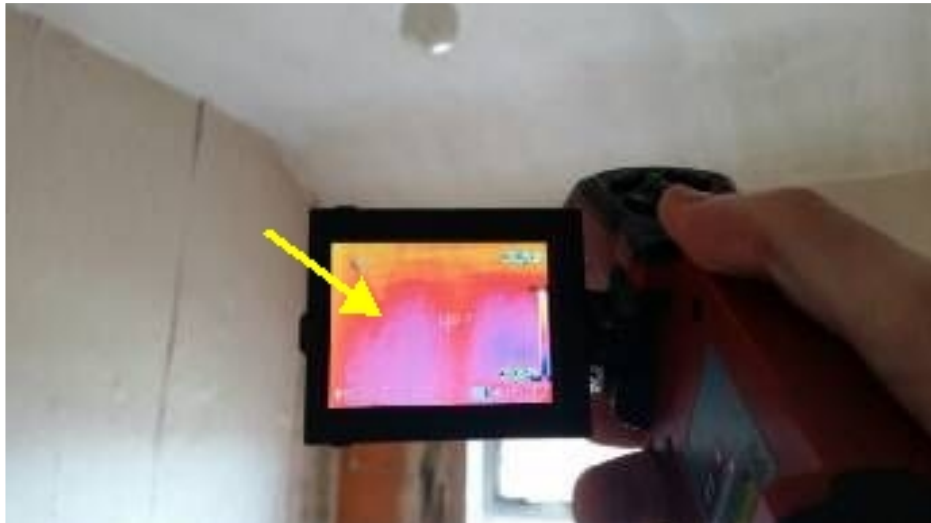
4.1. Considering the age of the property no / minimal insulation would be expected in the walls.

No insulation would be expected in the exterior walls.
